## **The collision between the commercial fishing vessel *Vertrouwen* and recreational motor cruiser *James 2* resulting in the sinking of *James 2* and loss of three lives Shoreham-by-Sea 6 August 2017**

### **SUMMARY**

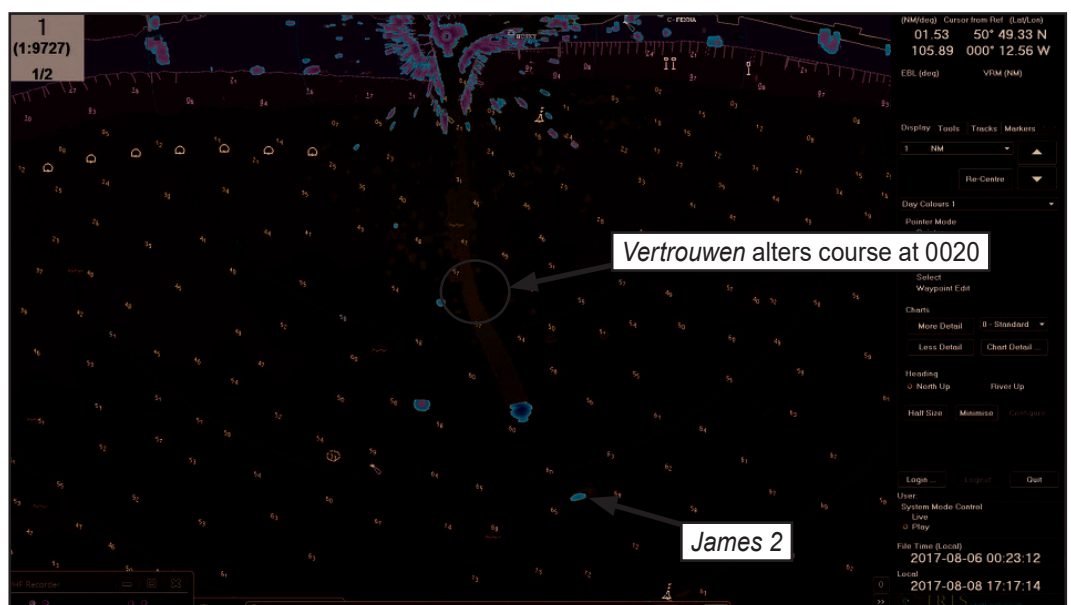
At 2354, *Vertrouwen's* skipper manoeuvred his vessel out of the dry dock and into the harbour lock. About 15 minutes later, *Vertrouwen* left the lock and proceeded out of the port, passing the outer breakwaters at 0015 (6 August). As the skipper brought the vessel out of the port, his crew made their way from the deck to the wheelhouse. The skipper told the crew that he had no other work for them to do and that he would take the first watch. The crew left the wheelhouse and went to their bunks. Once clear of Shoreham, the skipper increased *Vertrouwen's* speed to about 7kts and set a southerly course on the autopilot. At 0020, he altered course slightly to port, putting the vessel on a south-south-easterly heading (**Figure 3b**).

**Figure 3b:** *Vertrouwen* passage from Shoreham
