**Collision between the tender to *Isabell Princess of the Sea* and the rigid inflatable boat *Vega* in Göcek, Turkey, resulting in one fatality on 27 July 2024**

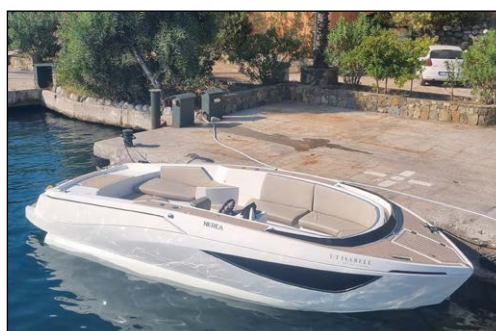
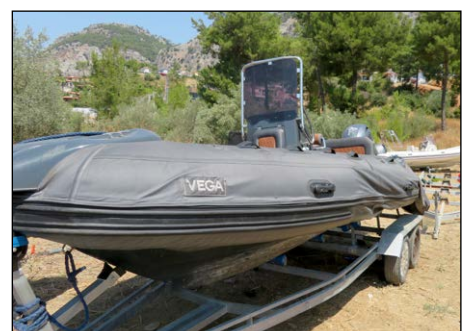
Tender to *Isabell Princess of the Sea* and RIB *Vega*

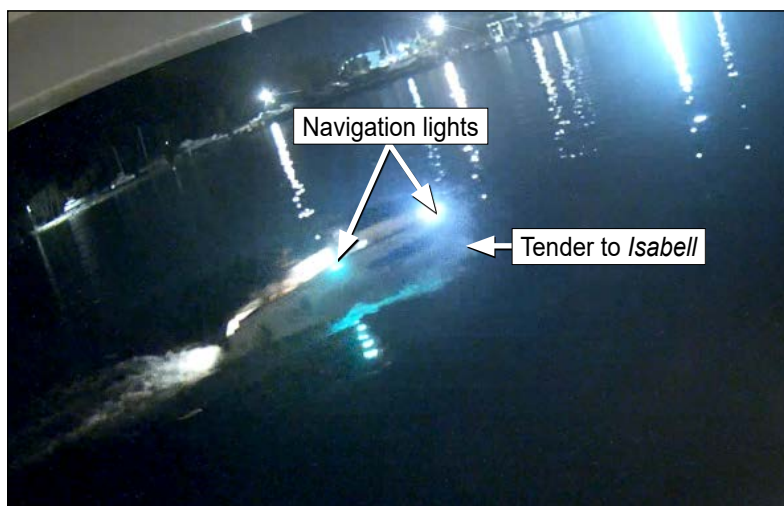
**Figure 2:** CCTV still, showing the tender underway
