## SYNOPSIS

On 3 December 2015, the Panama registered pure car carrier *City of Rotterdam* collided with the Danish registered ro-ro ferry *Primula Seaways* on the River Humber, UK. Both vessels were damaged but made their way to Immingham without assistance. There was no pollution and there were no serious injuries.

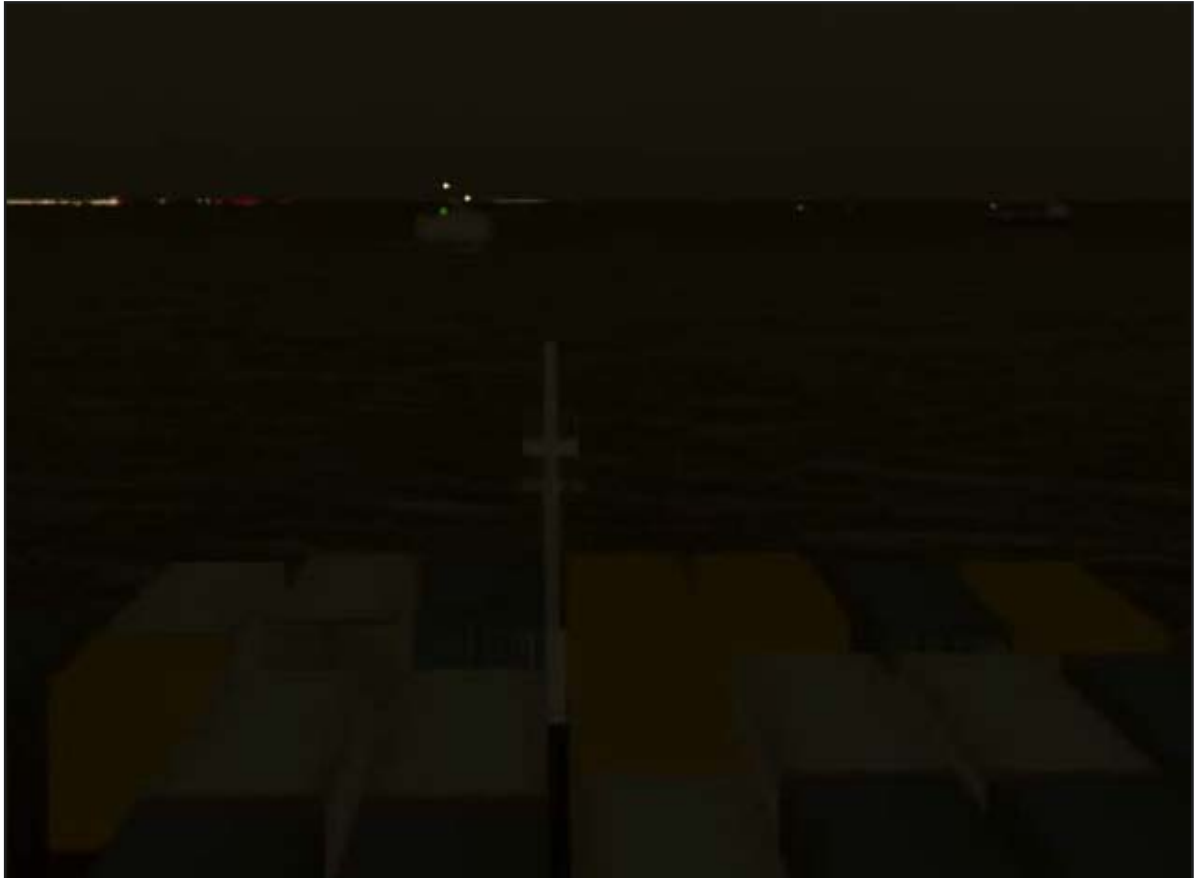
- When *Primula Seaways* started to reduce speed to 'half ahead' at 2038:25, *City of Rotterdam* was within 1nm (**Figure 18**). The car carrier's pilot had informed the ferry's master several times that he was manoeuvring to the south, yet there was no sign of the vessel doing so. From the simulations, it was evident that a course alteration to starboard would have caused the ferry to cross *City of Rotterdam*'s bow while an alteration to port would have exacerbated the close quarters situation that was developing if the car carrier did turn more to the south as the pilot had indicated.

**Figure 18:** Simulated night-time view from *Primula Seaways* at 2038:25, *City of Rotterdam* is showing its two masthead lights and green sidelight
