## SYNOPSIS

At 1658 on 29 August 2015, the Cyprus registered cargo ship *Daroja* and the St Kitts and Nevis registered oil bunker barge *Erin Wood* collided 4 nautical miles south-east of Peterhead, Scotland. Minor damage was caused to *Daroja* but damage to *Erin Wood* included breaches of the hull, resulting in flooding of the vessel and pollution from leaking fuel cargo.

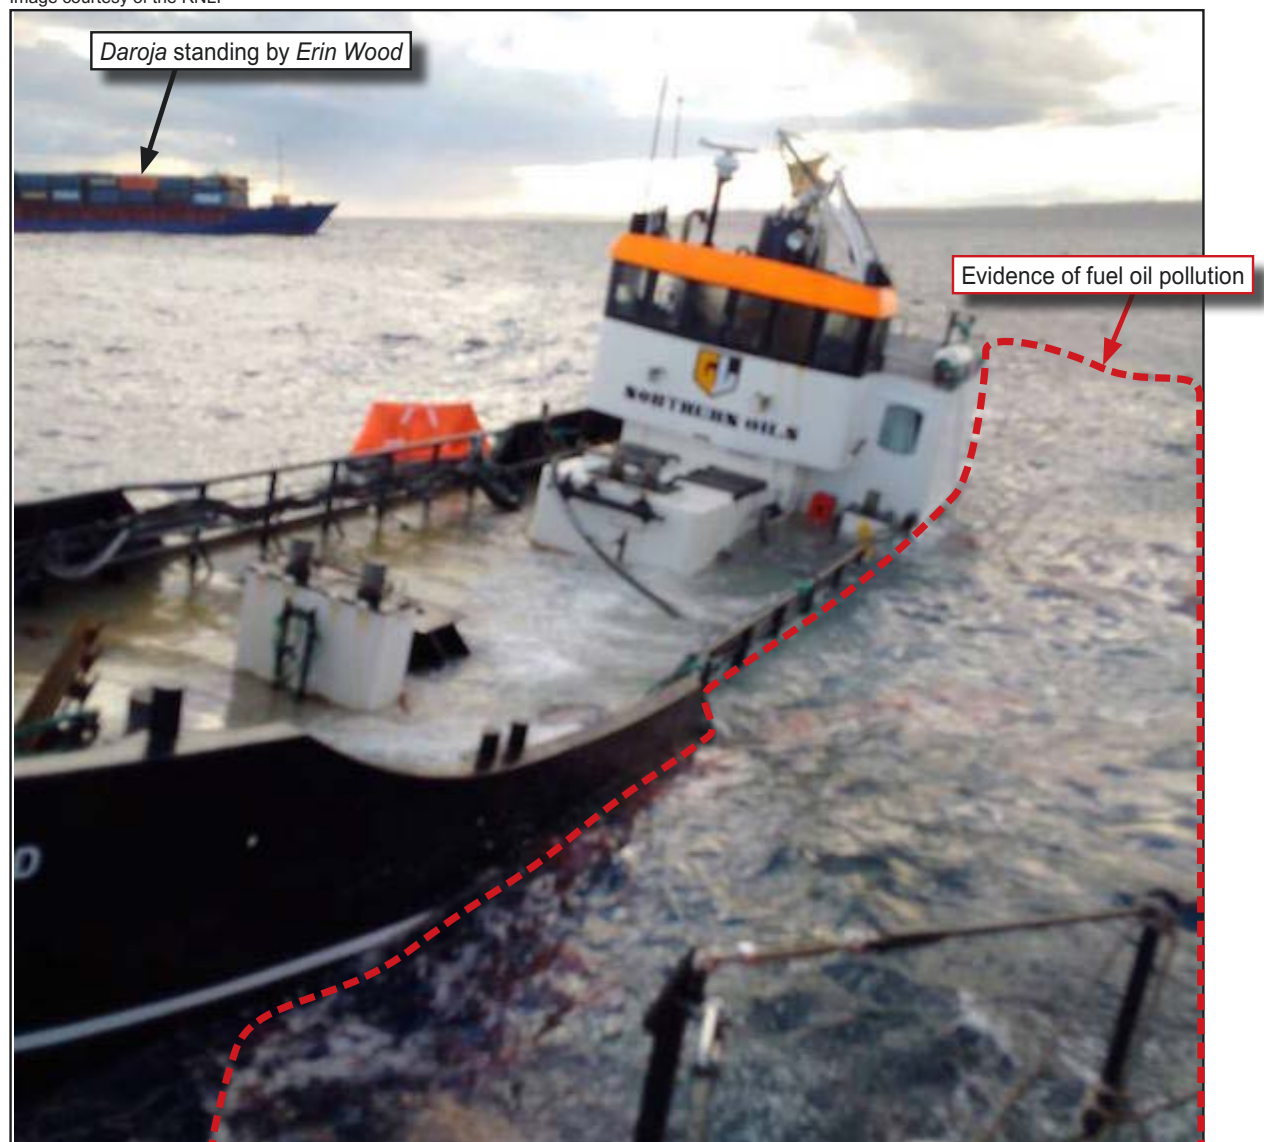
**Figure 6:** *Erin Wood* after the collision as seen from the Peterhead lifeboat, including evidence of fuel cargo pollution

The Peterhead RNLI lifeboat arrived at 1732 (**Figure 6**) and transferred two crewmen and a salvage pump onto *Erin Wood*. The RNLI salvage pump was used to assist the crew of *Erin Wood* in their efforts to pump out the floodwater from the

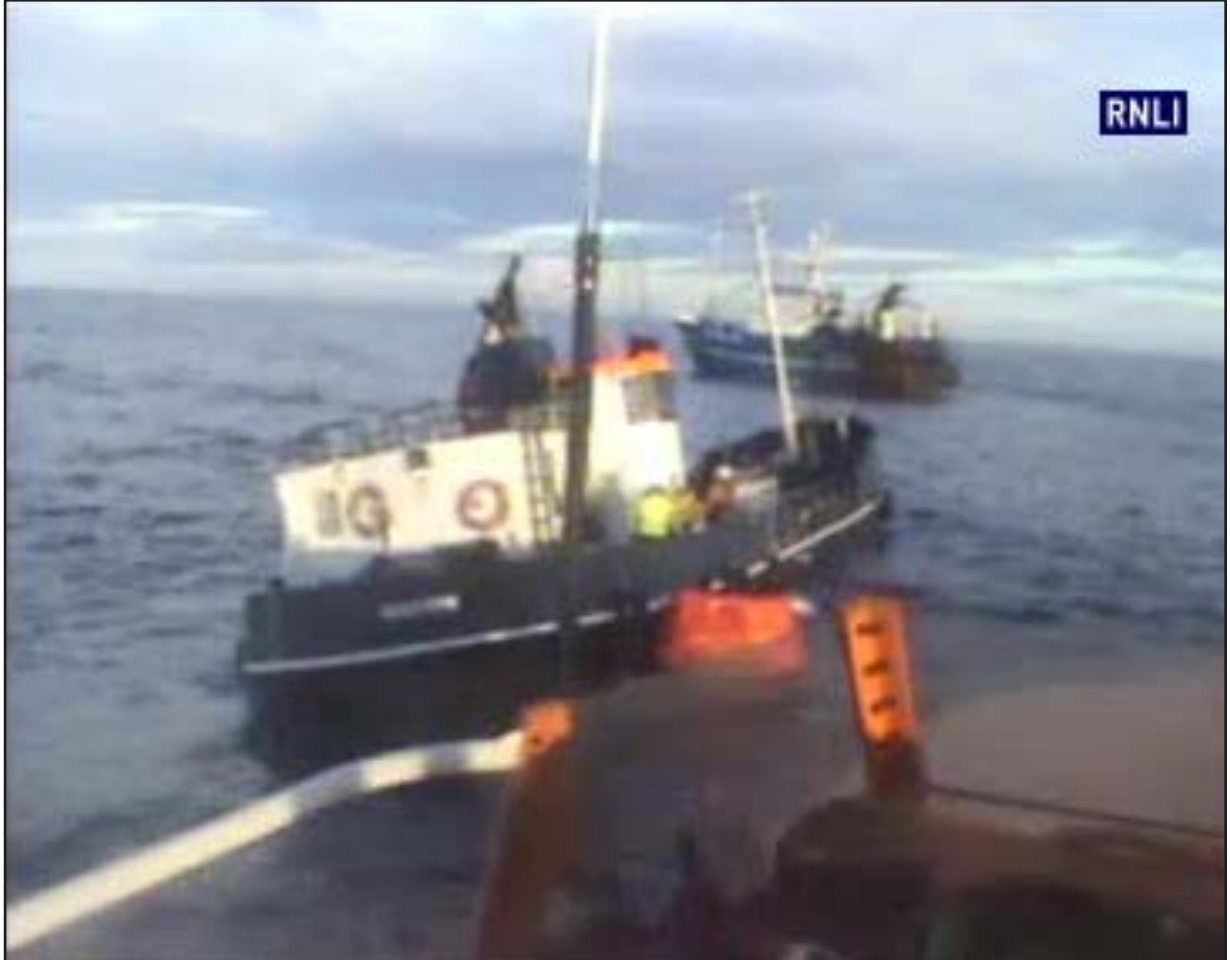
**Figure 8:** Fishing vessel *Ocean Endeavour* with *Erin Wood* in tow, taken from the Peterhead lifeboat

At 1830, Aberdeen Coastguard released *Daroja* from the scene but directed it to proceed alongside in Peterhead, where it arrived at 1945. The fishing vessel *Ocean Endeavour* arrived on scene at 1842 and started preparing to take *Erin Wood* in tow. *Grampian Talisman* was stood down by the lifeboat coxswain at 1941. Escorted by the lifeboat and under tow by *Ocean Endeavour* (**Figure 8**), *Erin Wood* berthed in Peterhead at about 2230.
