## SYNOPSIS

At about 1600 BST on 16 October 2000, the MAIB was informed of a collision involving the United Kingdom ro-ro passenger ferry *European Tideway*, and the Netherlands fishing vessel *Vrouw Grietje*. Damage was said to have been sustained by the ferry which was heading towards Felixstowe at slow speed. The ferry reported no injuries. It was unknown at that time if the fishing vessel had suffered any damage or injuries. MAIB inspector Andrew Clifton carried out the investigation.

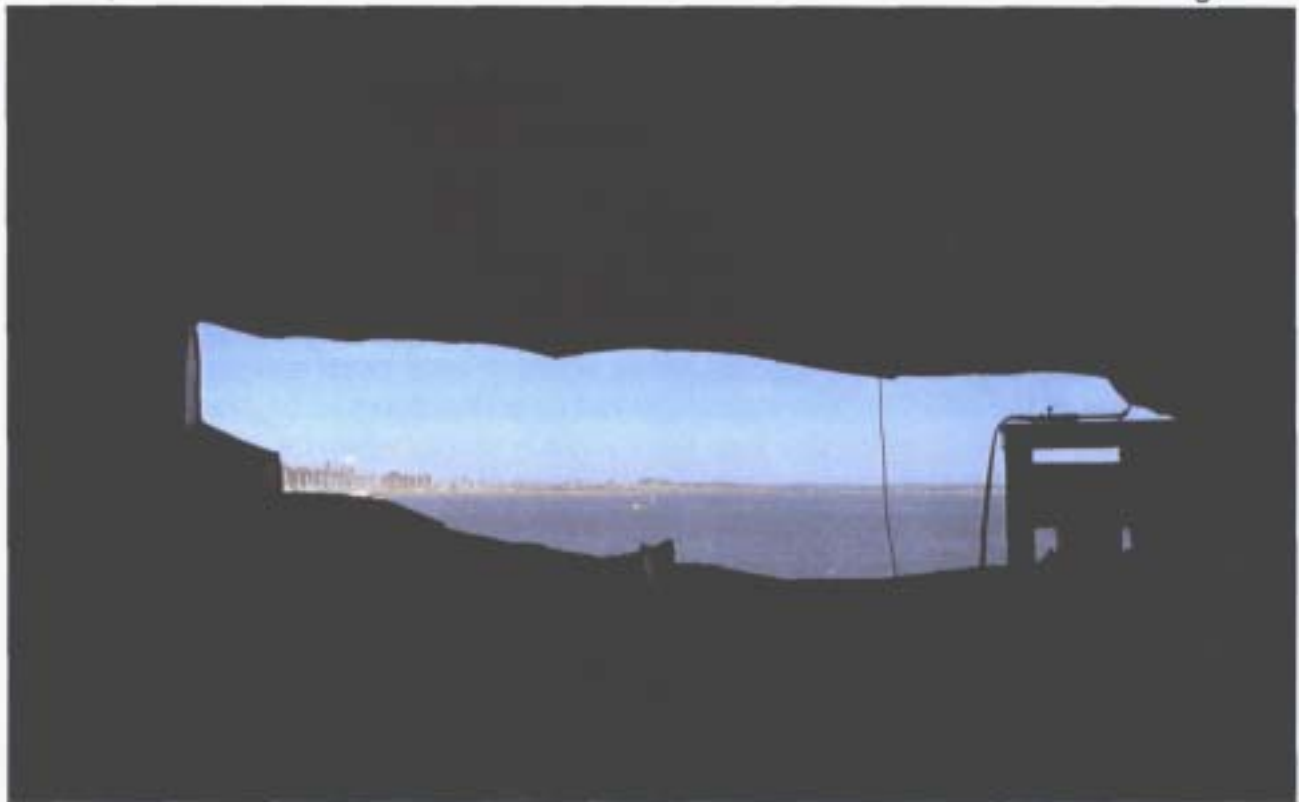
Figure 4

A 6 x 1.5m gash was found in the port bow of the ferry about 4m above the waterline. This was in way of the main car deck, (see Figure 4). *Vrouw Grietje* sustained only light damage to her bow and forward handrails (see Figure 5). She continued fishing for the rest of the week before returning to port.

Damage to *European Tideway* (viewed from car deck)

*European Tideway* discharged her cargo and then proceeded to Rotterdam for repairs, which were completed on 23 October when she resumed service.

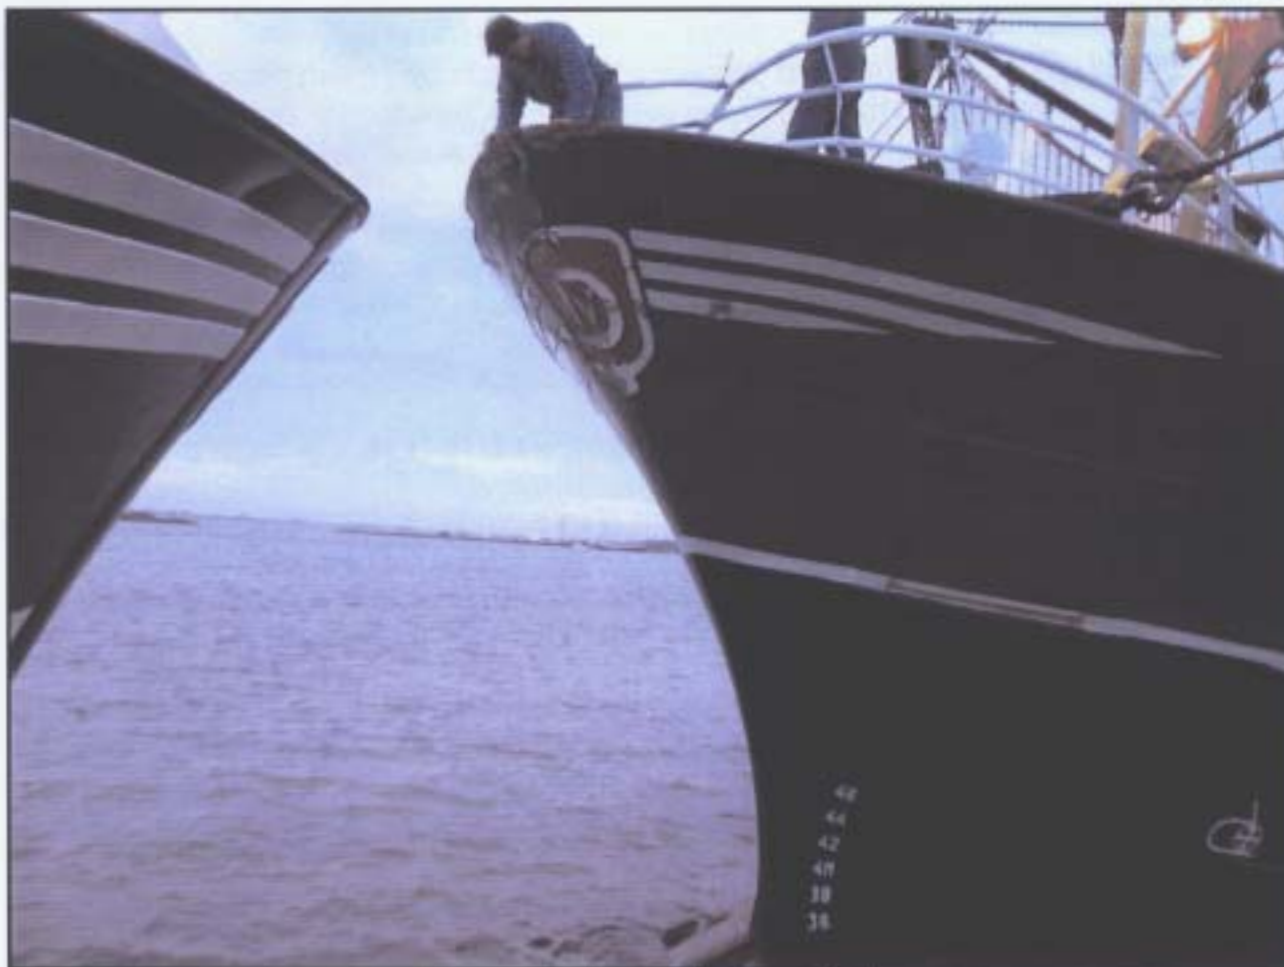
*Vrouw Grietje* suffered slight damage to her bow and forward handrails. *European Tideway* sustained a 6-metre long gash in her port bow above the waterline. There were no injuries and no pollution.

Damage to bow of *Vrouw Grietje*
