## SYNOPSIS

On 24 June 2022, while alongside at King George Dock, Hull, England, the crew of the UK registered fishing vessel *Kirkella* lost control of its propulsion system and the vessel collided with the unmanned tug *Shovette*, which was moored ahead of *Kirkella*. During the collision *Shovette*'s hull and starboard fuel tank were breached by *Kirkella*'s bulbous bow. The tug partially sank, which resulted in pollution of about 7,000 litres of marine diesel oil being released into the dock. *Kirkella* was not significantly damaged and there were no injuries.

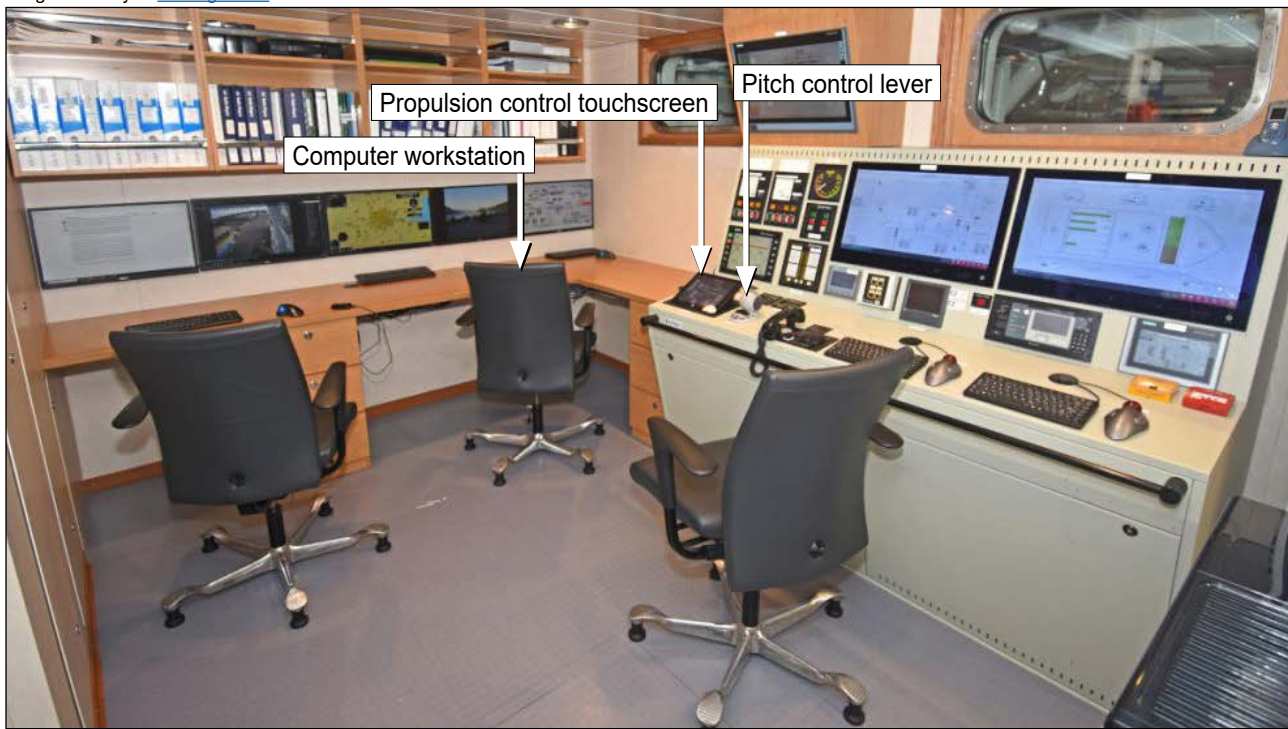
**Figure 3:** The engine control room

At 0611, *Kirkella*'s master passed control of the vessel's propulsion system from the starboard wing control station to the centre console position (**Figure 2**). At the same time, the crew deployed the vessel's gangway to the quayside. Once the master was content that the vessel was secured in position control of the propulsion system was passed to the ECR (**Figure 3**) so that the main engine could be shut down.

1. The engine control room pitch control lever had been left in the 'full ahead' position following engine maintenance conducted while the vessel was at sea. [2.3]

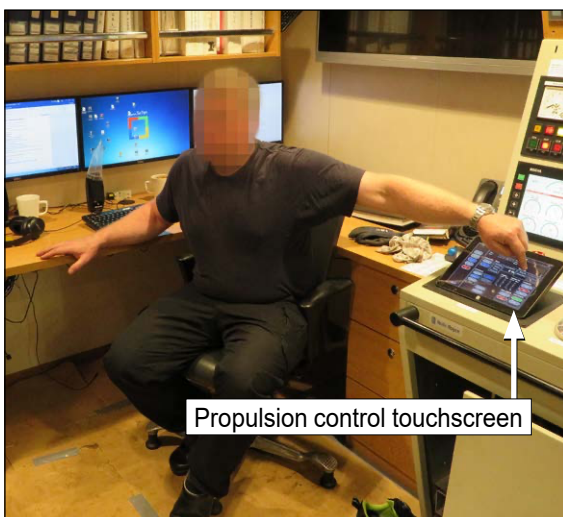
**Figure 4:** Engineer reaching across to the propulsion control touchscreen

The first engineer (1/E) was sitting in the ECR working at a computer. The 1/E heard the propulsion command change alarm and reached across from their chair and pressed the 'ECR' then 'Accept' buttons on the touchscreen to accept control (**Figure 4**). Eighteen seconds later, *Kirkella* started to move ahead.

The sounding of the control change alarm had become routine because the 1/E had completed the acceptance process many times before. With no telephone communication from the bridge to advise of changeover, the 1/E had no reason to stand in front of the propulsion control screen and pitch control lever (see **Figure 4**) and did not expect anything to be different on this occasion. This was evident from the 1/E's immediate return to administrative duties until the telephone call from the

2. *Kirkella's* engineer accepted control without checking that the pitch control lever was set at zero. With no interlocks to prevent changeover with mismatched levers, control was taken at the ECR control station with its pitch control lever at 'full ahead' and the propeller pitch increased to 85% before the master pressed the emergency declutch button. [2.3]

2. Robust shipboard practices are essential to maintain propulsion control during handover, regardless of whether system interlocks are fitted. Documented procedures should contain a requirement for the operator of the sending station and the receiving station to check that propulsion systems pitch settings are aligned at the time of transfer.
