## SYNOPSIS

On 10 August 2009, the Greek registered tanker *Saetta* and the Marshall Islands' registered tanker *Conger* collided when completing a ship to ship (STS) transfer operation off Southwold, Suffolk. *Saetta*'s starboard lifeboat and davit were damaged. *Conger* was undamaged and there were no injuries and no pollution.

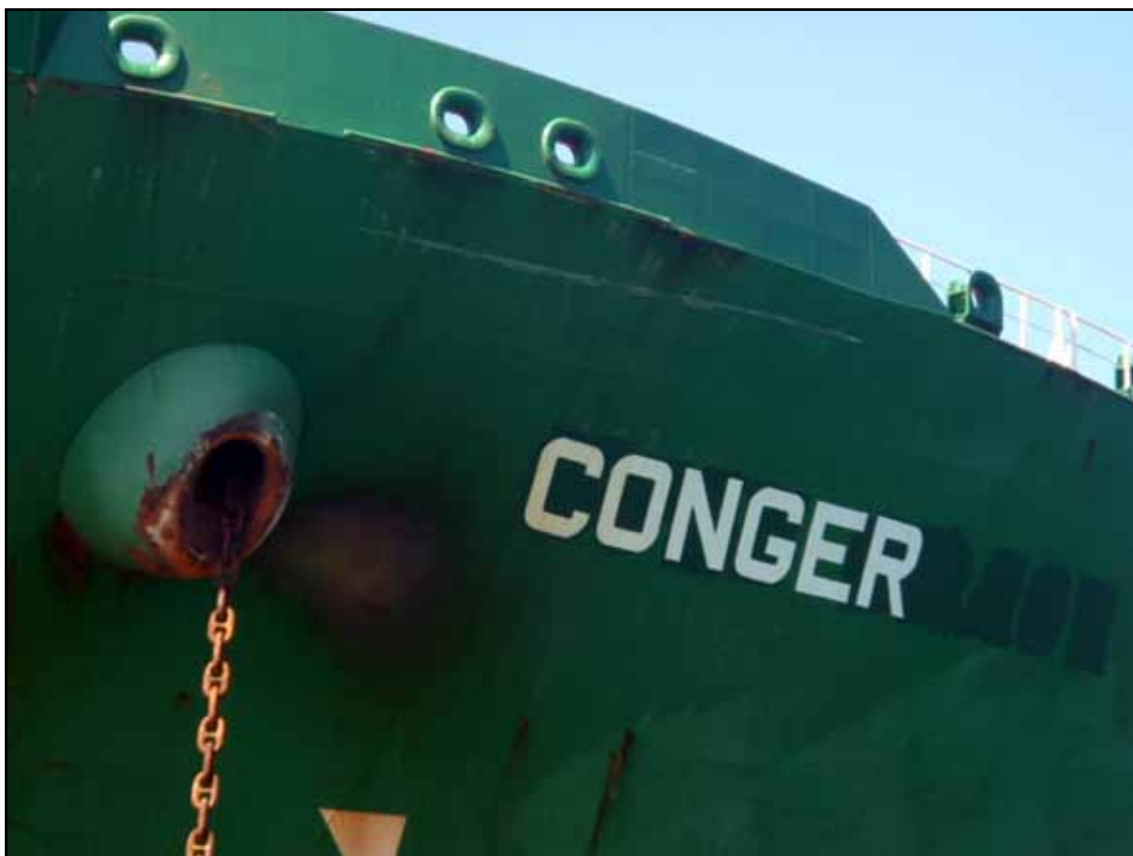
*Saetta* suffered structural damage to her starboard lifeboat (**Figure 5**) and the lifeboat davit arm (**Figure 6**). *Conger* suffered only scratches to her paintwork (**Figure 7**).

Scratches to *Conger's* paintwork
