## SYNOPSIS

At 0327 on 13 December 2021, the UK registered general cargo ship *Scot Carrier* and the Denmark registered split hopper barge *Karin Høj* collided in the precautionary area adjacent to the Bornholmsgat traffic separation scheme, Sweden. As a result of the collision, *Karin Høj* capsized and its two crew lost their lives.

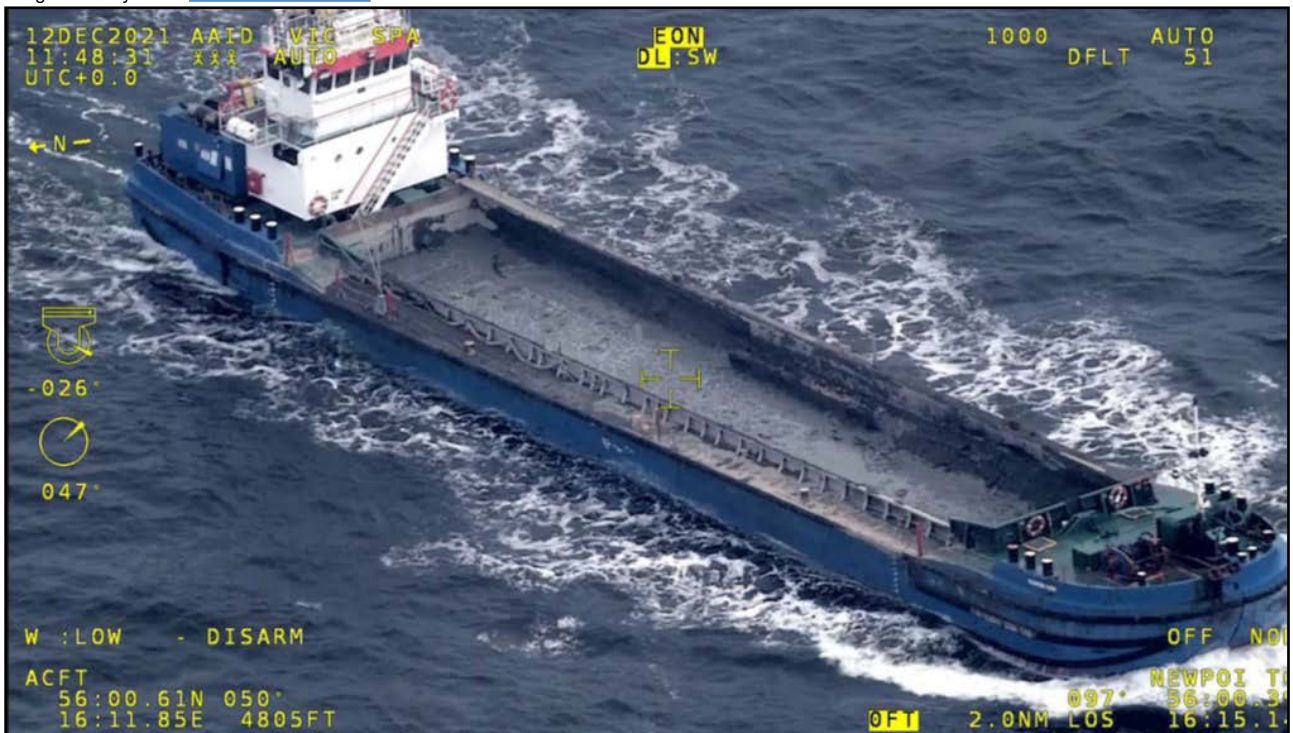
**Figure 2:** Swedish Coast Guard maritime surveillance photograph of *Karin Høj* on 12 December

At 1248 on 12 December, a Swedish Coast Guard maritime surveillance aircraft flew over *Karin Høj* and captured footage of the barge in transit (**Figure 2**), which showed the vessel carrying a part load of silt and water as ballast.

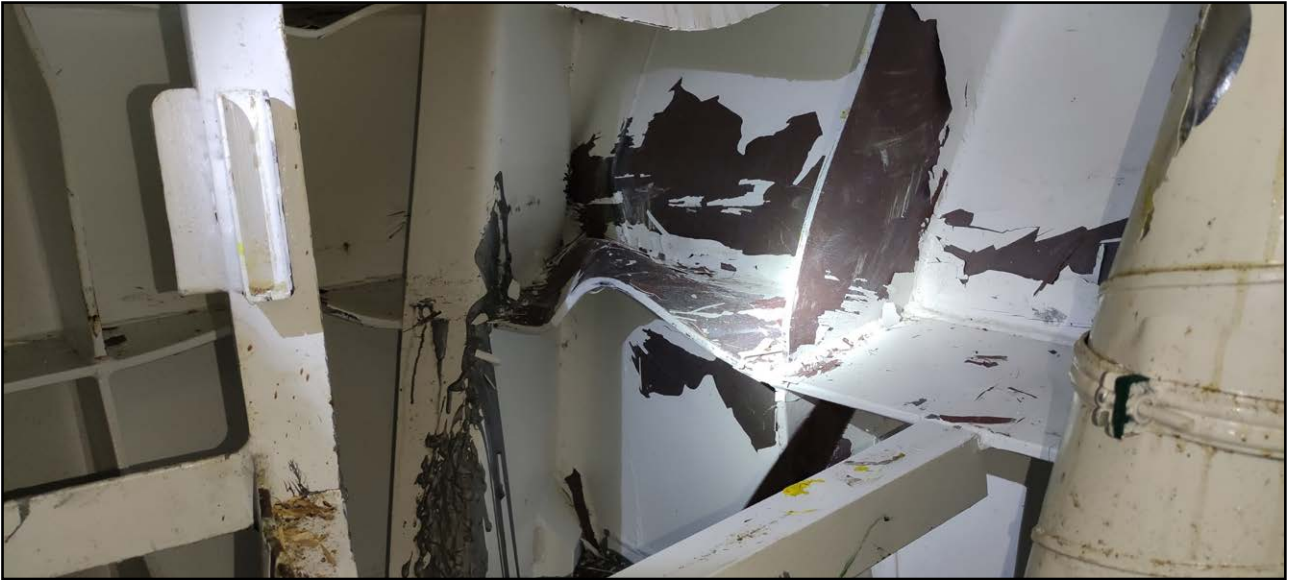
**Figure 18:** Damage to *Scot Carrier*'s internal bow structure

On 14 December, a Lloyd's Register surveyor attended *Scot Carrier* to assess the damage to the ship's bow (**Figures 15, 16 and 18**) and noted:

*Indentations in the bow in height of paint store, well above waterline. An area of 600x500x500[mm] in the bow, internals (stiffener+ brackets) bent on both side of bow about half frame distance [sic]*

It was estimated that the draughts of *Scot Carrier* and *Karin Høj* measured 5.10m and 1.70m, respectively (**Figure 32**). As the ships collided at a relative speed of 8.7kts, *Scot Carrier*'s bulbous bow struck *Karin Høj*'s bilge plating broad on the port quarter; AIS data showed that the angle of impact was about 50°, which corresponded with both the angle of indent in the bilge plating on *Karin Høj* and the damage and silt residue to *Scot Carrier*'s bow.

The surveyor issued *Scot Carrier* with a condition of class<sup>10</sup> that required repairs to be completed within 2 months.
