## SYNOPSIS

At 0027 on 11 December 2013, the general cargo vessel *Paula C* and the bulk carrier *Darya Gayatri* collided in the south-west lane of the Dover Strait Traffic Separation Scheme. Both vessels were damaged but there were no injuries and there was no pollution. The collision occurred as a result of *Paula C* turning into the path of *Darya Gayatri* after the action taken by the general cargo ship's officer of the watch to avoid the Belgium registered beam trawler *Raquel* had not gone as intended.

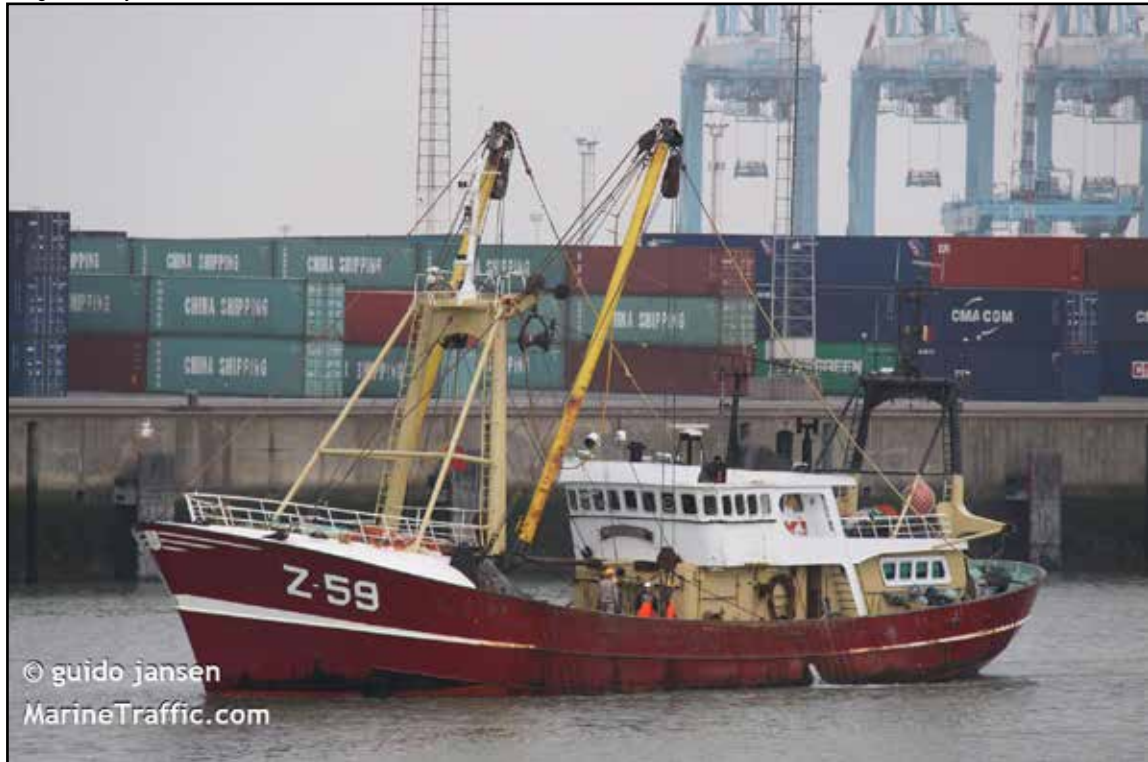
The vessel ahead of *Paula C* was the Belgium registered beam trawler *Raquel*, which was towing its nets on a COG of 153° at a speed of 4.8kts (**Figure 2**). *Raquel* was displaying the appropriate lights for a power-driven vessel underway and engaged in trawling<sup>4</sup>; the vessel's deck lights were also switched on. The beam trawler's AIS was transmitting static and dynamic information, including its status (engaged in fishing), SOG and COG. However, no heading information was broadcast.

*Raquel*'s skipper was on watch in the wheelhouse and he was monitoring other vessels in the area visually, by radar and by AIS. The skipper had seen *Paula C* and *Darya Gayatri* following the traffic lane and he was aware that he needed to take action in order to keep out of their way. Accordingly, at approximately 0013, with *Paula C* 3.4nm off the trawler's port bow, *Raquel*'s skipper began the first of several alterations to port, which were intended to eventually turn the fishing vessel onto a north-westerly heading (**Figure 3**). A single, broad alteration was not possible because *Raquel*'s manoeuvrability was limited by its fishing gear.
