## SYNOPSIS

At 0052 on 6 March 2004, the chemical tanker *Reno*, and the fishing vessel *Ocean Rose*, collided. *Reno* was carrying a cargo of acrylonitrile and was on passage from Teesport to Immingham; *Ocean Rose* was engaged in fishing. A further collision between the two vessels occurred several minutes later when *Reno* was manoeuvring at slow speed to provide assistance. *Ocean Rose* sustained major damage during the first collision, but with the assistance of the coastguard and the Staithes and Whitby lifeboats, was able to reach Whitby under her own power. The damage to *Reno* was superficial.

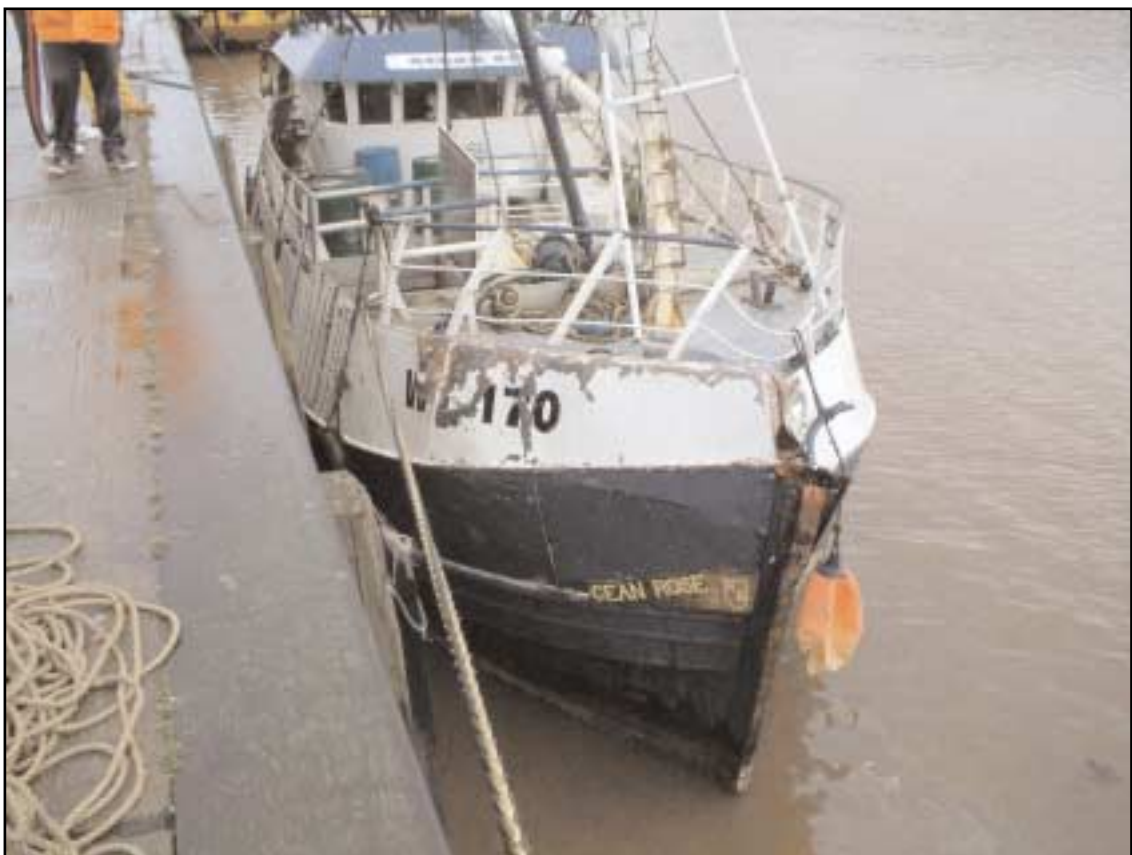
Figure 1

The collision occurred at 0052 and 38 seconds, and was almost head on. *Ocean Rose* was hit on her stem and starboard bow, which caused her to roll heavily to port. The skipper was thrown to the port side of the wheelhouse, and the deckhands fell forward on to the deck. The skipper immediately assessed that *Ocean Rose* had suffered substantial damage, and sent a "Mayday" via VHF radio, and by pressing the distress button on his Inmarsat radio. The damage to the forward part of *Ocean Rose* is shown at **Figure 1**.

Damage to *Ocean Rose* - forward
