How to read input shaper graphs: a work in progress

Compilation by Reth (the original Reth)

Reth's Voron Trident – serial 1190

Version 8-8-2024

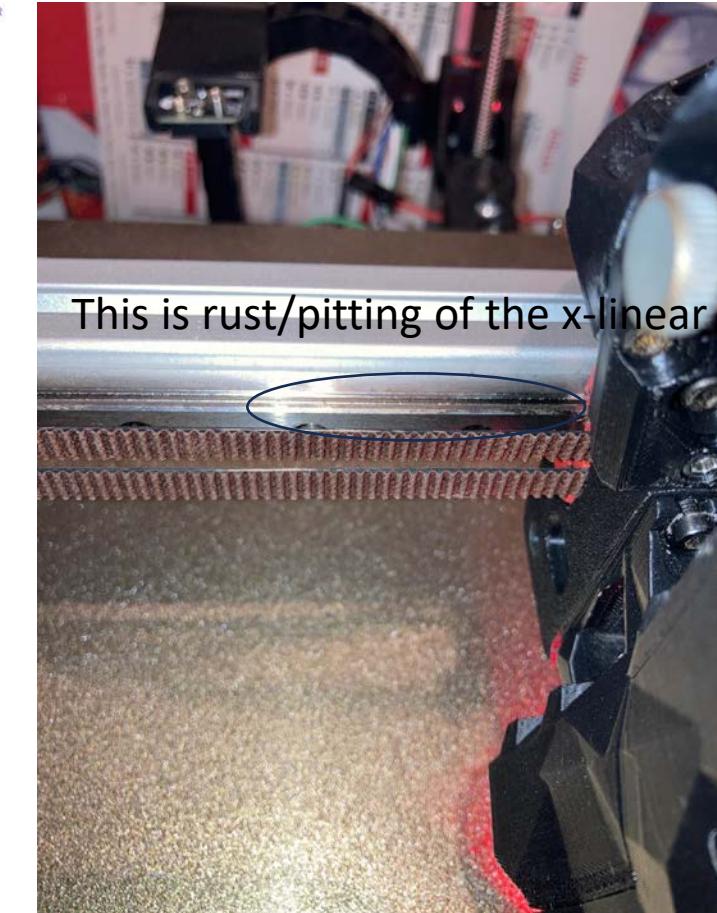
The 100hz spike in belts and x-shaper
Is due to a rusted (pitted) potentially
Twisted x-linear rail

This is rust/pitting of the x-linear rail
