# How to read input shaper graphs: a work in progress

Compilation by Reth (the original Reth)

Version 8-8-2024

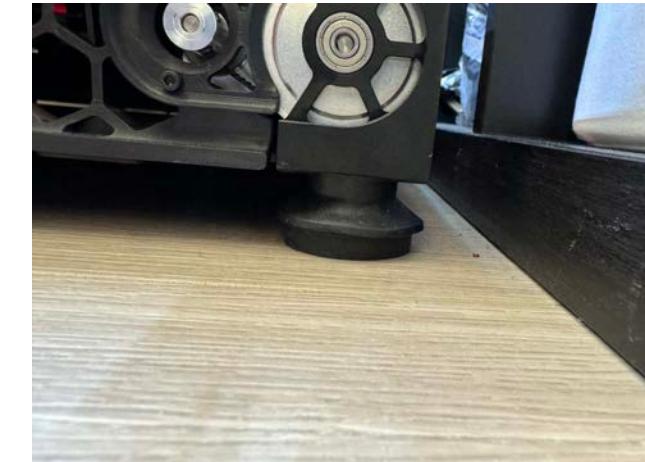
# Printer wobbled on floor. Added dampers to the printer feet

As additional vibration  
damper

Ioannis\_gi V2.6589  
Used: Raise It Isolation  
Feet for Speaker  
Vibration/Ventilation
