# CLOSING PACKET

9614 DEER TRACK CT, BRENTWOOD, TN 37027

9614 Deer Track Court, Brentwood, TN August 3, 2026

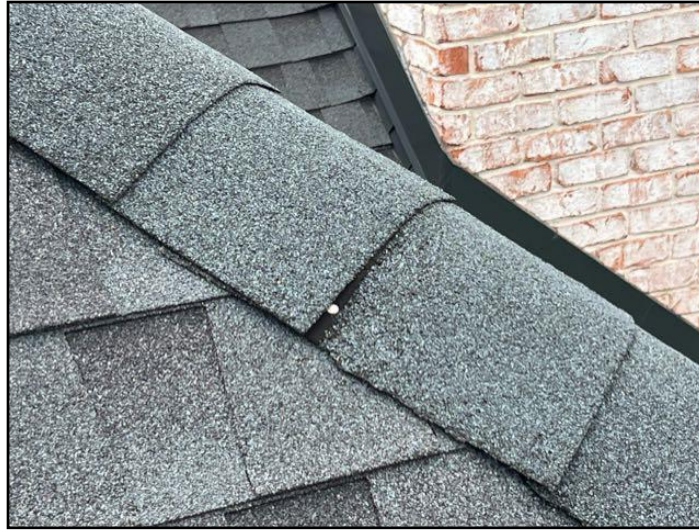
1. Exposed fasteners

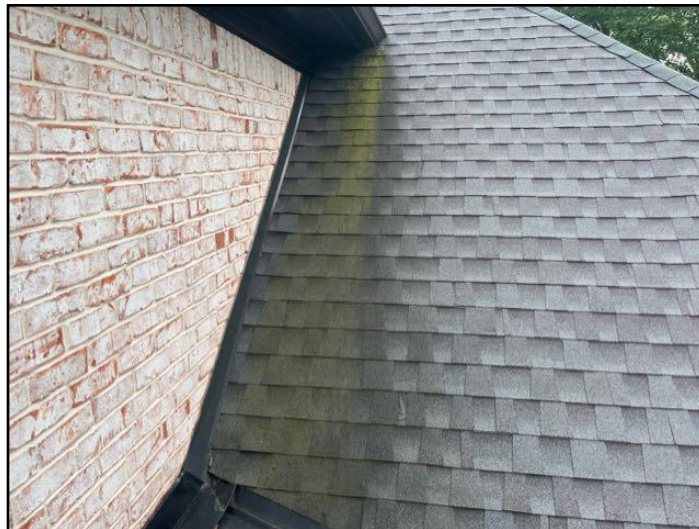
2. Moss growth

## 2. Condition: • Moss growth

Moss growth is a symptom and evidence that a portion of the roof is not receiving enough sun to dry out. The presence of moss may allow for additional water to be retained in that area leading to potential water intrusion issues, and heavy moss growth can lead to build up of debris or degradation of the shingles. Moss should be monitored, and/or removed as desired, or as buildup increases.

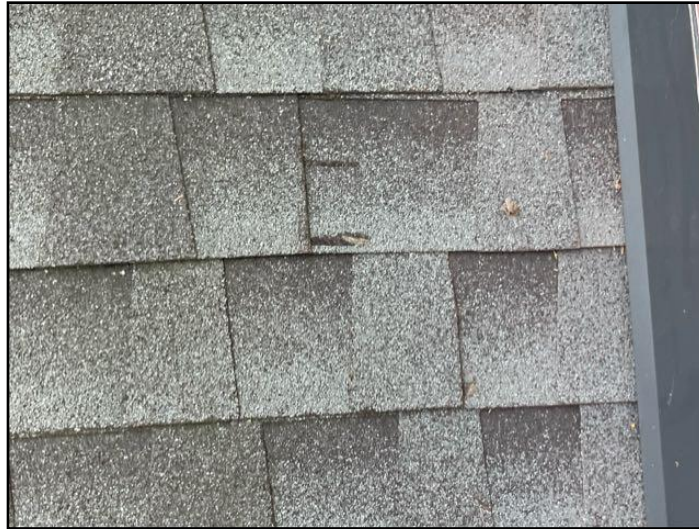
3. Minor abrasions

## 3. Condition: • Minor abrasions

Minor abrasions were found in the shingles at various locations. This can be caused by foot traffic, ladders and cleats used during construction, but can also be a result of minor manufacturing defects. The damage is unlikely to affect the roof's performance but can be repaired if desired.

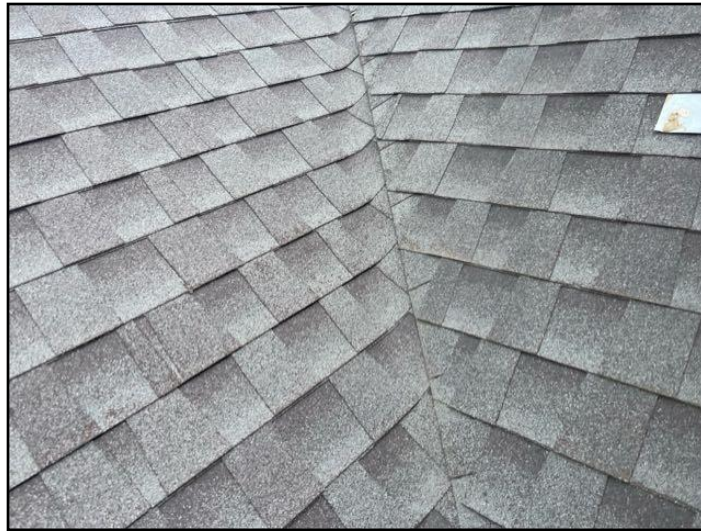
4. Granule loss

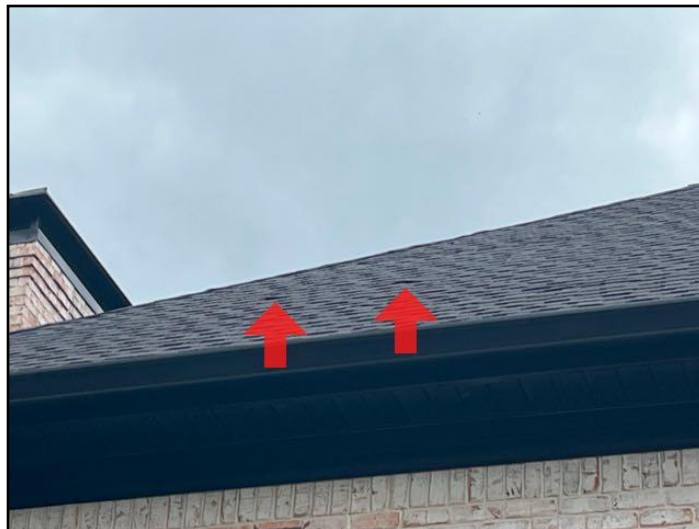
5. Withdrawn fasteners

## 5. Condition: • Withdrawn fasteners

Seasonal expansion and contraction of roofing materials and sheathing can cause fasteners to withdraw. This results in lifting of the shingles above the fastener. It is recommended that withdrawn fasteners be re-driven or replaced to prevent eventual, minor damage to the shingle due to penetration.

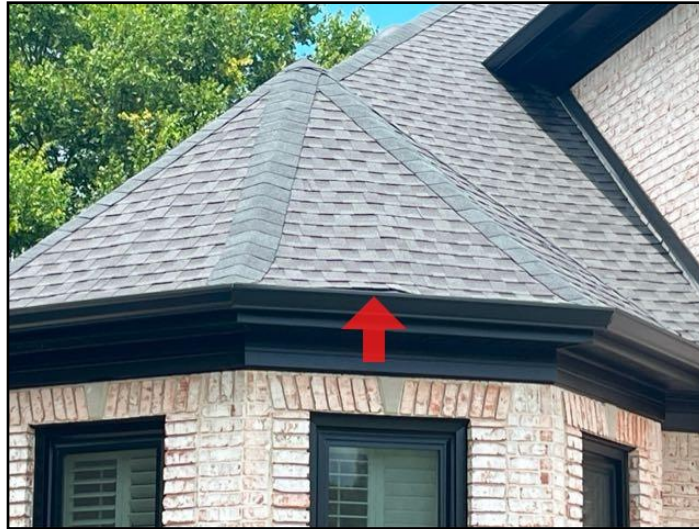
6. Loose

## 6. Condition: • Loose

Loose shingles were noted at the indicated areas of the roof. To deter moisture entry/wind damage, it is recommended that the shingles be re-secured.

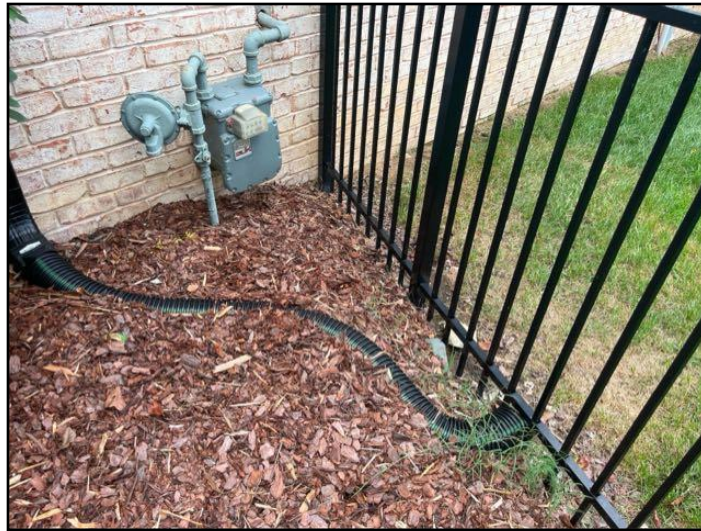
7. Discharge too close to building

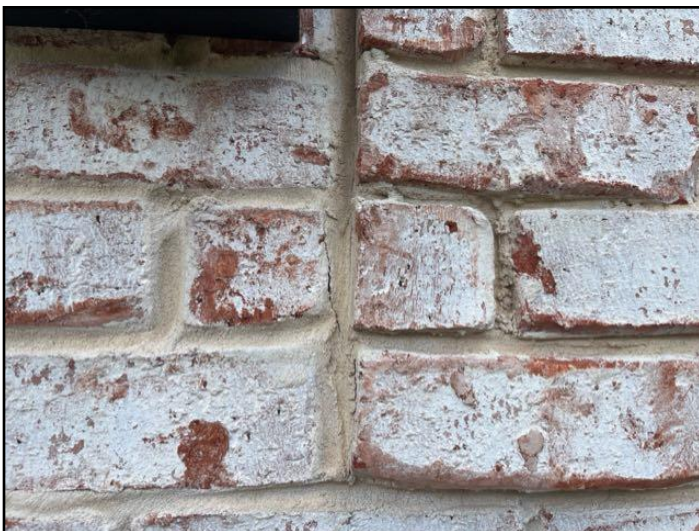
9. Cracked

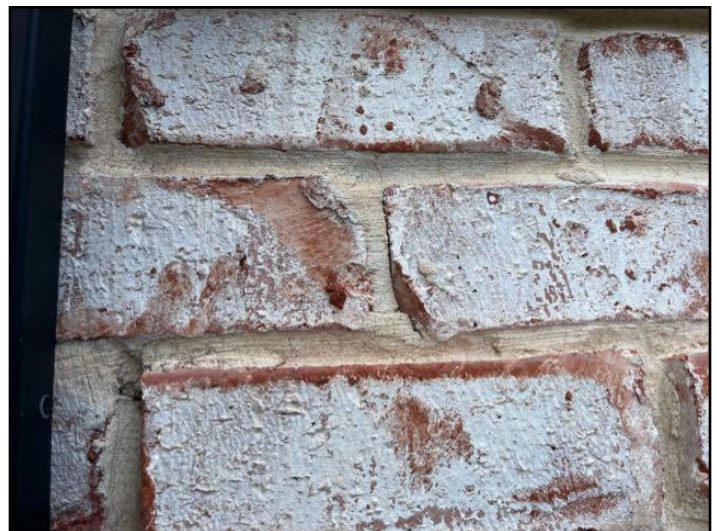
10. Cracked

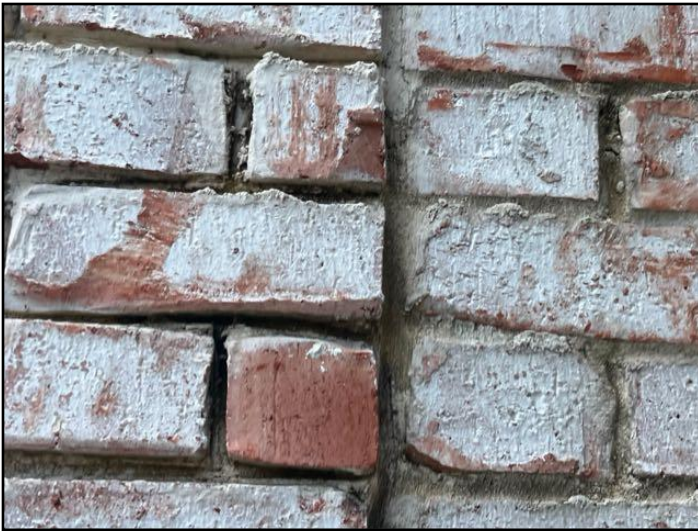
11. Cracked

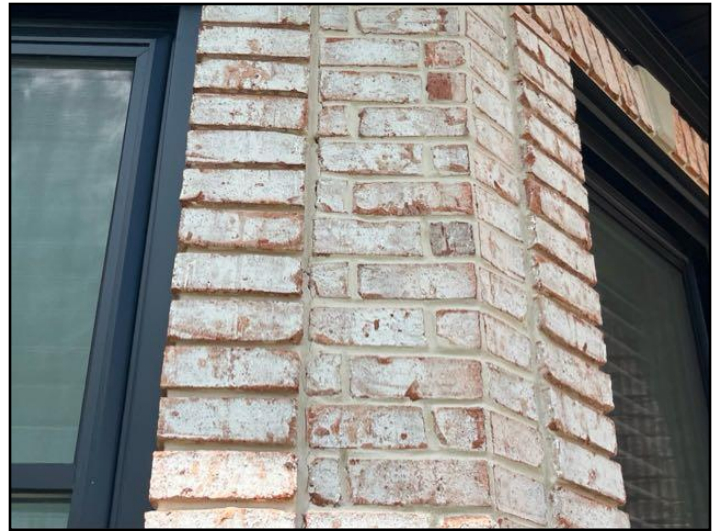
12. Cracked

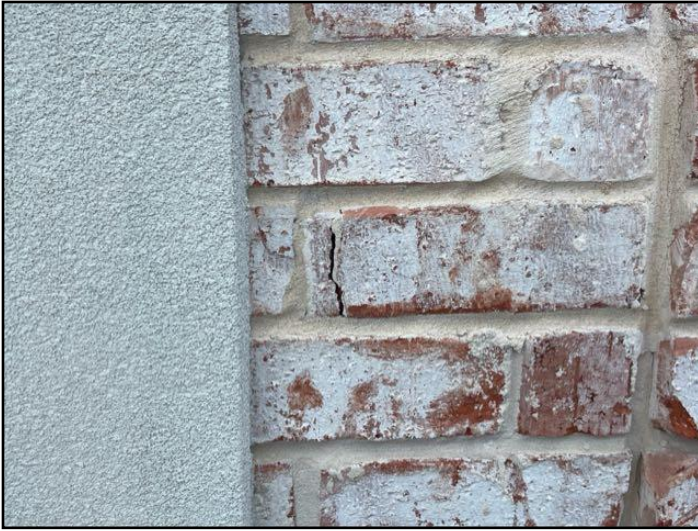
13. Spalling

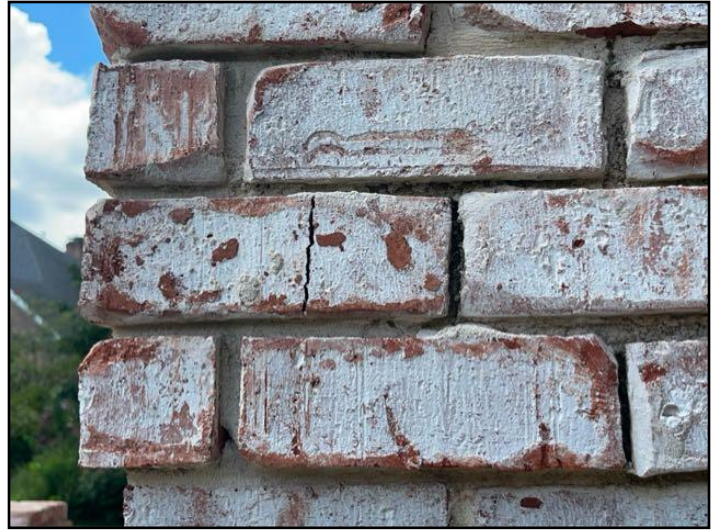
14. Spalling

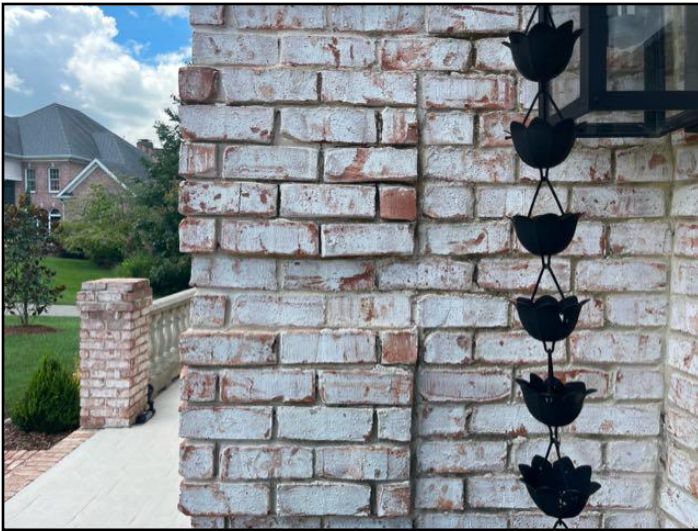
15. Mortar deterioration / missing

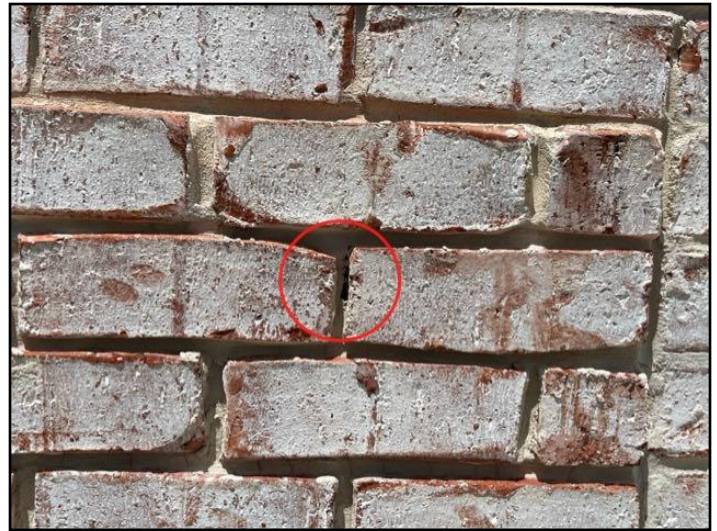
16. Mortar deterioration / missing

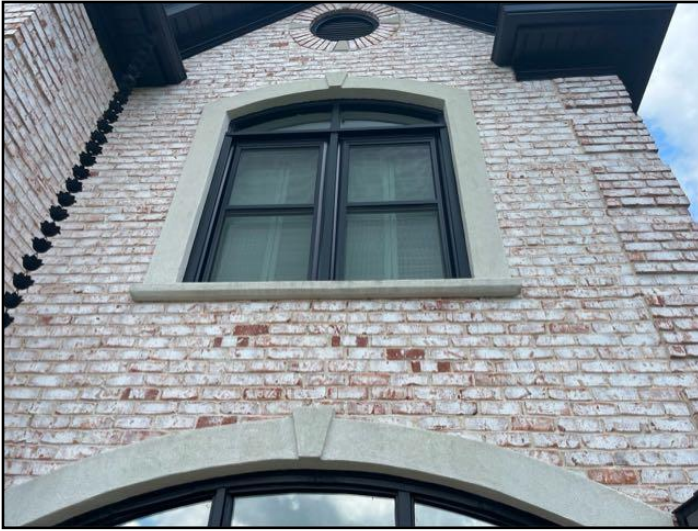
18. Missing, ineffective weep holes or flashings

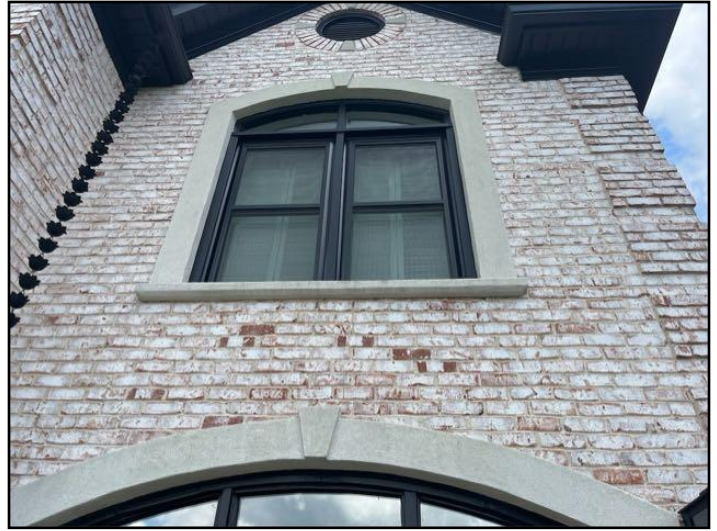
19. Missing, ineffective weep holes or flashings

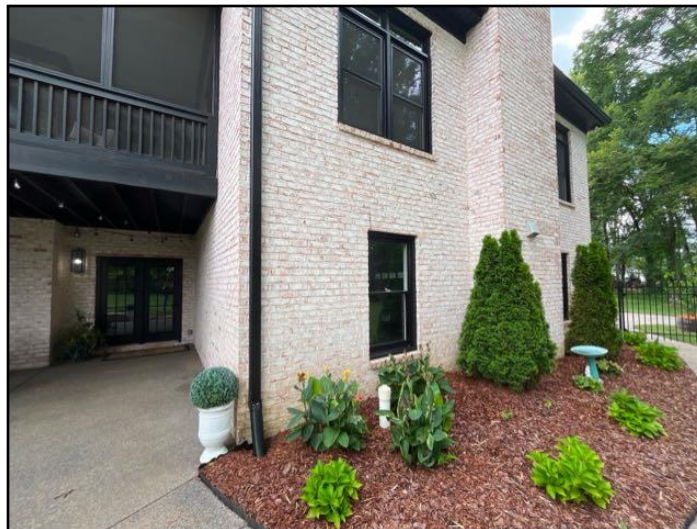
20. Missing, ineffective weep holes or flashings

## 13. Condition: • Missing, ineffective weep holes or flashings

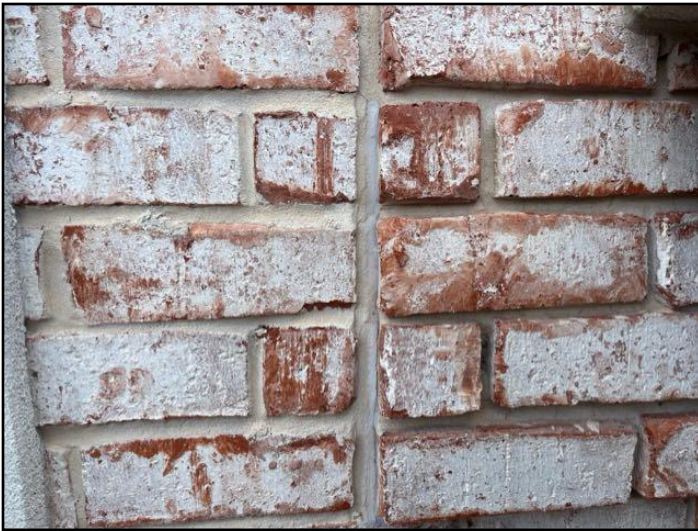
21. Prior repairs

## 14. Condition: • Prior repairs

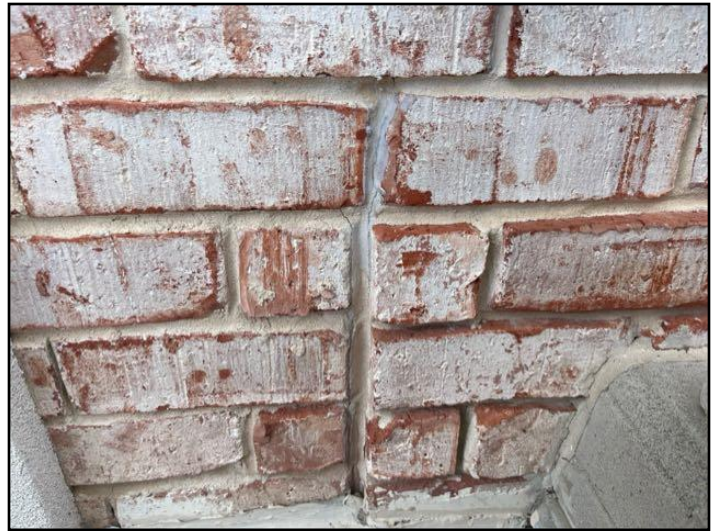
22. Prior repairs

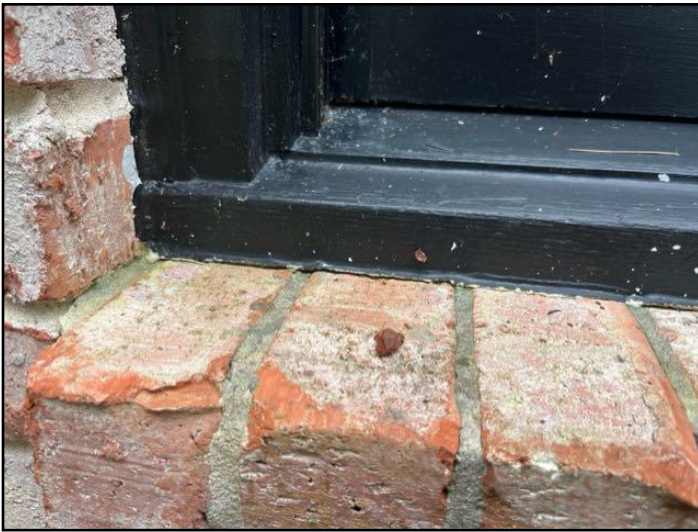
25. Caulking loose, missing or deteriorated

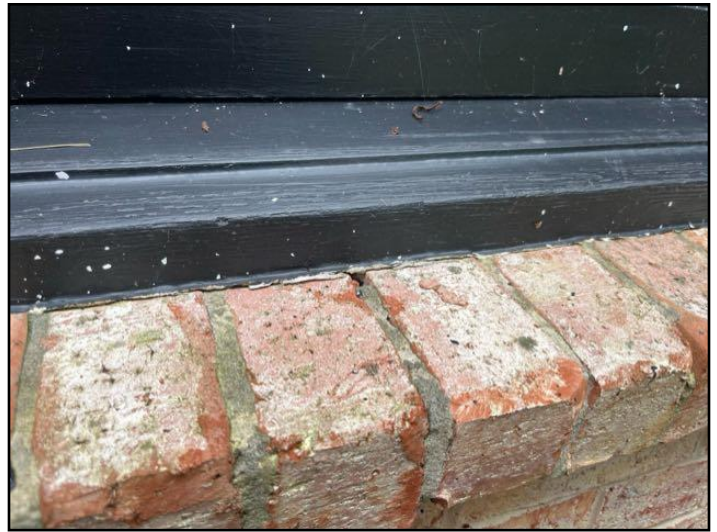
26. Caulking loose, missing or deteriorated

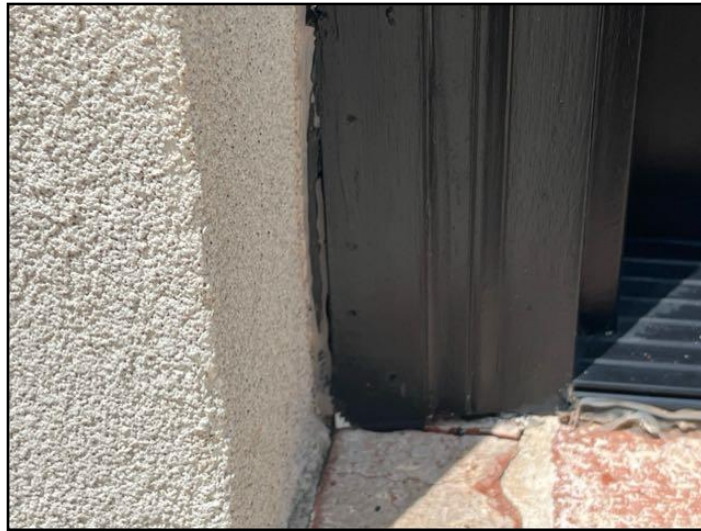
32. Caulking missing, deteriorated or loose

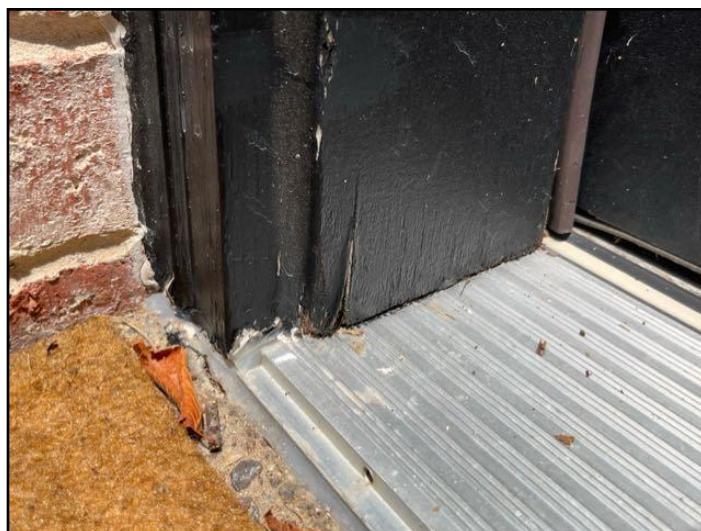
33. Rot

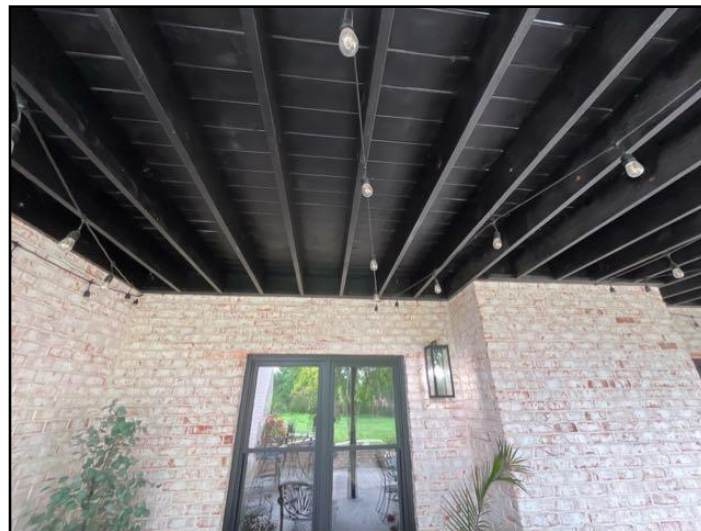
35. Ledgerboard problems

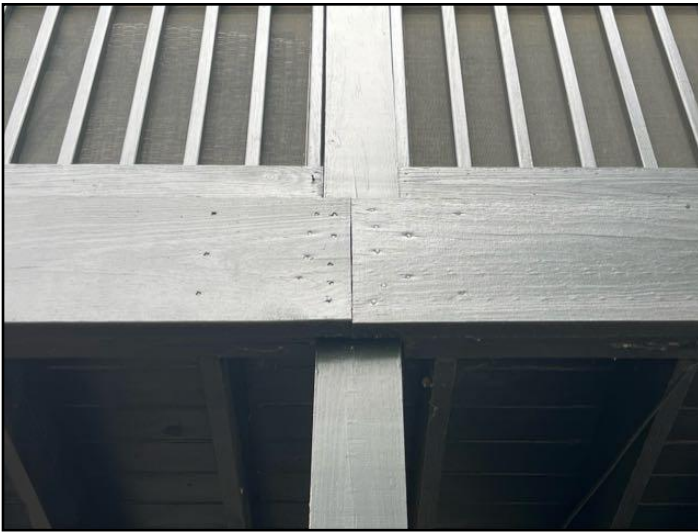
**36.** *Fastener problems*

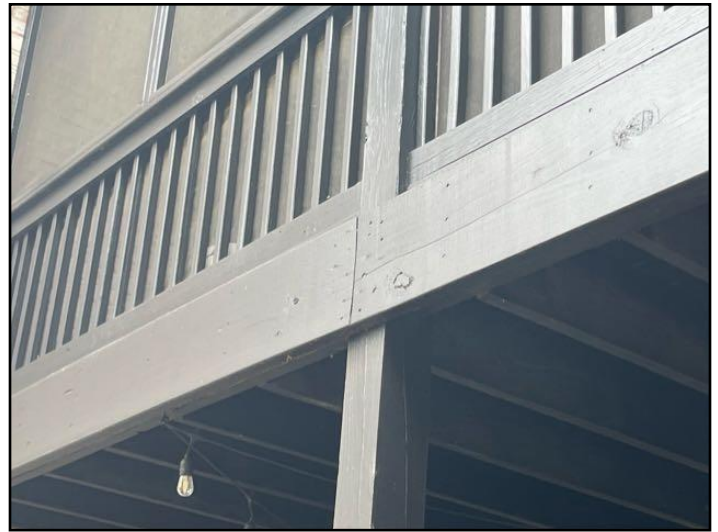
**37.** *Fastener problems*

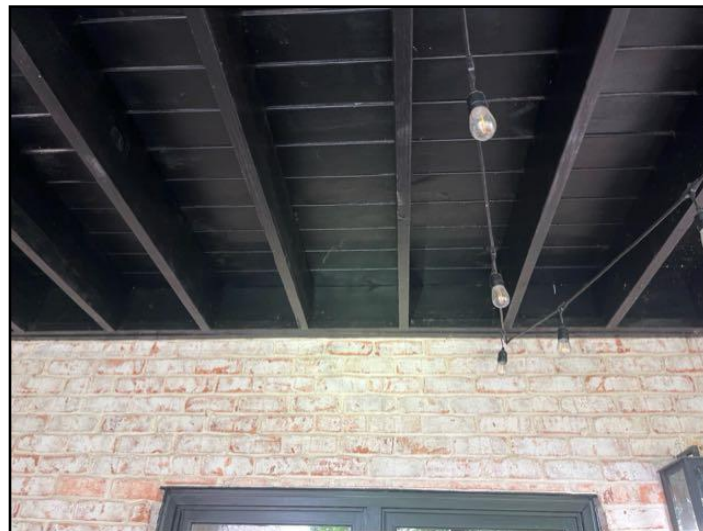
38. Missing flashing at deck connection

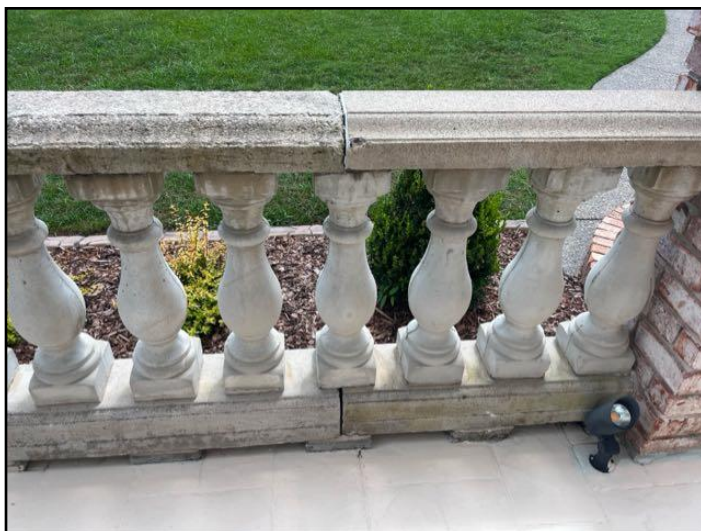
39. Masonry or concrete spalling

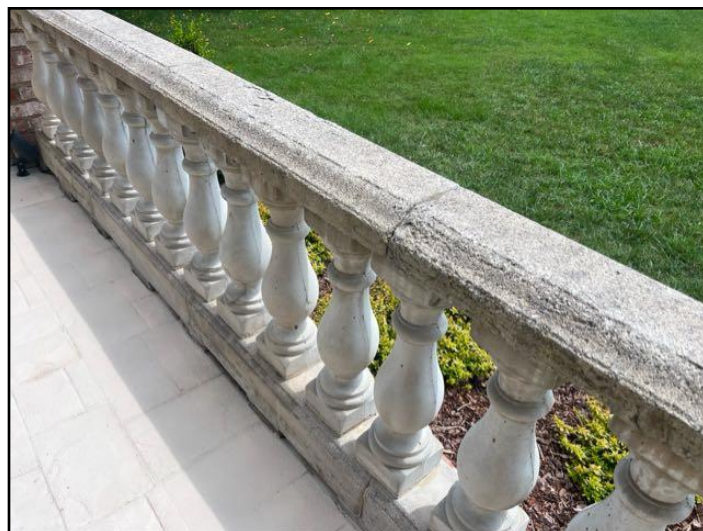
40. Masonry or concrete spalling

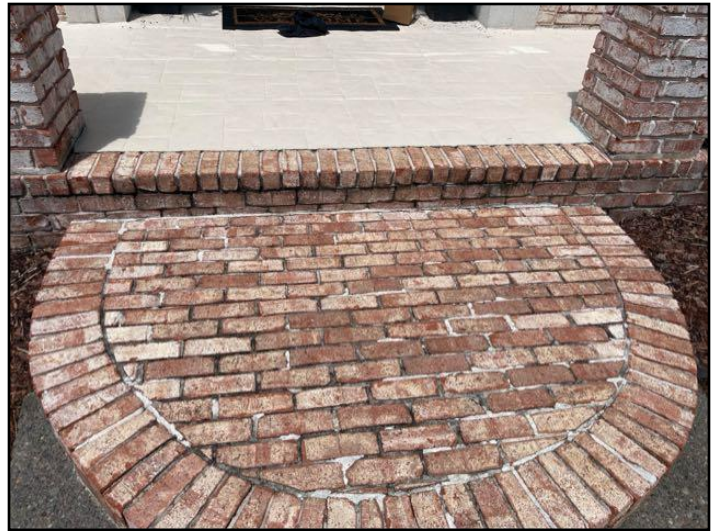
42. Masonry or concrete spalling

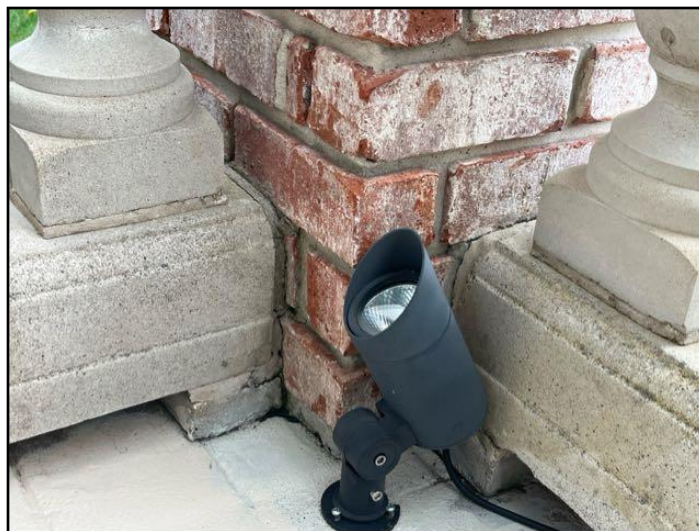
43. Masonry or concrete spalling

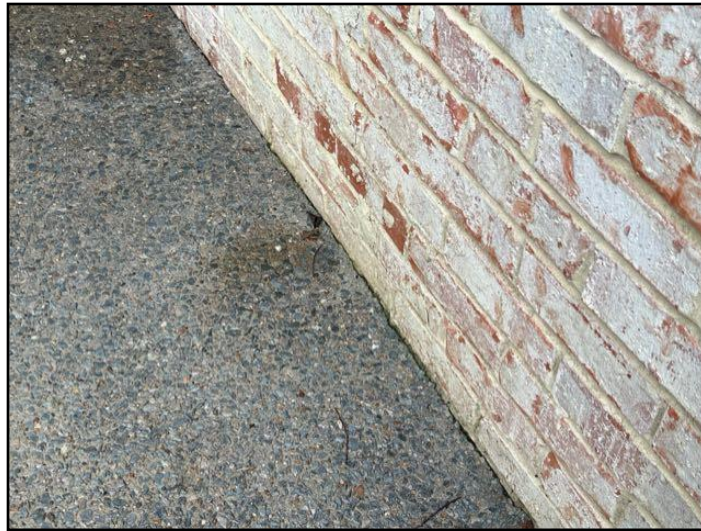
44. Unsealed gap at building

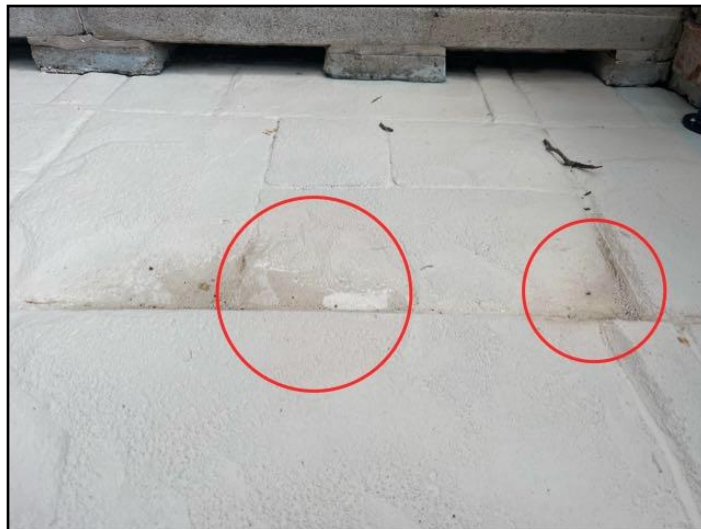
45. Poor drainage

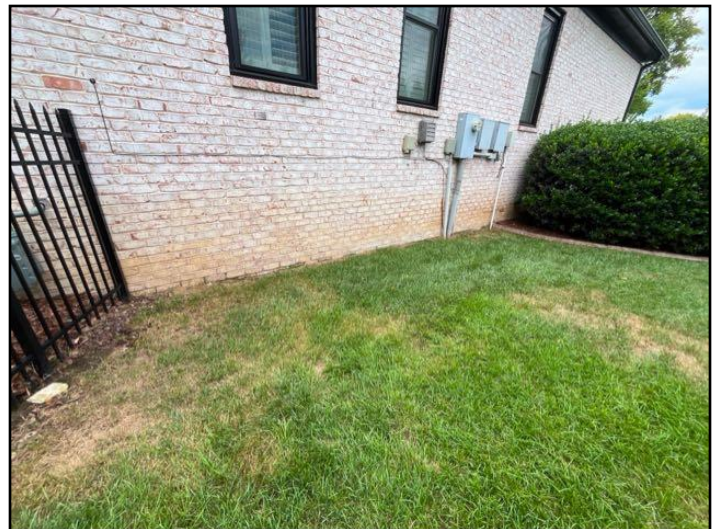
48. Improper slope / drainage issues

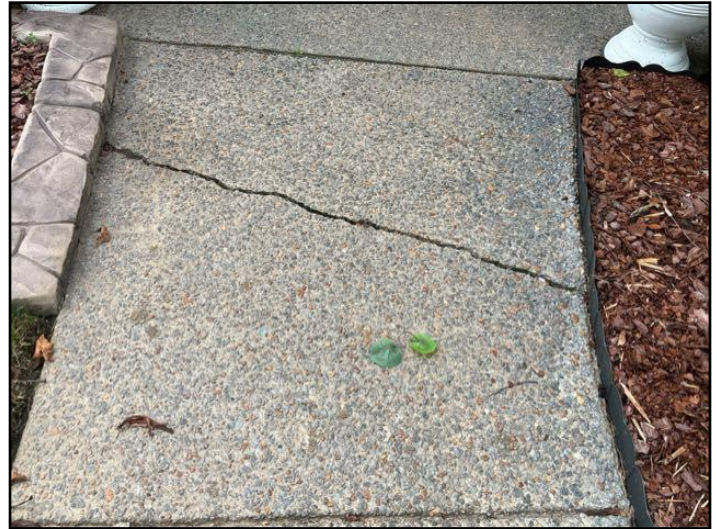
50. Cracked or damaged surfaces

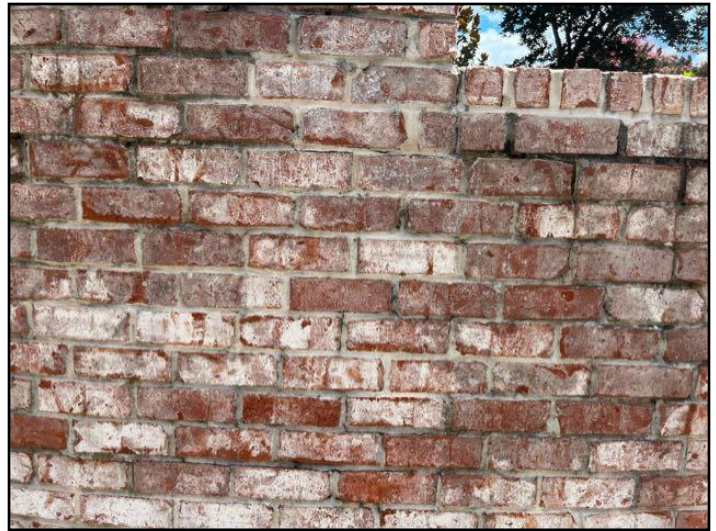
53. Cracked

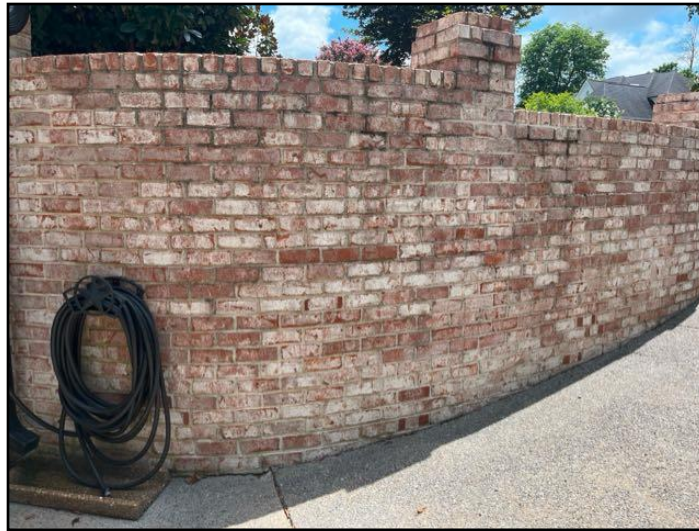
54. Drainage system missing

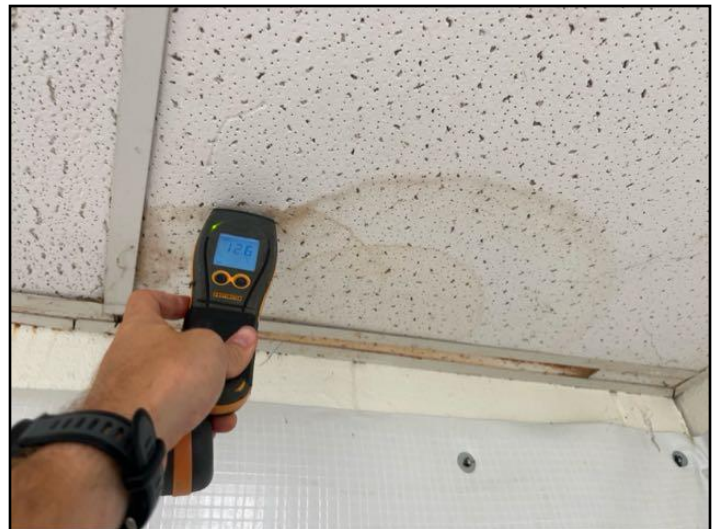
56. Water stains - Currently dry

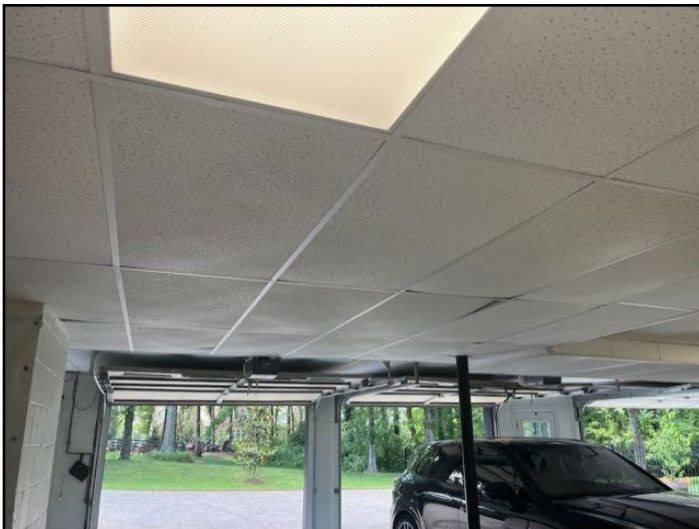
58. Fire separation between garage and living...

## 34. Condition: • Fire separation between garage and living space not adequate

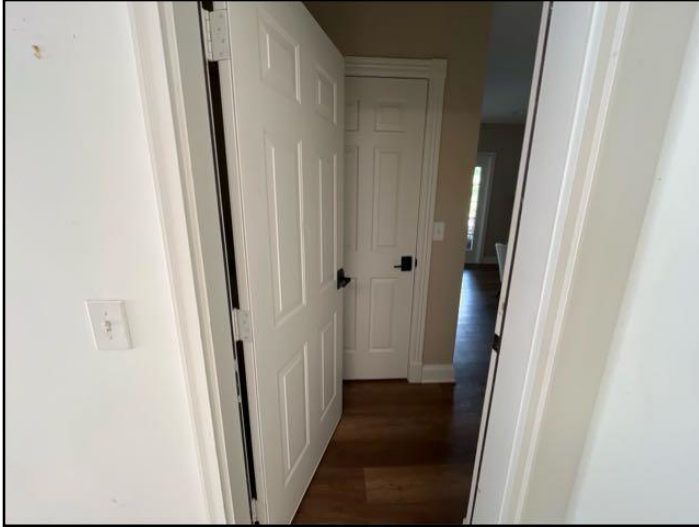
### 35. Condition: • No self-closer

60. No self-closer

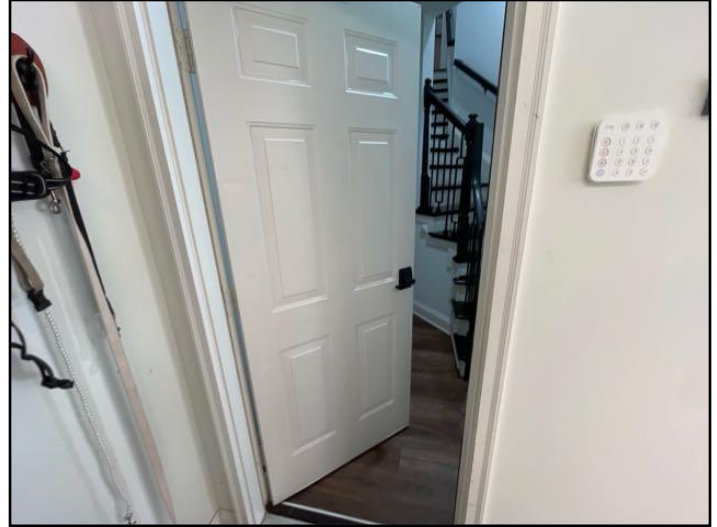
61. No self-closer

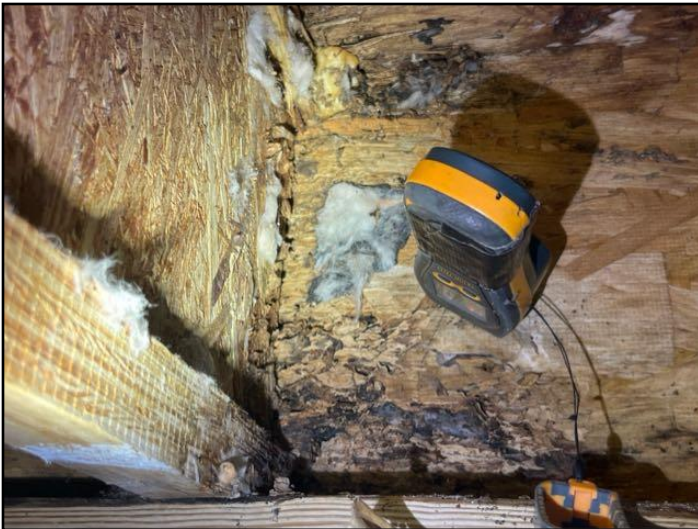
#### **36. Condition:** • Rot

Rot was present at the indicated sections of framing materials. Rot and decay are most commonly a symptom of a localized moisture presence, or a poorly ventilated area with high ambient moisture levels. It is recommended that sections of the framing with rot or decay be repaired as the wooden members have been weakened from their original state during installation. Minor amounts of rot may only need small repairs (or monitoring), while larger damage may warrant replacement of the damage wood. Additionally, some damage was noted on a section of the I-joist. As alterations of the i-joist top or bottom chord is not allowed (environmental or mechanical), further evaluation by a structural engineer would be necessary to determine if repair is warranted. If a repair is performed, any related documentation should be acquired and retained by the buyer for future use (e.g. when selling the home).

Note: The definitive source of the decay could not be determined. Further evaluation will be necessary to repair the cause of the deterioration to help deter future damage. Further damage may be found while making repairs.

63. Rot

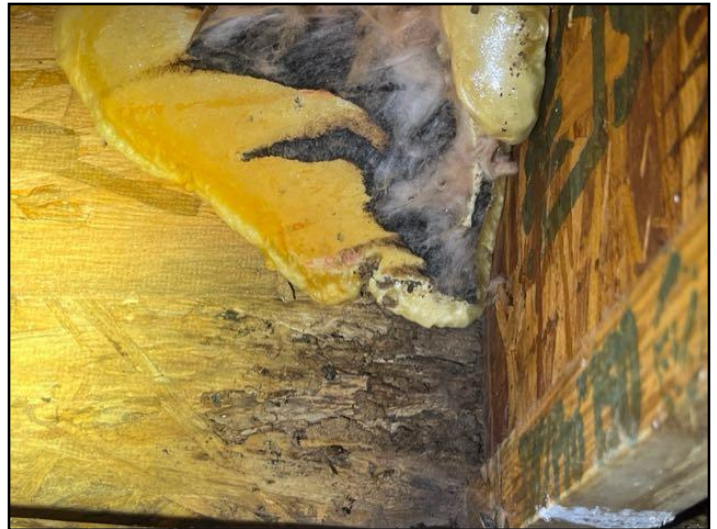
64. Rot

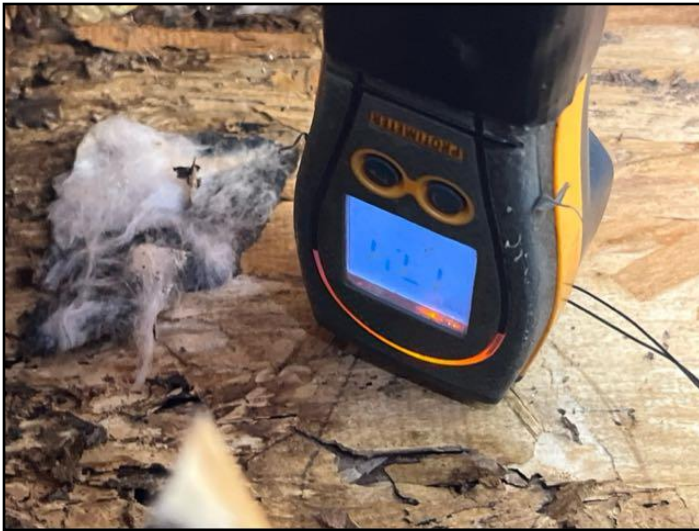
65. Rot

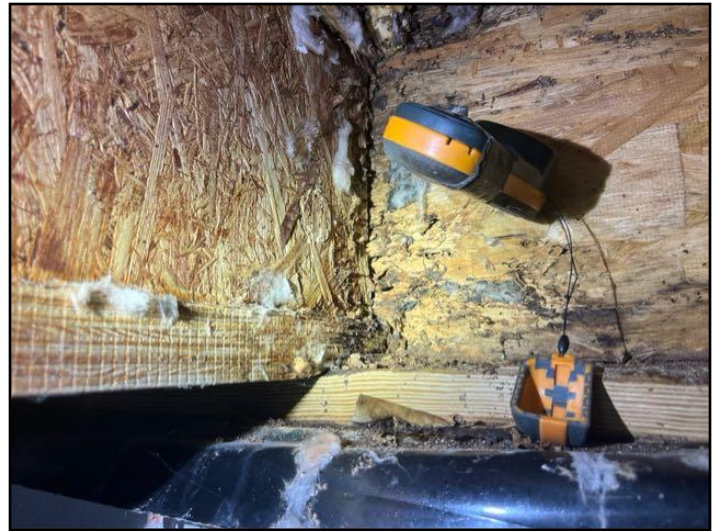
66. Rot

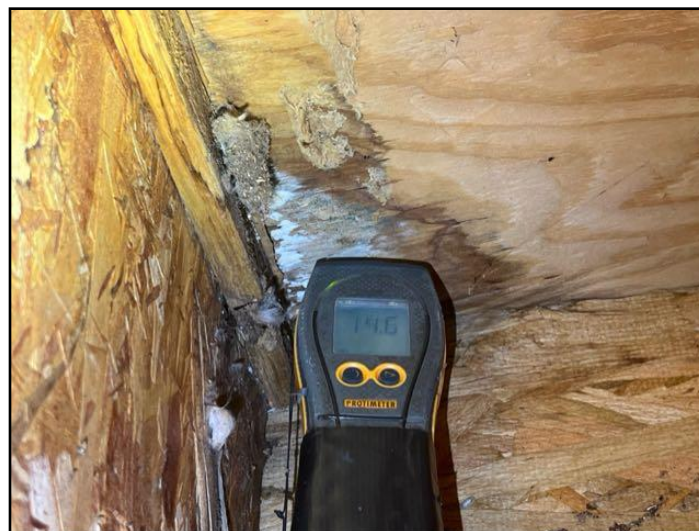
67. Water stains

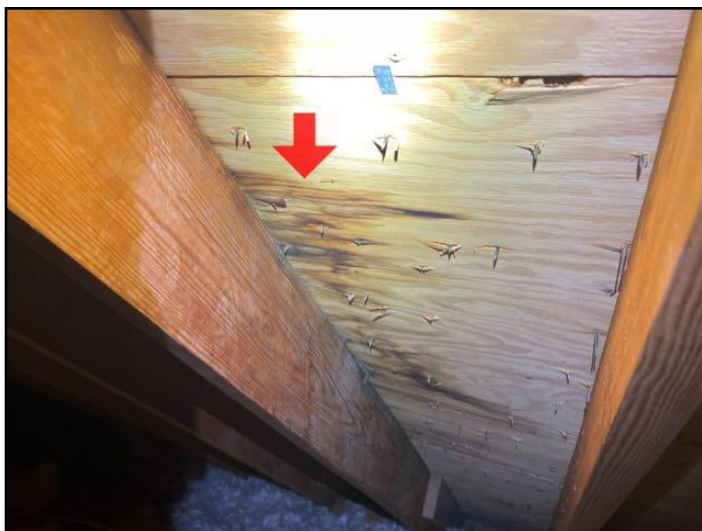
68. Water stains

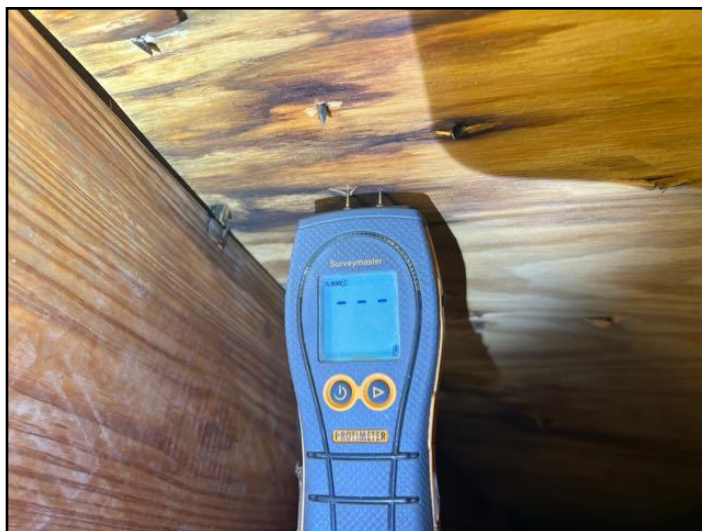
69. Water stains

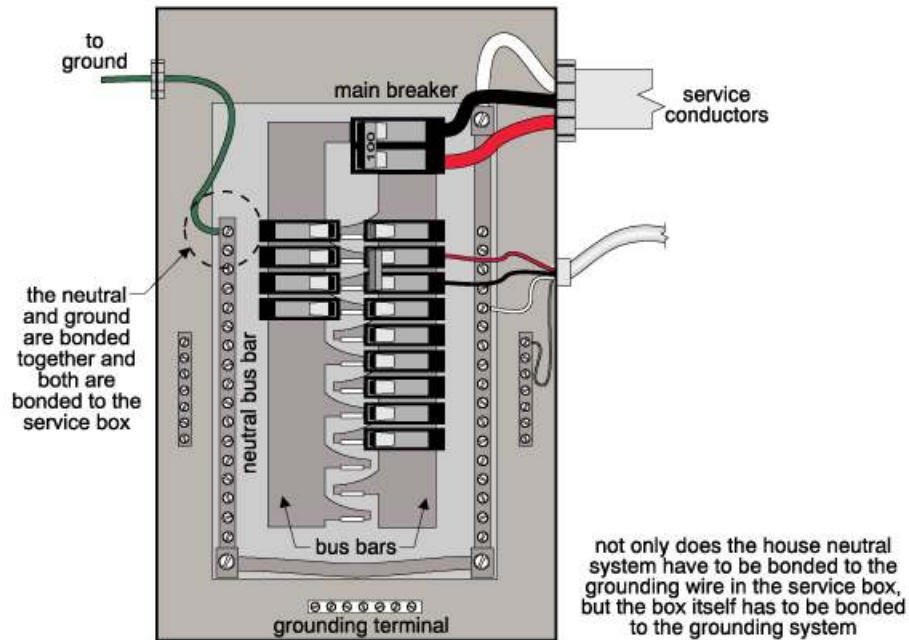
**39. Condition:** • Box not bonded to ground

70. Box not bonded to ground

**Bond service box to ground**

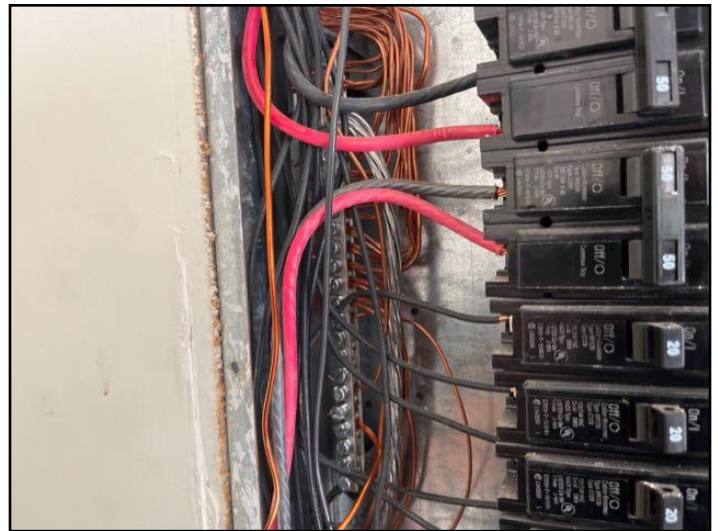
71. Box not bonded to ground

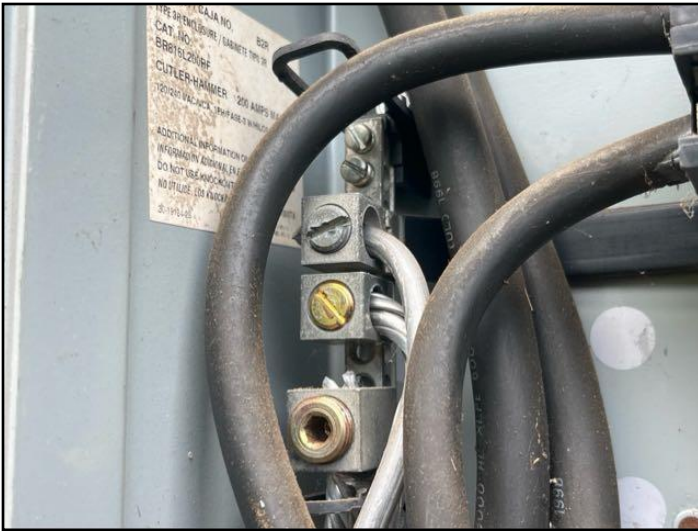
72. Box not bonded to ground

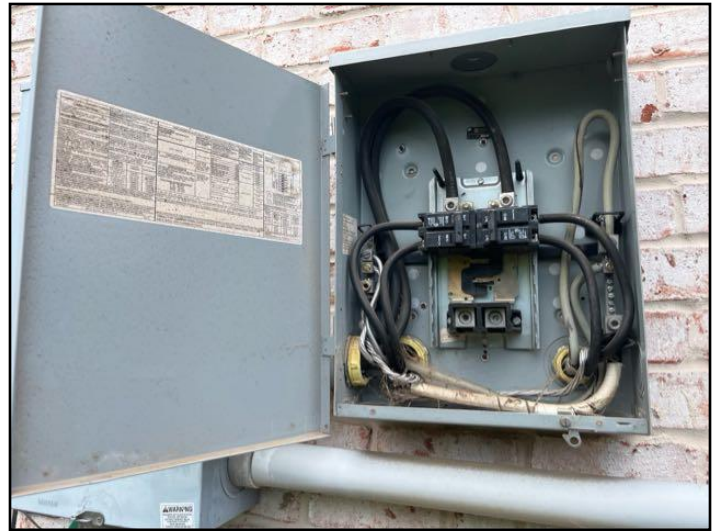
73. Box not bonded to ground

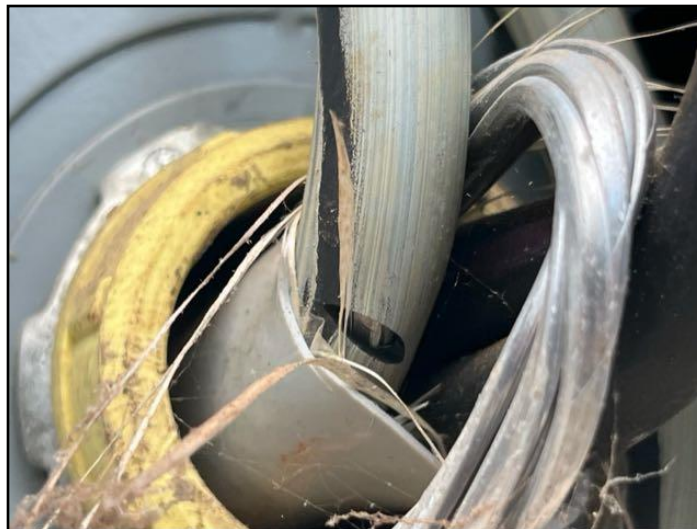
Wire(s) were damaged inside the indicated distribution panel. Damaged wires are potential shock and fire hazards. It is recommended that all damaged electrical components be repaired by a qualified electrician.

74. Damage

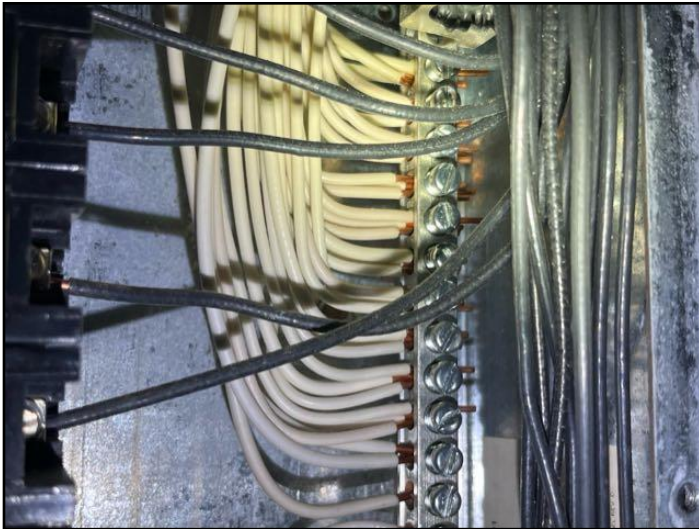
**41. Condition:** • Double tapped neutrals

Electrical standards require that each neutral conductor be connected to a separate lug (hole) on the neutral bus. This is a commonly found defect due to a lack of clarity in electrical standards throughout the past few decades; however, this requirement has been in place since the mid-60s. Double tapping of neutrals can result in loose connection which are prone to overheating. Additionally, the incorrect practice of double-tapping neutrals makes it difficult for an electrician to

75. Double tapped neutrals

isolate a circuit. Repair by a licensed, qualified electrician is recommended.

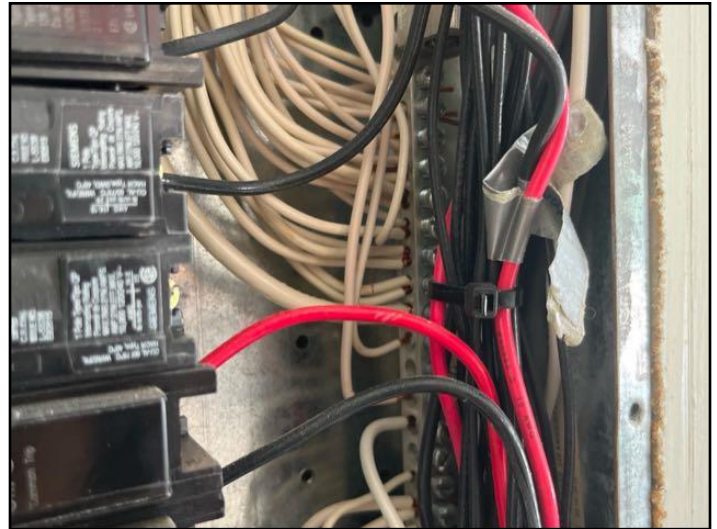
76. Double tapped neutrals

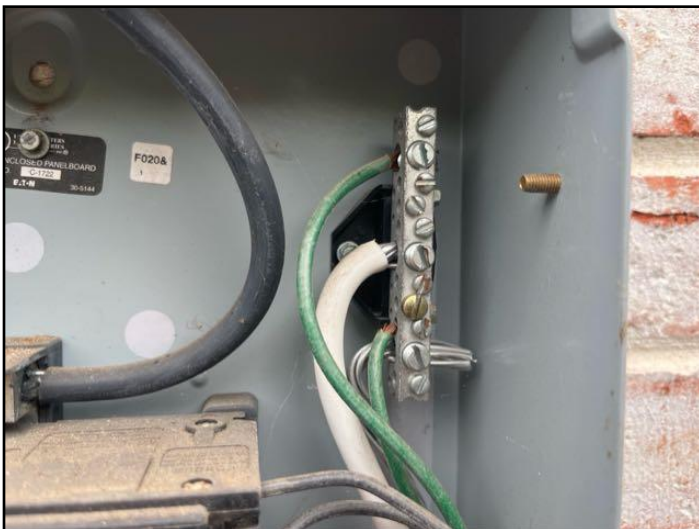
**42. Condition:** • Neutral and ground wires bonded at auxiliary panel

Neutral and grounding conductors were bonded together within the auxiliary panel. Bonding should only occur in the panel which houses the main disconnect. It is recommended that bonding be corrected by a licensed, and qualified electrician.

77. Neutral and ground wires bonded at auxiliar...
