# CLOSING PACKET

9614 DEER TRACK CT, BRENTWOOD, TN 37027

9614 Deer Track Court, Brentwood, TN August 3, 2026

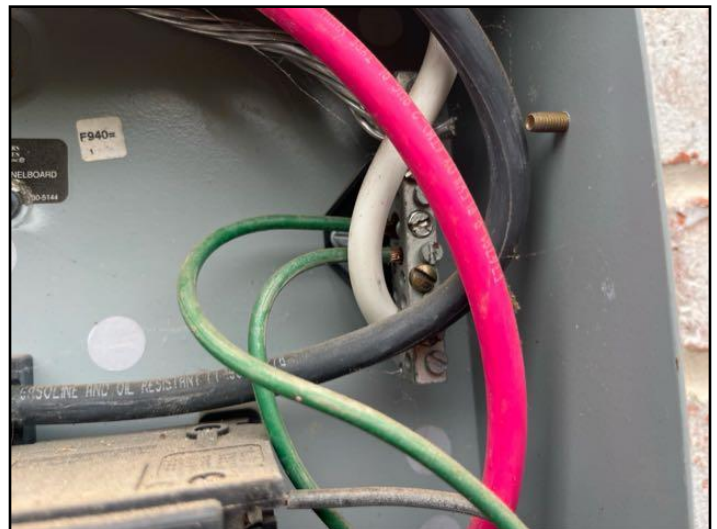
78. Neutral and ground wires bonded at auxiliar...

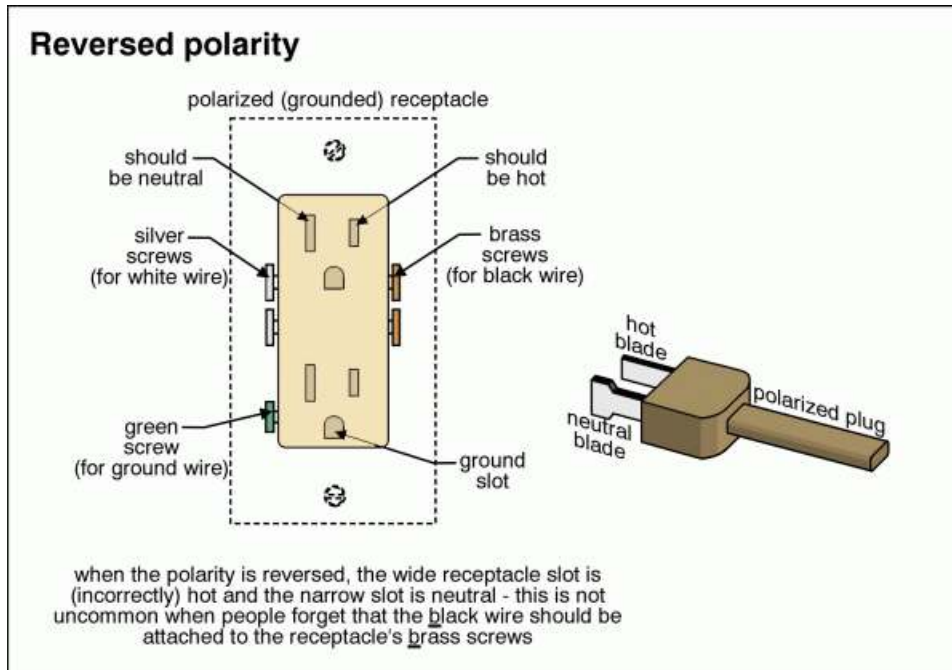
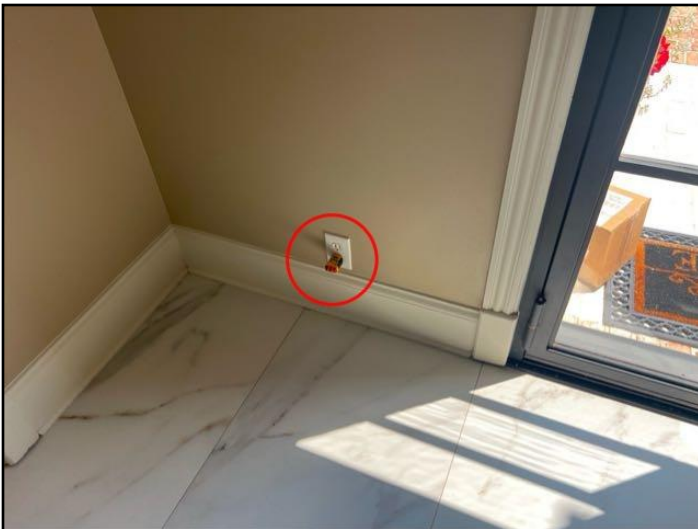
**DISTRIBUTION SYSTEM \ Outlets (receptacles)****43. Condition:** • Reversed polarity

The polarity was reversed (hot and neutral swapped) on the indicated outlets. This can pose shock hazards to occupants when using certain appliances. It is recommended that the polarity be corrected by a qualified, licensed electrician.

79. Reversed polarity

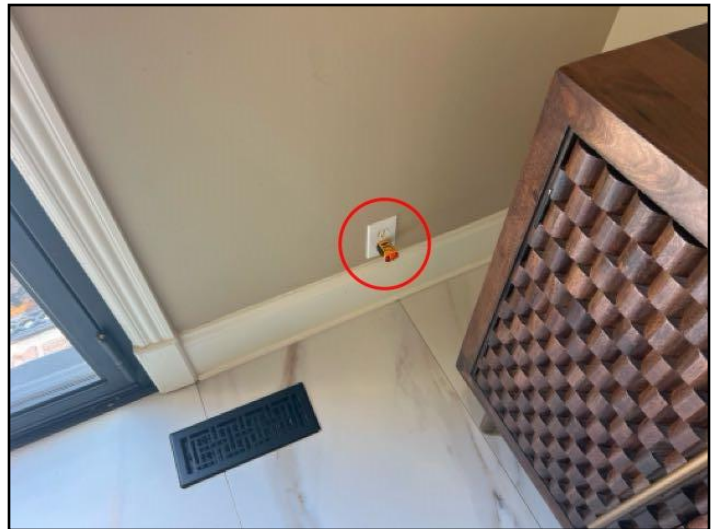
80. Reversed polarity

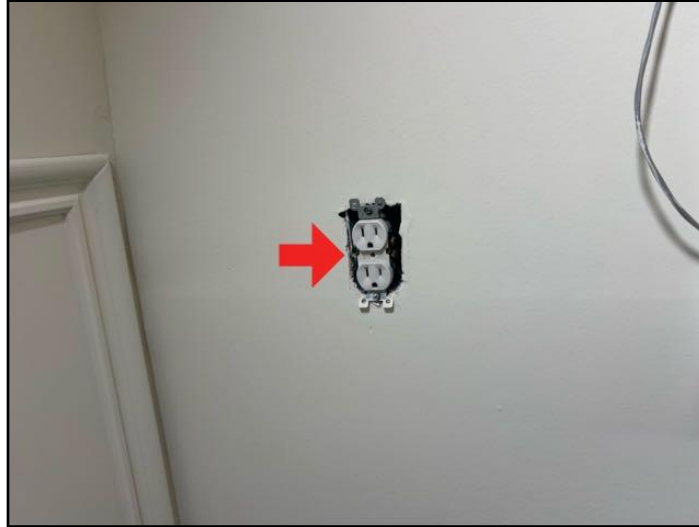
**DISTRIBUTION SYSTEM \ Cover plates****44. Condition:** • Missing

A cover plate was missing from the indicated junction box. To prevent accidental contact with energized conductors, it is recommended that appropriate cover plates be installed.

81. Missing

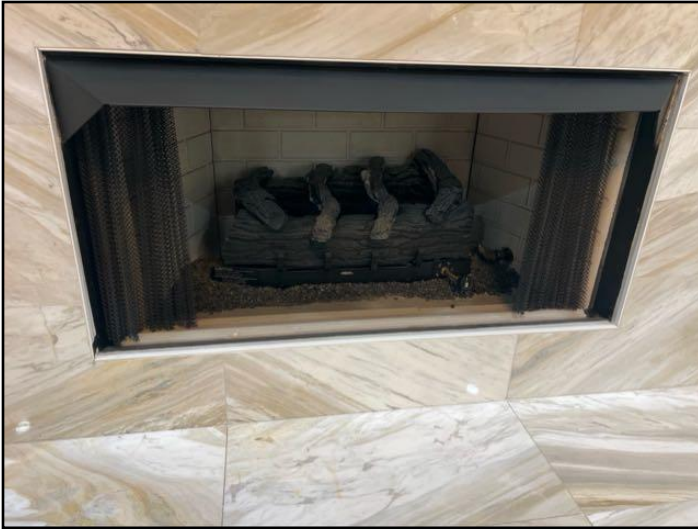
- Ventless (vent free) gas logs are not intended to be operated for extended periods of time and, therefore, should not be operated while occupants are sleeping. Additionally, ventless gas logs should not be used as a primary source of heat for the home.

96. Ventless (vent free) gas logs are not...

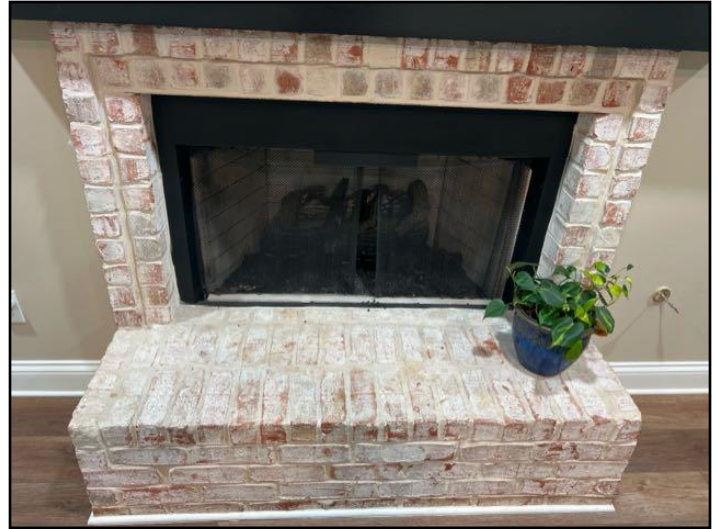
97. Ventless (vent free) gas logs are not...

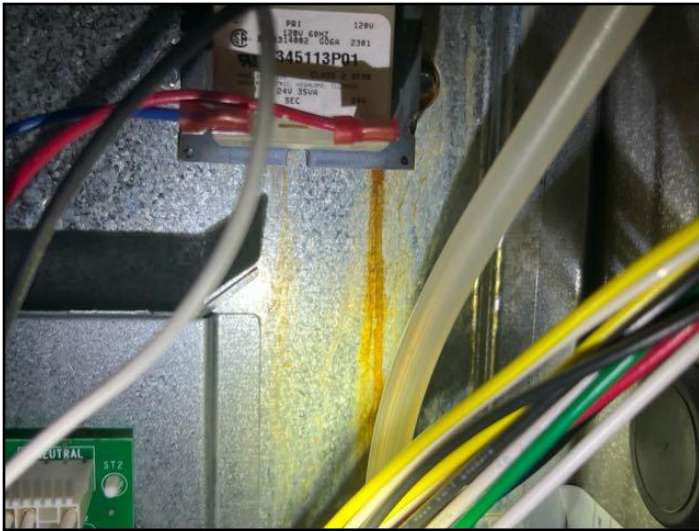
98. Rust

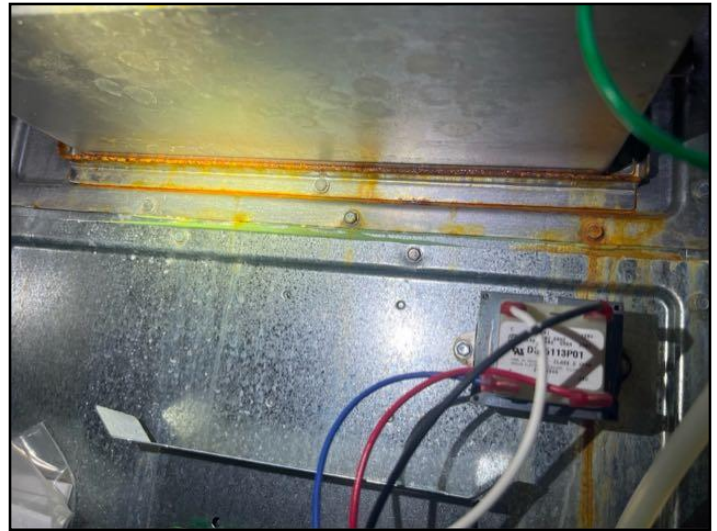
99. Rust

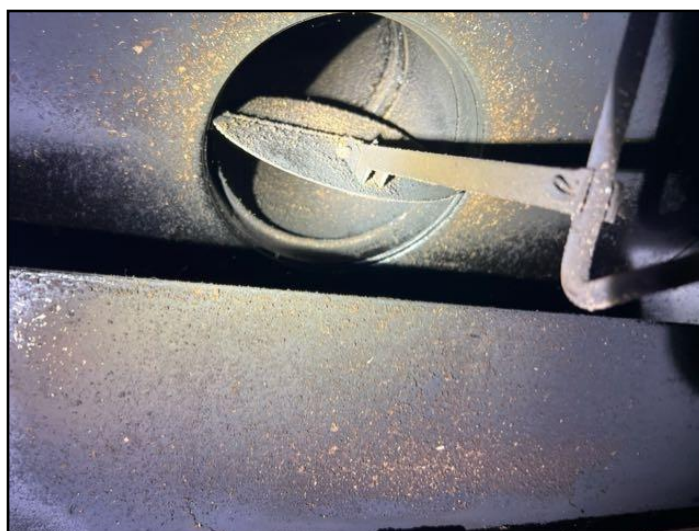
**46. Condition:** • Inspect (and/sweep if needed) before using

If the wood burning fireplace is to be returned to service as a wood burning fireplace, it is recommended to have the chimney inspected and swept, as needed, by a qualified chimney specialist before use. The National Fire Protection Agency (NFPA) recommends that a level II inspection be performed by a qualified chimney specialist prior to all real estate transactions. This inspection often includes video scoping of the interior of the flue to detect defects which would otherwise be hidden from view.

NOTE: Minor to moderate creosote levels were present in visible areas of the firebox, flue, and/or exterior masonry. Excessive creosote within the chimney is a fire safety hazard.

100. Inspect (and/sweep if needed) before using

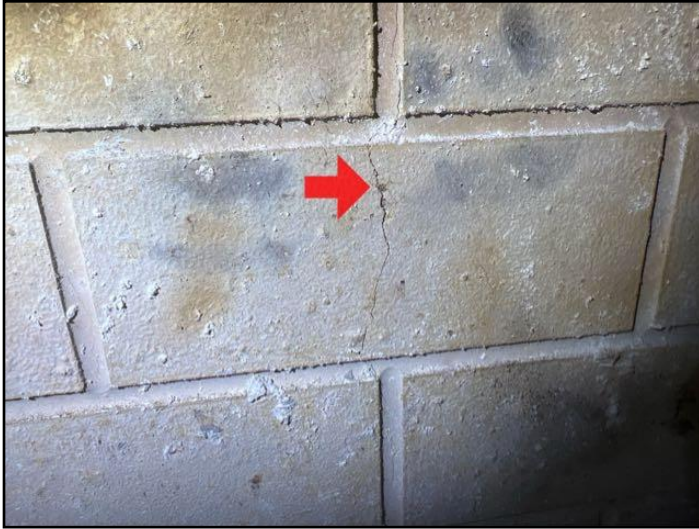
### **47. Condition:** • Cracked masonry or refractory

Cracking was found in the refractory brick inside the fireplace. It is recommended that the wood burning fireplace be evaluated by a qualified, licensed chimney sweep prior to use.

101. Cracked masonry or refractory

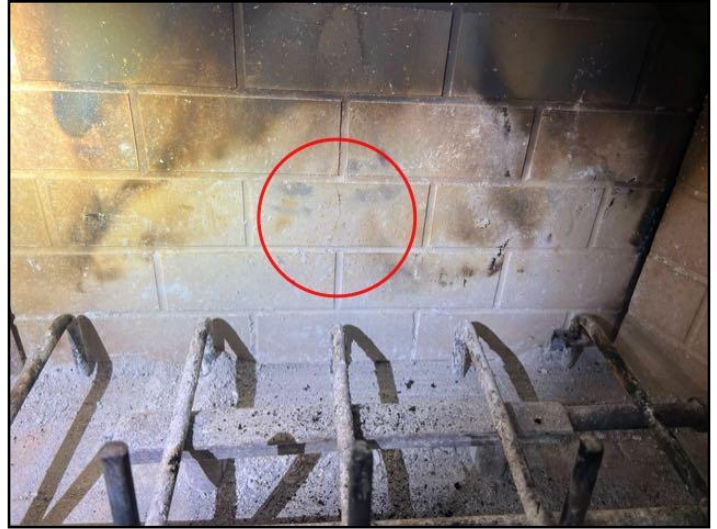
102. Cracked masonry or refractory

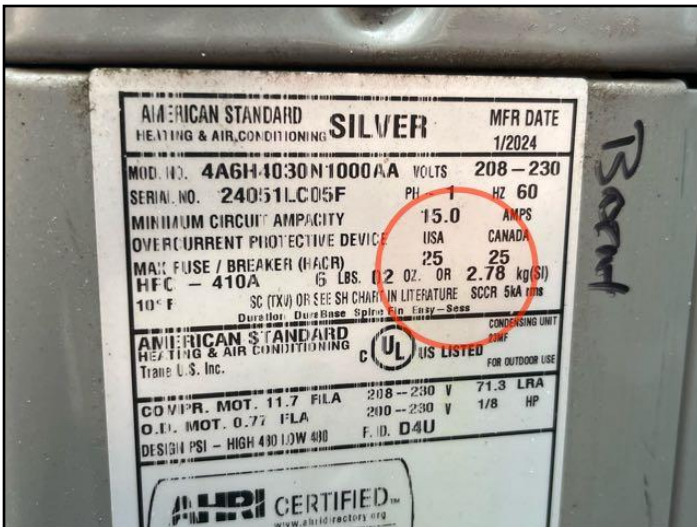
119. Wrong breaker size

#### 48. Condition: • Wrong breaker size

The breakers servicing the HVAC equipment were incorrectly sized. Under-sizing the breakers supplying the condensing units can cause nuisance tripping, while over sized breakers may fail to protect the equipment in the event of a fault. It is recommended that the correct breakers be installed in accordance with the manufacturers recommendations.

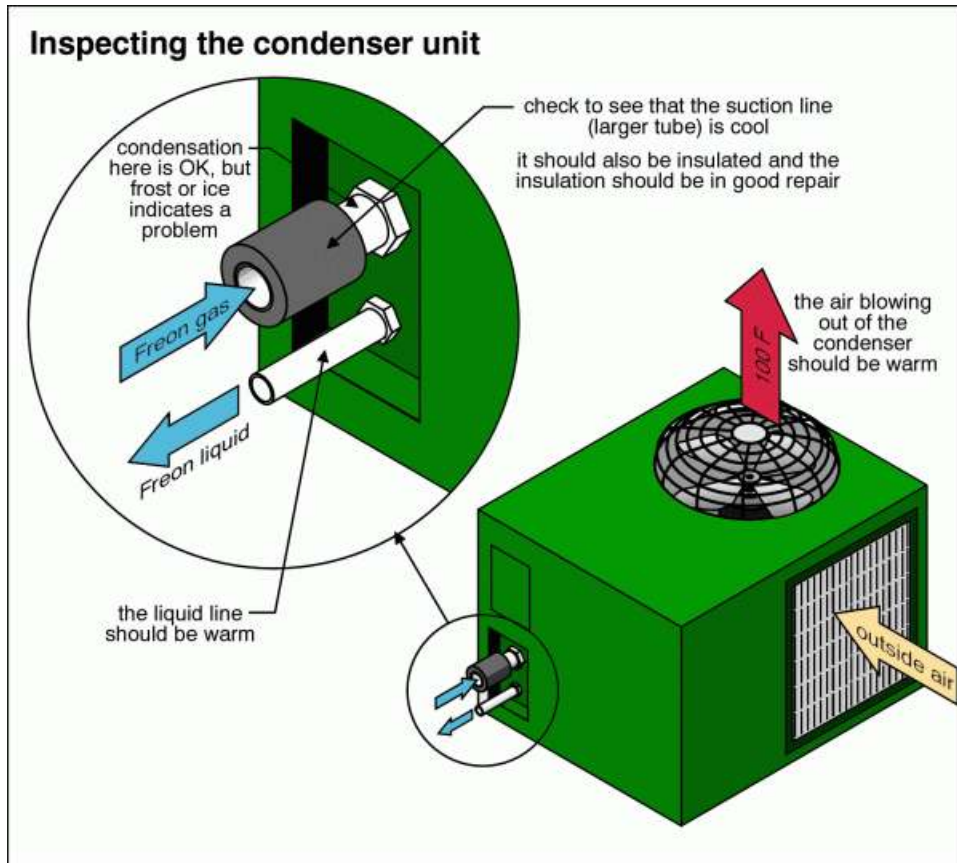
122. Dirty

#### 49. Condition: • Dirty

The coils on the condensing unit were dirty. Coils are typically cleaned as part of annual service. This may indicate that service of the unit is overdue. Cleaning/service by a qualified HVAC technician is recommended.

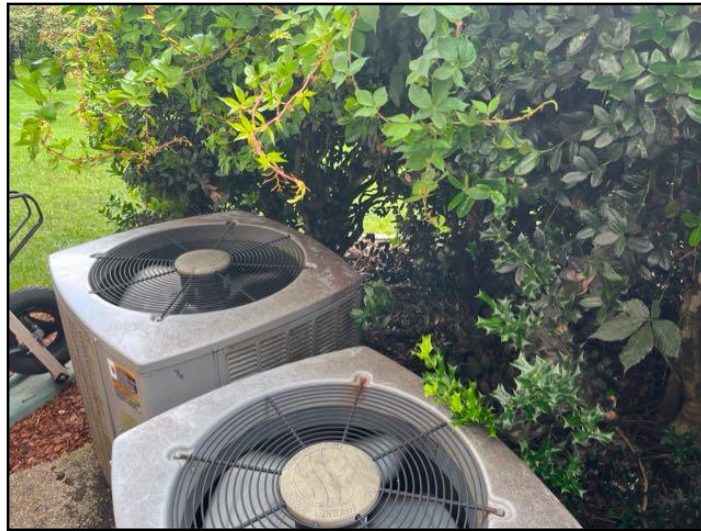
123. Poor clearance

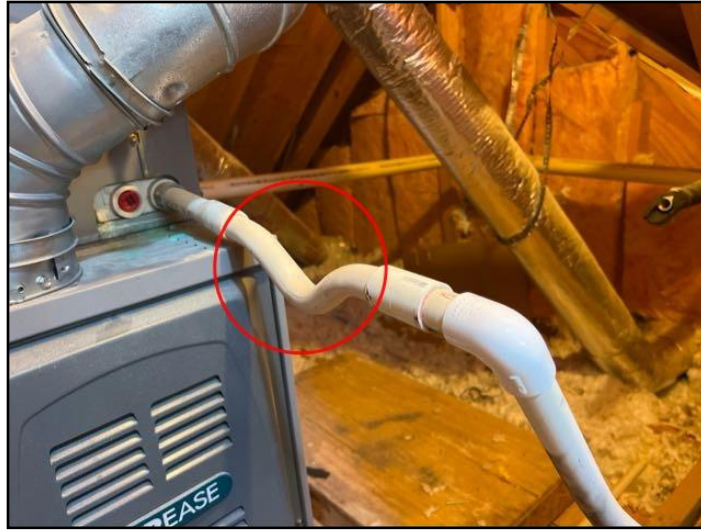
124. Trap insulation needed

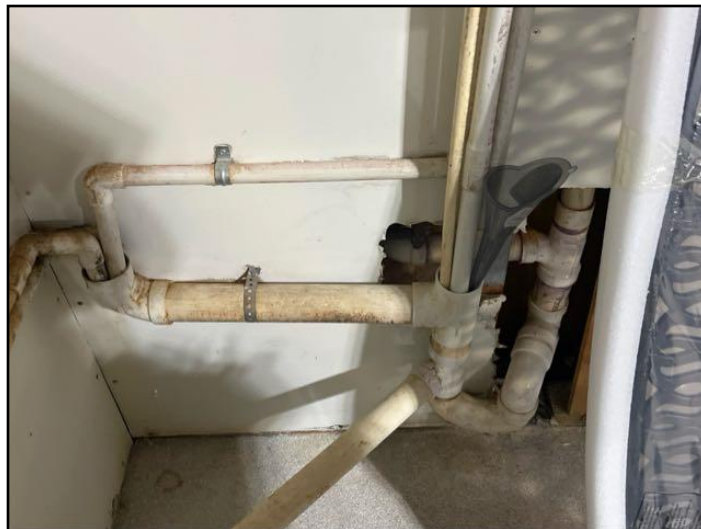
125. Discharge into waste pipe

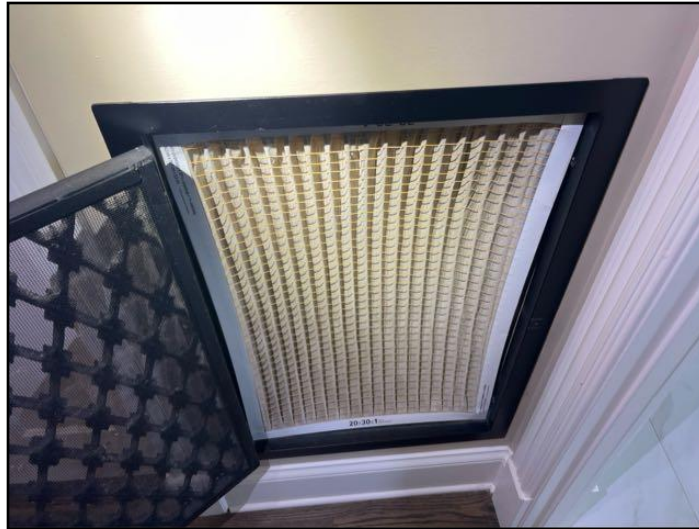
126. Dirty air filter

### 53. Condition: • Dirty air filter

The air filter for the HVAC system was dirty. This can result in a reduction of efficiency of the system and, in extreme cases, cause the evaporator coils to freeze. The useful lifespan of air filters is dependent upon the quality of the filter, as well as the lifestyle of the homeowner. As a general rule, filters should be changed when visibly dirty.

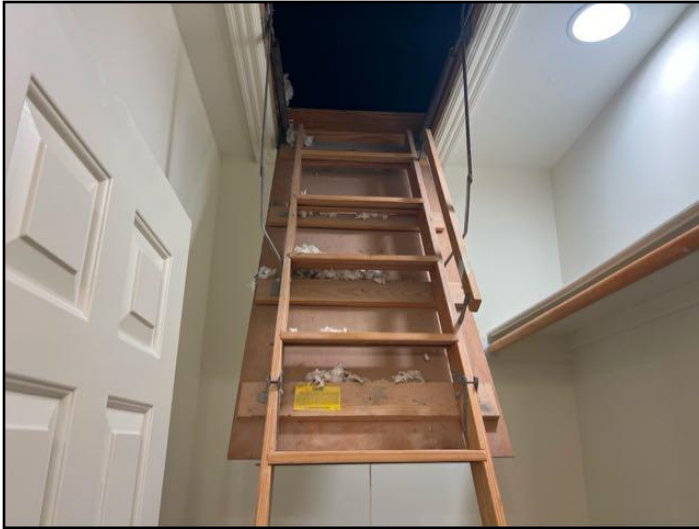
127. Not insulated or weather-stripped.

**54. Condition:** • Not insulated or weather-stripped.

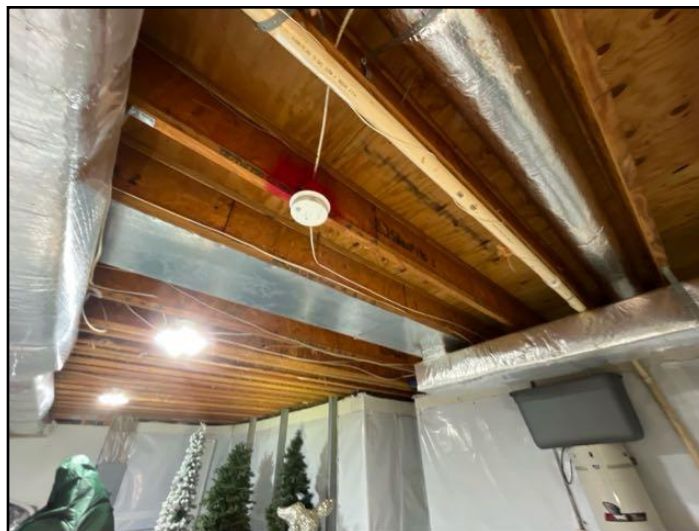
129. No insulation present

### 55. Condition: • No insulation present

Note: The insulation of the rim joist will provide the largest increase in efficiency, while insulating the center, or field of the floor may only provide marginal improvement. In some situations fiberglass insulation may also inhibit air flow in crawlspaces and exacerbate moisture issues under the home.

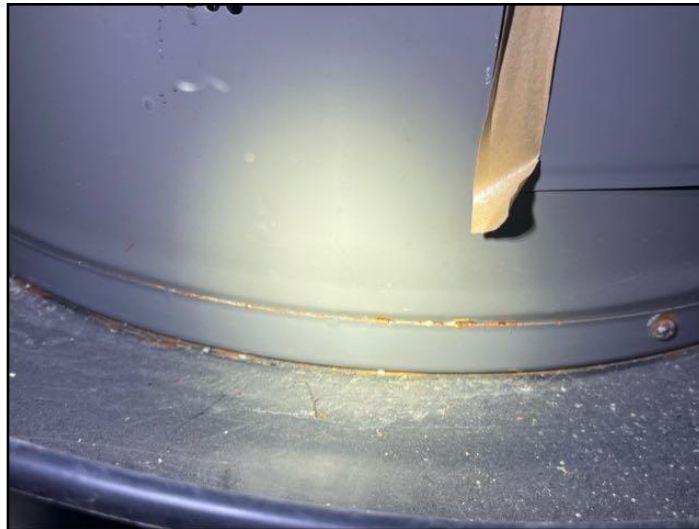
135. *Rust*

**56. Condition:** • Rust

Minor rust was observed on the exterior of the tank of the water heater. Although no issues were noted regarding performance of the water heater, this may serve as an indicator that the unit is near the end of its useful lifespan.

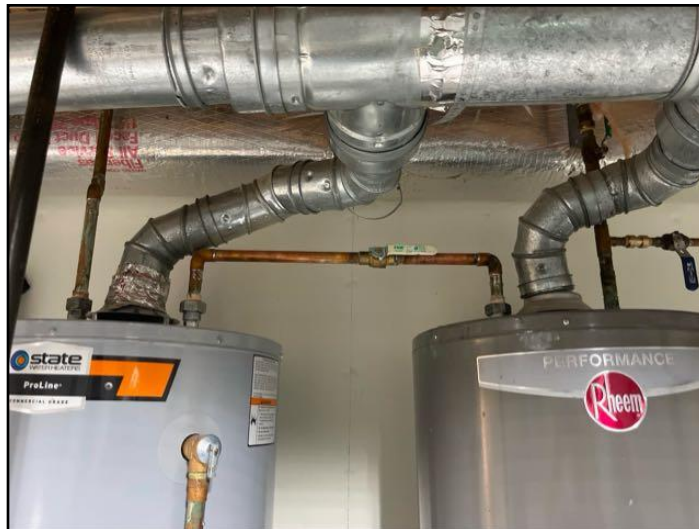
136. *Initial vent rise inadequate*

**57. Condition:** • Initial vent rise inadequate

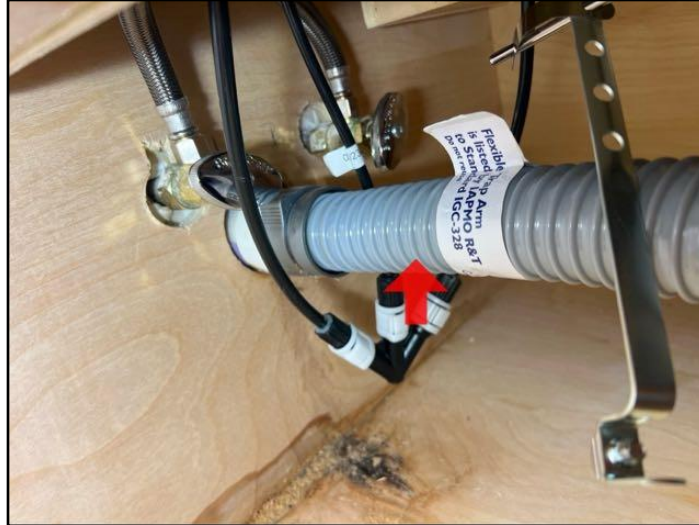
**137.** Flex pipe not recommended

**58. Condition:** • Flex pipe not recommended

The use of corrugated flex pipe is not recommended. This type of piping is prone to leakage and clogging. According to modern plumbing standards, drain piping materials should be smooth-walled with a uniform bore.

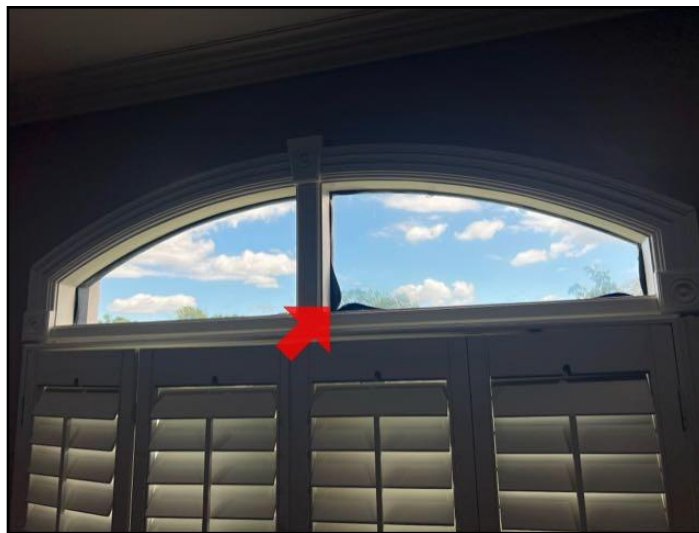
**143.** *Lost seal on double or triple glazing*

**59. Condition:** • Lost seal on double or triple glazing

Note: This defect was noted on approximately 1 window. It can be difficult to accurately diagnose the presence of this defect because symptoms only present themselves under certain conditions.

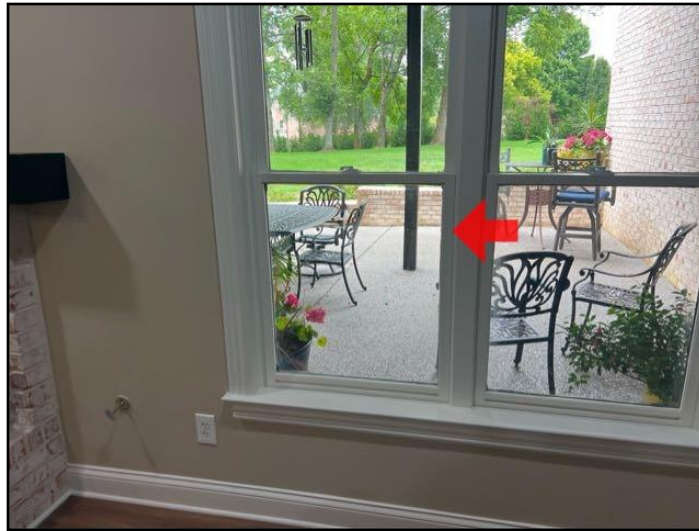
144. Inoperable - egress present

**60. Condition:** • Inoperable - egress present

Some of the windows throughout the home were unable to be opened with reasonable force. This is often due to sashes which have been painted shut, or lack of regular use. Minor repairs to the hardware or removal of the paint between the sashes and frames should restore functionality.

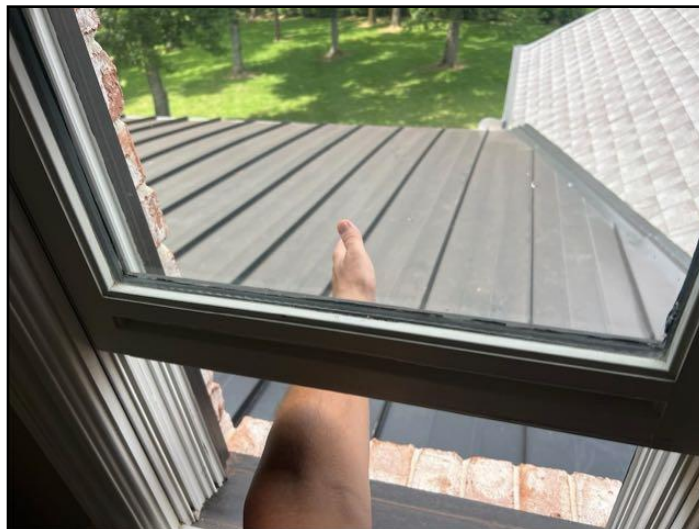
145. Missing

**61. Condition:** • Missing

Window screens were missing from areas of the home. The need for replacement of the screens is dependent upon the homeowner's intended usage of the windows.

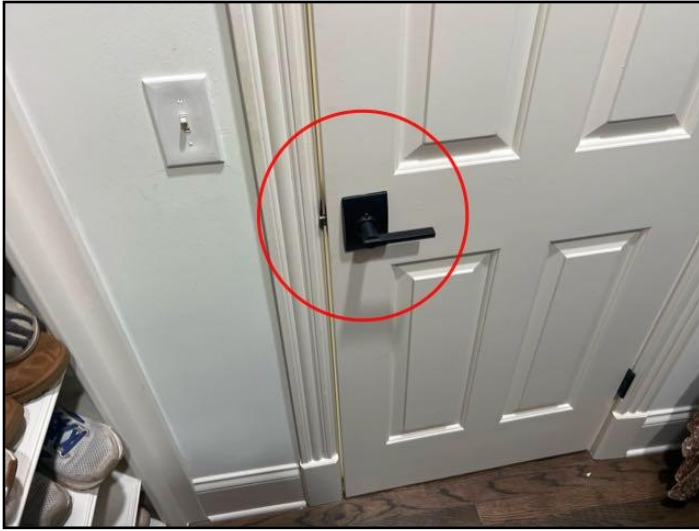
146. Does not latch properly

**62. Condition:** • Does not latch properly

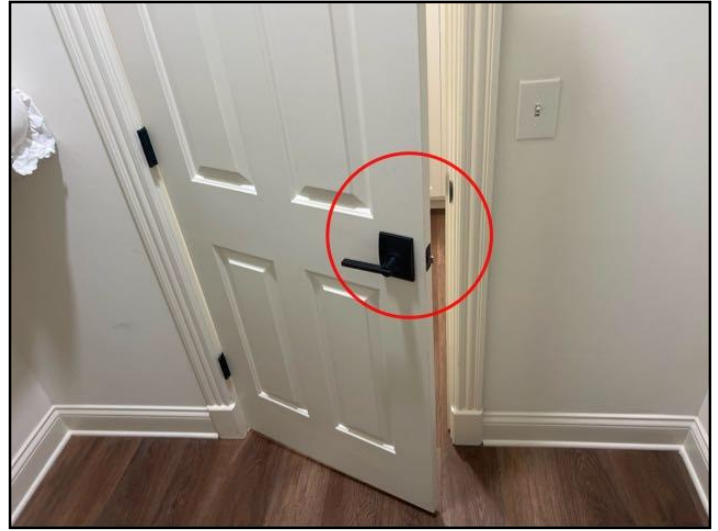
147. Does not latch properly

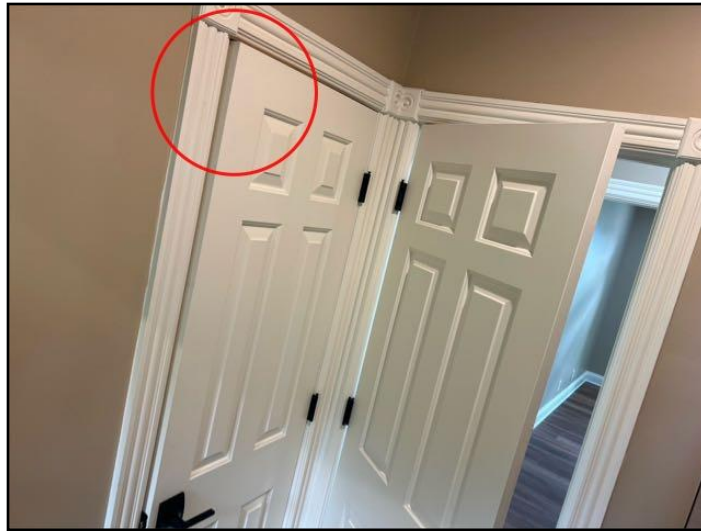
148. Racked/out-of-square

## 63. Condition: • Racked/out-of-square

The door was out of square inside the jamb. It is recommended that adjustments to the fit or hardware be made to restore normal function.

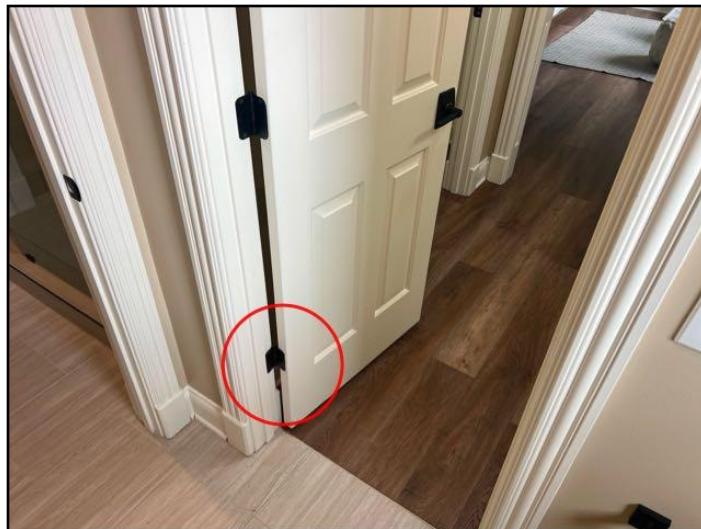
149. Loose

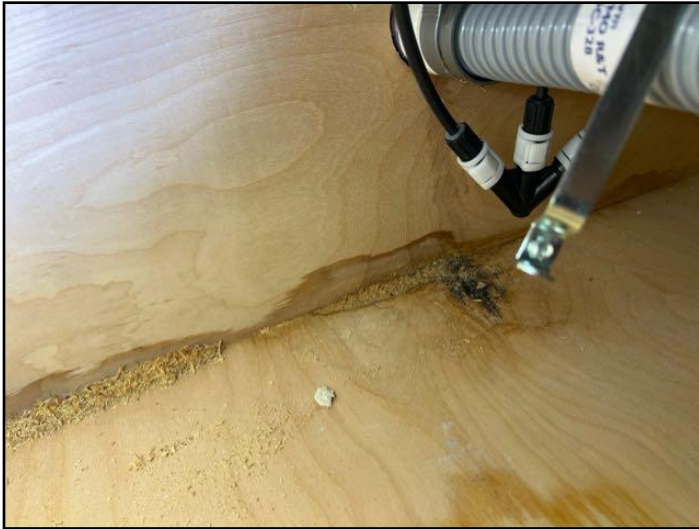
150. Damage to base (floor) - Dry

### 65. Condition: • Damage to base (floor) - Dry

Evidence was present which suggests the occurrence of past moisture issues beneath the basin. The affected areas were tested with a moisture meter and found to be dry. No visible signs of current leakage were found.

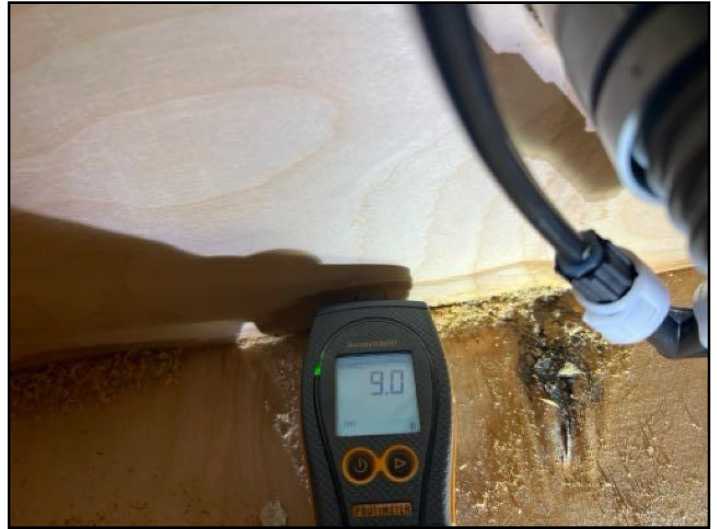
151. Damage to base (floor) - Dry

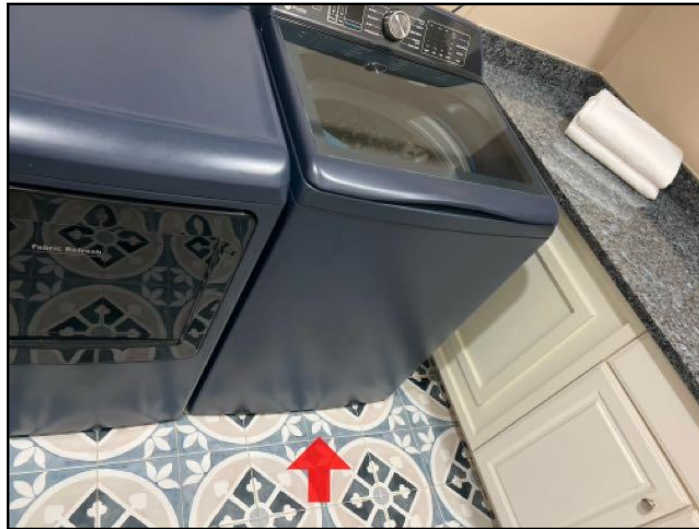
153. Drip pan missing

**66. Condition:** • Drip pan missing

Although not required, it is a recommended practice to install drip pans (preferably plumbed to the exterior) beneath clothes washers to decrease the risk of damage to materials in the event of water spillage.

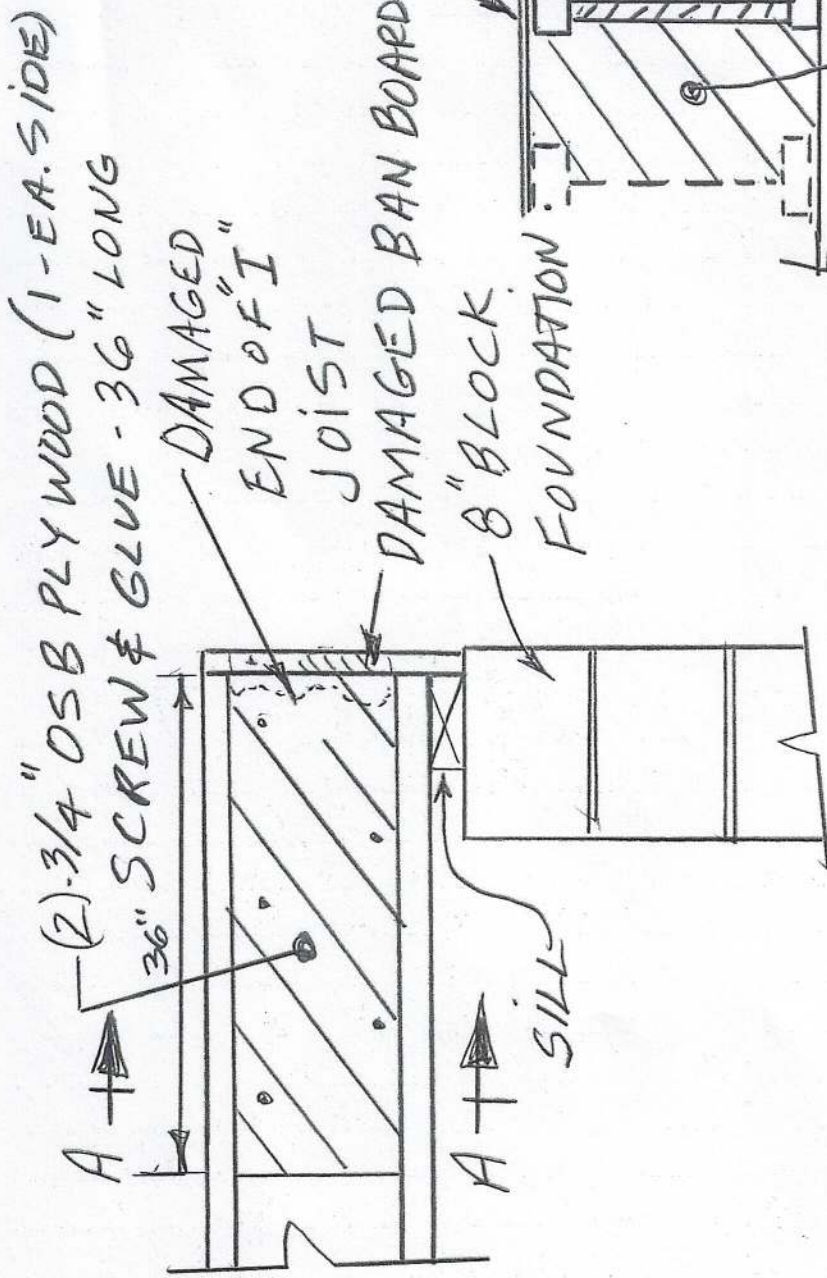
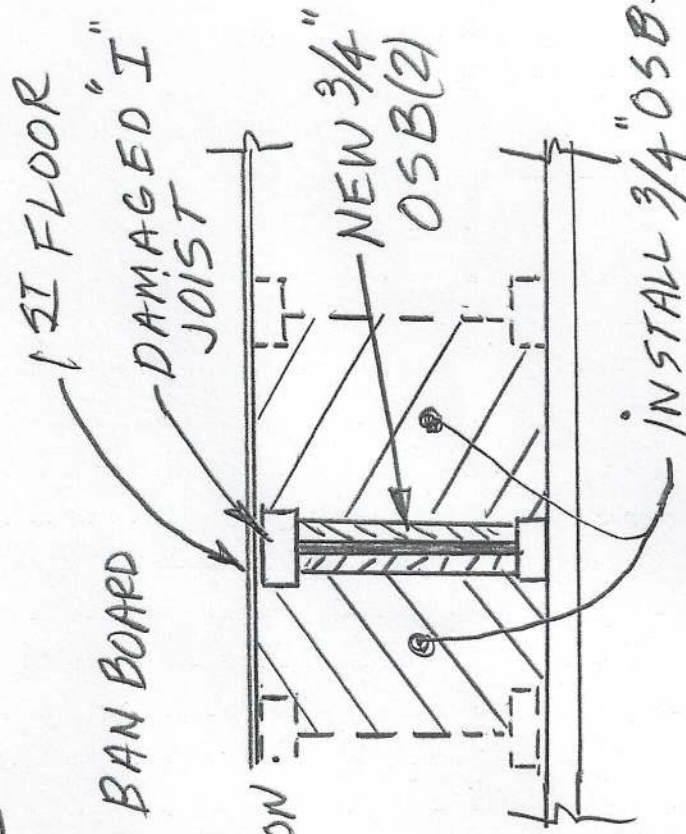
ELEVATION VIEW  
REPAIR TO JOIST

SECTION A-A (END VIEW)  
OVER - BAN BOARD (DAMAGED)  
INSTALL 3/4\"/>
