This document will note and explain the changes done to the LIMB project during the summer of 2026

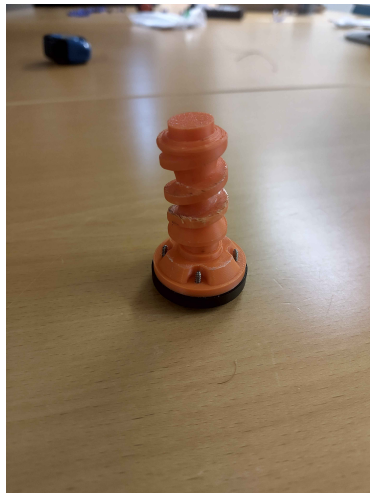
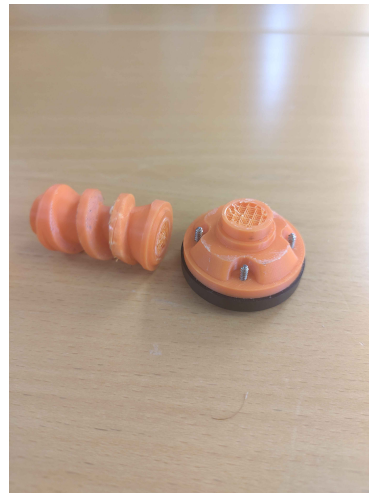
The original worm broke.

The reason for both these failures were the length of screws connecting the potentiometer being too long and digging into the worm gear.

This caused enough friction to require the motor to work incredibly hard until the breaking of the part gave the motor a back current strong enough to fry the MOSFETs.

The screws were exchanged for shorter ones, the gear, worm and casing were printed anew.

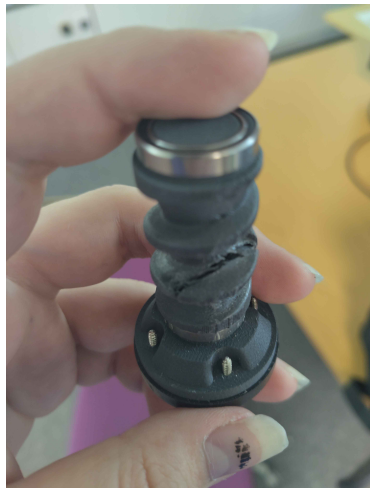
A new worm was printed out of carbonfibre. It also broke along with the motor driving it.
