# **PDX-2000**

## **Modification Manual**

**February 18, 2003**

Vestax Corporation

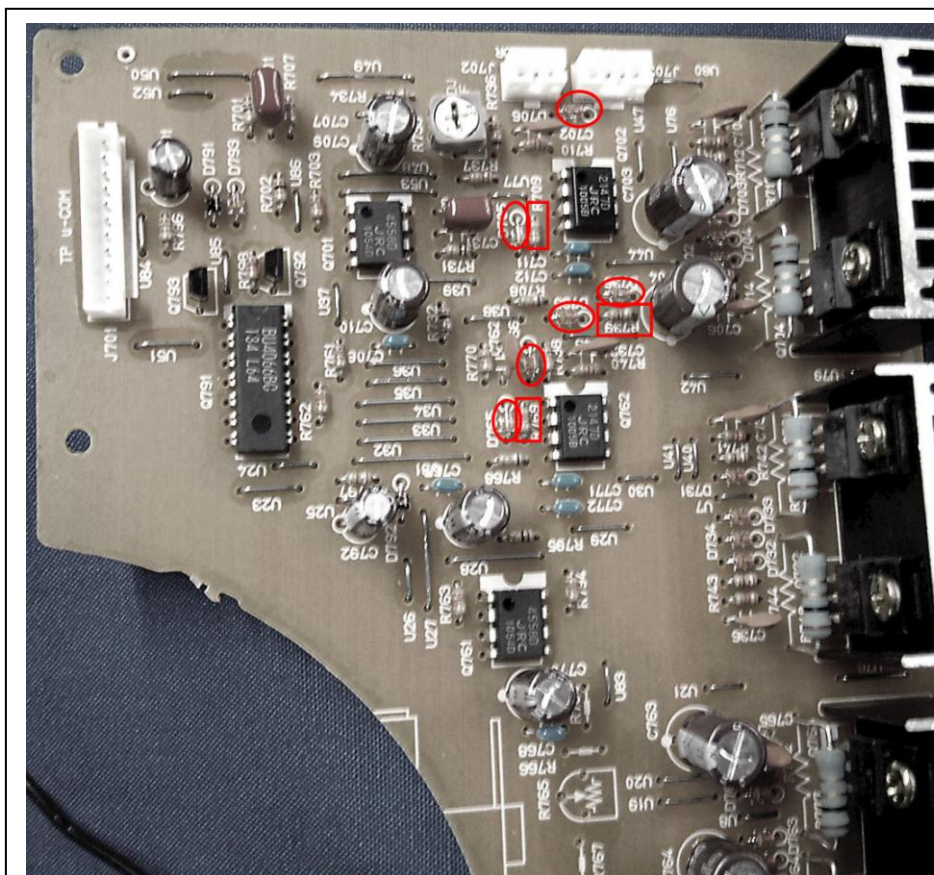
Please refer to attached figure #1.

When the platter is pushed down and a fair amount of pressure is applied (during scratch play), the platter may generate a vibration. This problem occurs on units produced in the first few batches.

**Remove**

D705, D706

D735, D736

D765, D766

**Replace**  
820  $\Omega$  — 470  $\Omega$

R709

R739

R769

1. On the main PCB (the largest PCB located besides the motor), remove the following six diodes; D705, D706, D735, D736, D765 and D766.
2. Replace the following resistors (from 820 ohm to 470 ohm); R709, R739 and R769.
