# NATIONAL TRANSPORTATION SAFETY BOARD

MATERIALS LABORATORY STUDY

Report No. 06-090

Place : Boston, Massachusetts  
Date : July 10, 2006  
Vehicle : Connector Tunnel to Ted Williams Tunnel  
NTSB No. : HWY06MH024  
Investigator : Mark Bagnard

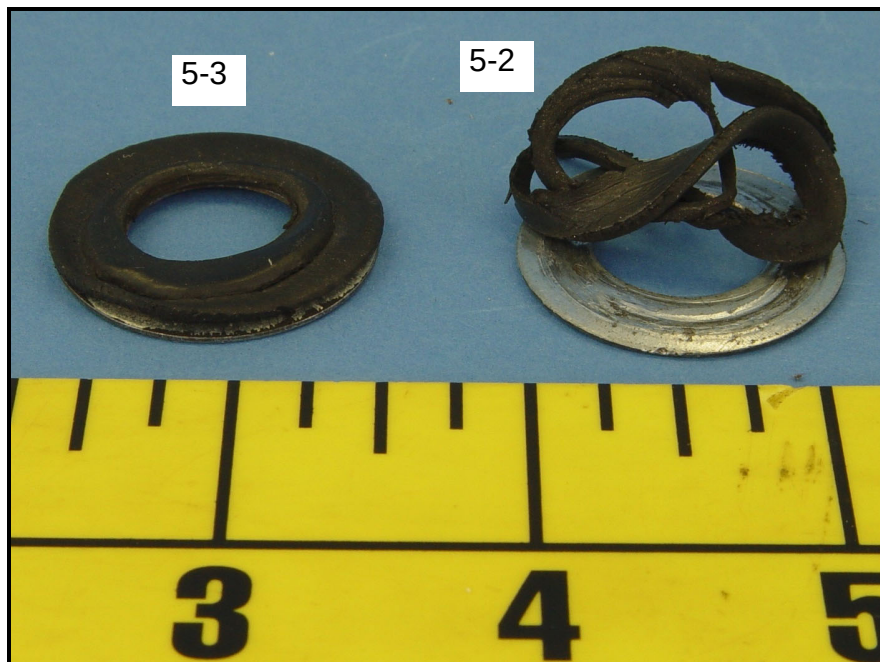
The sealing (rubber/metal) washer from accident hardware had been somewhat deformed before the beginning of torque test 3. It was noted that during application of the 125 foot-pounds of torque, the rubber portion of the sealing washer was substantially deformed and was squeezed outward. Upon disassembly, it was observed that the rubber

portion had separated from the metal portion, and significant additional shredding and damage had occurred to the rubber portion of this washer. Figure 2 shows the sealing washer from the 5-2 anchor after the torque test in comparison to the sealing washer from the 5-1 anchor, which was not used in a torque test. Similar damage occurred to the sealing washer from the 6-1 anchor used in test 5.

Figure 2. Comparison photographs of the sealing washer from anchor 5-2 (on the right) after torque testing and the sealing washer from anchor 5-3 (on the left), which was not utilized in the testing.
