# NATIONAL TRANSPORTATION SAFETY BOARD

MATERIALS LABORATORY STUDY REPORT

Report No. 06-075

Place : Boston, Massachusetts  
Date : July 10, 2006  
Vehicle : Connector tunnel to Ted Williams Tunnel  
NTSB No. : HWY06MH024  
Investigator : Mark Bagnard

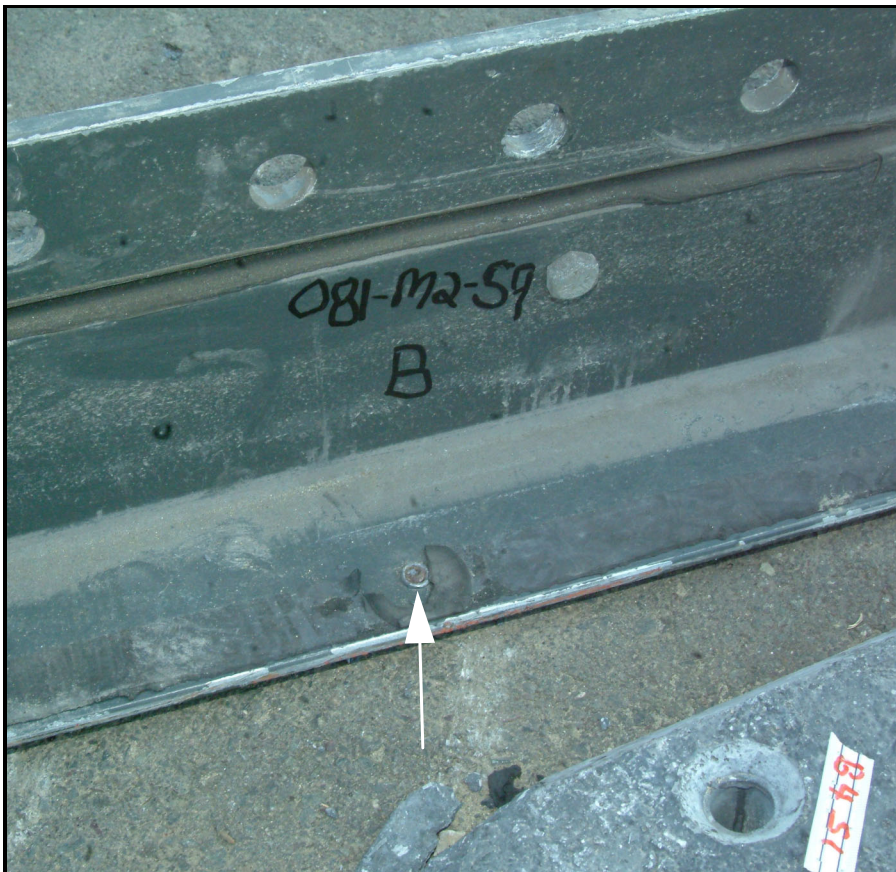
Figure 5. View of beam "M2" looking south and showing the location (arrow) of the west Nelson stud for the south end of panel "C3". Photo courtesy of Massachusetts State Police.

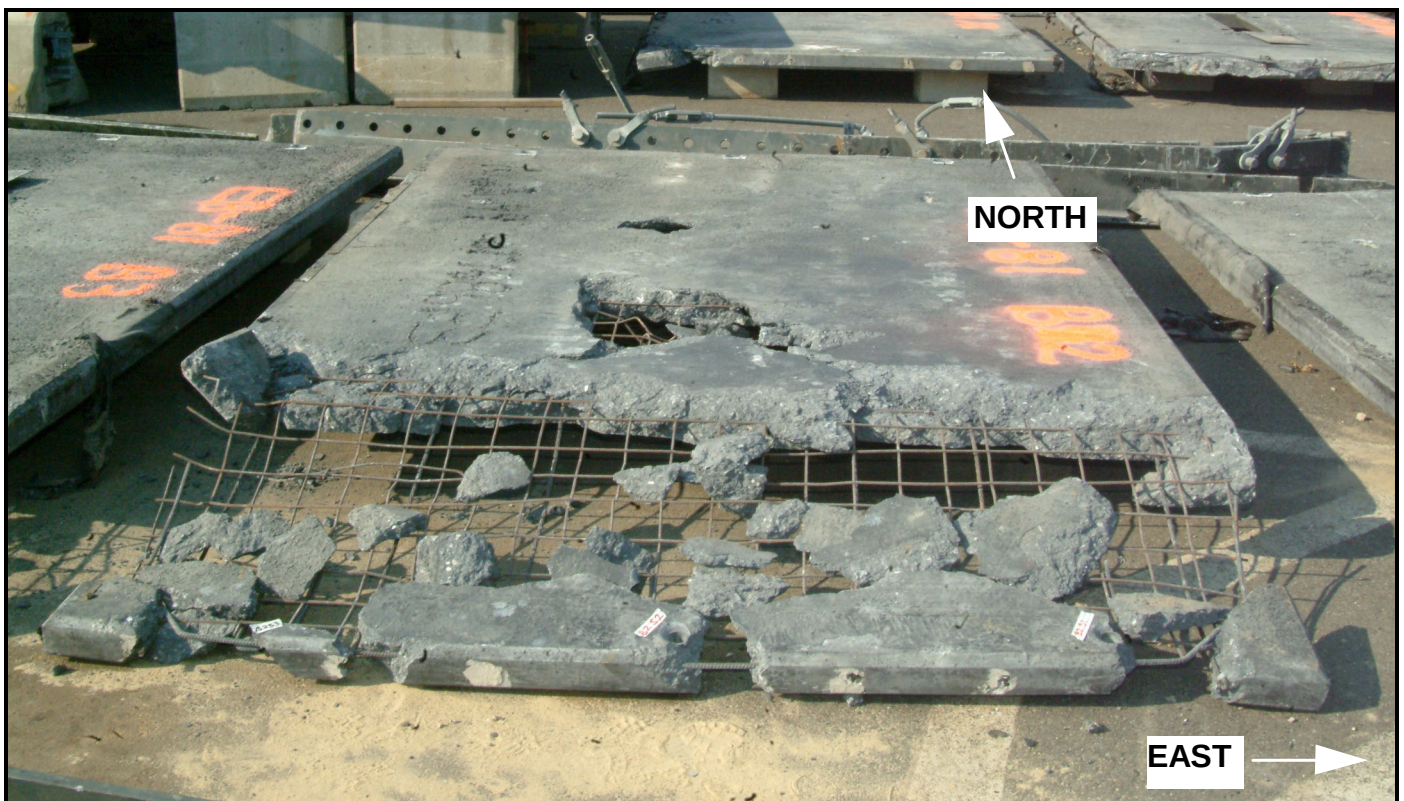
After fracture of the Nelson studs along the south end of the center concrete panels, the entire set of 10 concrete panels, beam “M1”, and the supporting hardware for beam “M1” swung down and to the north, still connected to the support structure through the damaged connections at the “N” beam. The south ends of the center panels were the first structure to contact the roadway surface, resulting in significant crushing and fracturing along this line (see figure 2 and a closer view in figure 7). It was noted that the crushing damage extended increasingly further into the panels progressing from panel “C5” to “C1”.

Figure 7. Closer view of the damage to the south end of panel "C2". View is looking north at the upper surface of the panel. Photograph courtesy of Massachusetts State Police.
