# NATIONAL TRANSPORTATION SAFETY BOARD

## MATERIALS LABORATORY FACTUAL REPORT

Report No. 06-073

Place : Boston, Massachusetts  
Date : July 10, 2006  
Vehicle : Connector tunnel to Ted Williams Tunnel  
NTSB No. : HWY06MA024  
Investigator : Mark Bagnard

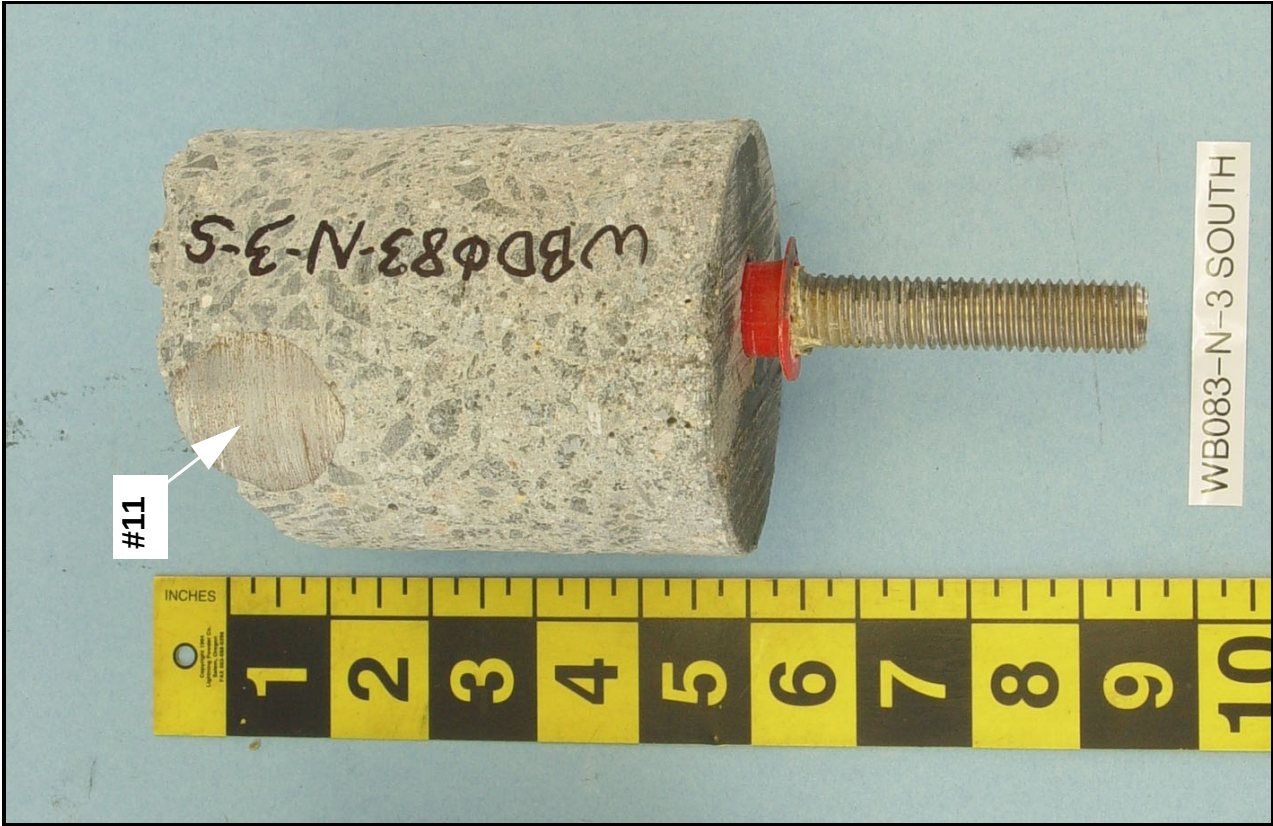
Figure 4 shows a side view and an oblique view of the core sample at the “WB083-N-3 south” anchor position. This sample was about 4.5 inches high, and measurements of the distance between the cap flange and the ceiling surface on this sample indicated that the anchor had displaced downward 0.3 inch to 0.4 inch<sup>2</sup>. The upper end of the core sample was fractured around a #11 rebar, and the hole for the anchor partially intersected this bar. The bottom of the #11 rebar was 3.1 inches above the ceiling.

As shown in figure 4, anchor "WB083-N-3 south" had displaced downward 0.3 inch to 0.4 inch, and the hole for this anchor had been drilled partially through a #11 rebar. Because the rebar did not totally surround the anchor hole, a transverse cut was made through the concrete up to the lower edge of the rebar piece, and the concrete between the cut and rebar was broken out. The rebar piece was then pulled laterally off the anchor. The remainder of the core sample was then cut longitudinally. Figure 18 shows the resulting pieces.

Figure 4. Overall side view (left photo) and oblique view (right photo) of the core sample "WB083-N-3 south". The location and size of rebar are indicated.

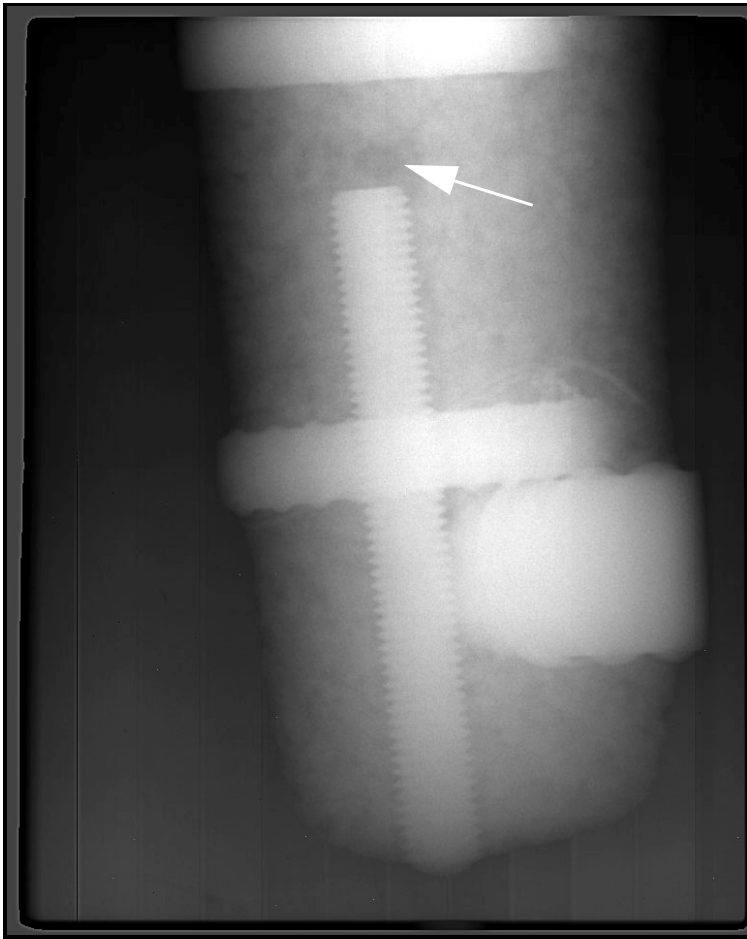
The x-rays images were able to show the sides of the drilled holes, but did not show clear evidence of voids in the epoxy between the threads of the anchors and the hole surface, although in some views, slightly darker bands suggestive of voids were visible. In several of the views of “WB083-S-8 north” what appeared to be an irregular void area was visible above the upper end of the anchor. Figure 6 shows the x-ray view with the most distinctly appearing void area.

Figure 6. X-ray image at 0 degrees of core sample "WB083-S-8 north", with the arrow indicating what appeared to be an irregular void area above the upper end of the anchor.

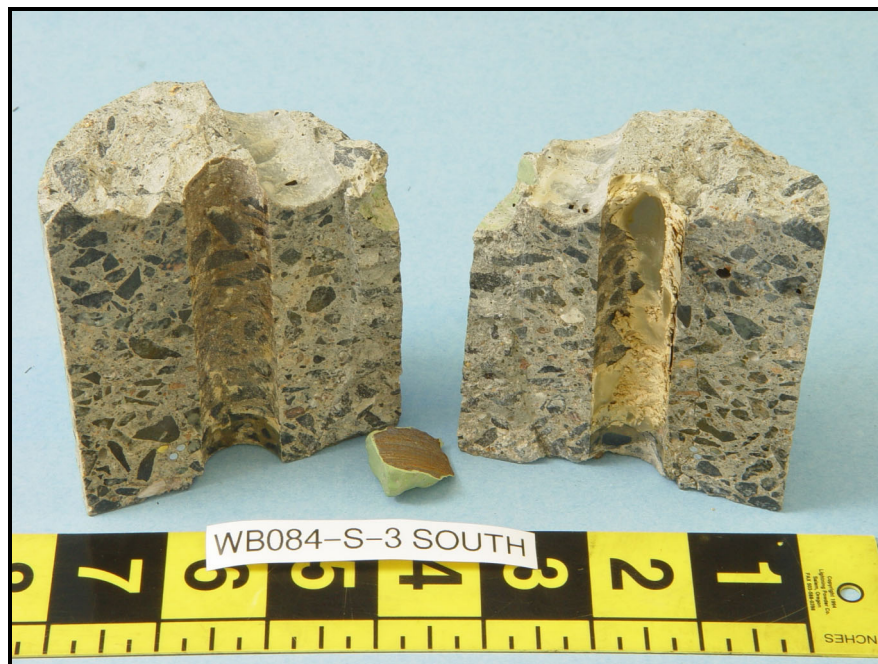
The saw cut surface visible in figure 7 was nearly through the centerline of the hole. It was noted that the intersections between the saw cut surface and the edges of the hole were nearly straight lines, and that the hole surface (where visible) contained no discernable cut lines or significant irregularities that might be expected when using a carbide drill bit. The straightness of the hole and its smooth surface appeared typical of a hole drilled with a diamond coring bit<sup>3</sup>.

Figure 7. Lower portion of core sample "WB084-S-3 south" after longitudinal cutting. A closer view of the piece on the right is shown in figure 8.

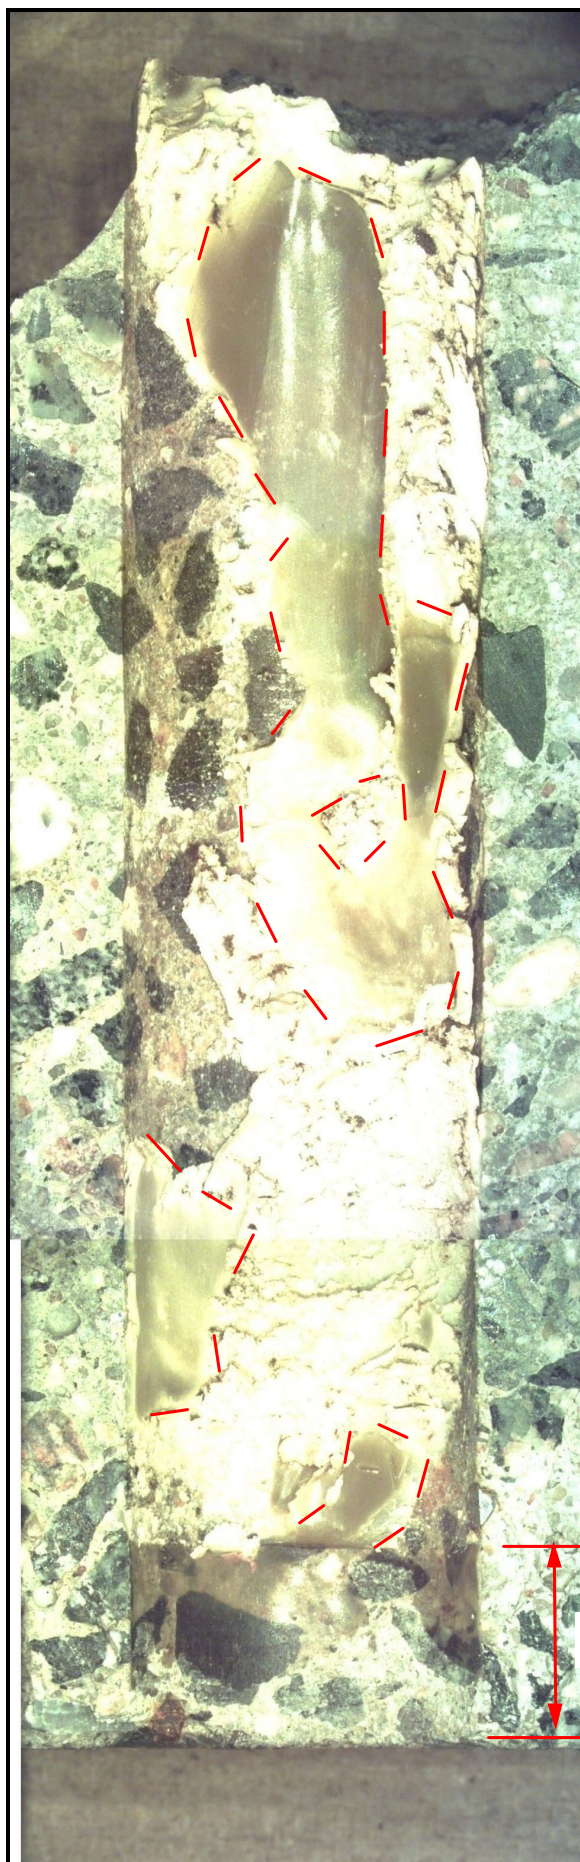
The loosely adhering epoxy was removed from the lower portion of core sample “WB 084-S-3 south” using a slender wooden rod. It was noted that about one half of the circumference of the hole contained very little epoxy, and that significant epoxy remained on the other half of the hole. After removal of the loose epoxy, this portion of the sample was cut longitudinally in the Safety Board’s Materials Laboratory using a high-speed, water-cooled abrasive cut-off wheel. The cut was oriented such that one half would have the bulk of the remaining epoxy. Figure 7 shows the lower portion of this section after cutting, and figure 8 shows a closer view of the side with the bulk of the remaining epoxy. Multiple void areas were visible, and are outlined by the dashed lines in figure 8. In areas where most of the epoxy was missing from the surface of the drilled hole, the aggregate (a darker stone) was easily discernable from the mortar.

Figure 8. Composite photograph with a closer view of the epoxy remaining in one half of the drilled hole in the lower portion of core sample "WB084-S-3 south". Dashed lines outline void areas. The plastic cap extended up inside the hole to the position indicated.

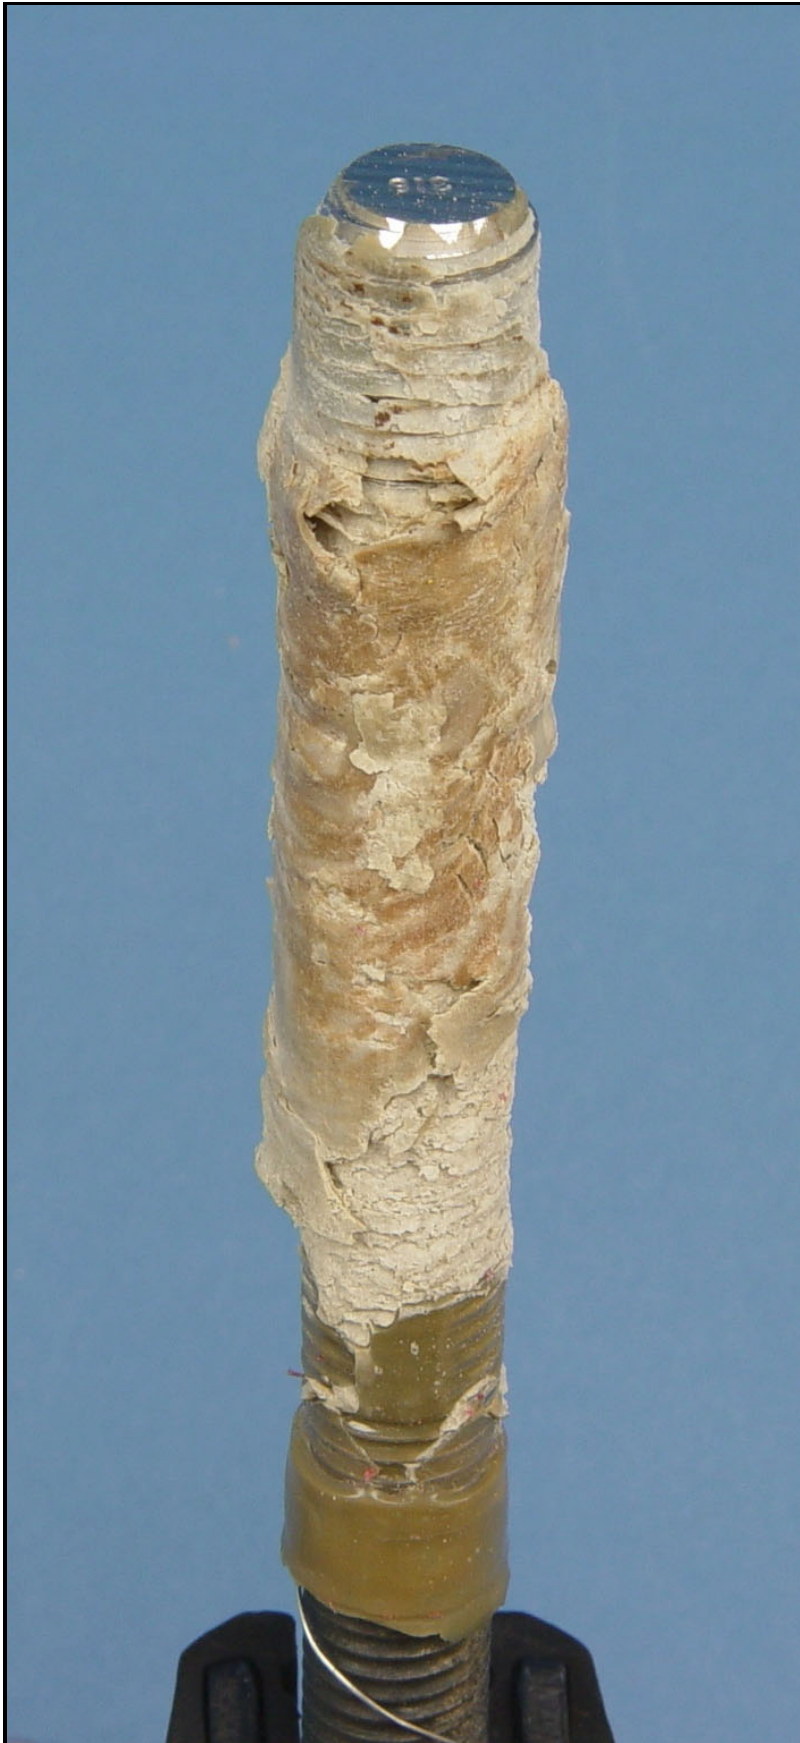
Examination of the “WB084-S-3 south” anchor showed that one side of the anchor contained a damaged and deformed layer of epoxy that appeared to have extended out to the surface of the anchor hole. The epoxy along this side of the anchor, shown in figure 10, appeared to have been compressed along the length of the anchor, with the relatively smooth surface of the epoxy apparently corresponding to the surface of the anchor hole. As can be seen in figure 10, the smoother surface of the epoxy in this area contained a reddish tint, not found on any other anchor that was a part of this examination. Portions of the epoxy with the reddish tint and without the reddish tint were subjected to X-ray energy dispersive spectroscopy in a scanning electron microscope. Spectra from the two areas were very similar, both showing peaks of calcium, silicon, and magnesium (associated with the filler material for the epoxy) as well as oxygen and carbon. Neither spectrum showed any amount of iron.

Figure 10. Overall view of the anchor from position "WB084-S-3 south", showing the smooth but axially compressed epoxy on this side of the anchor.

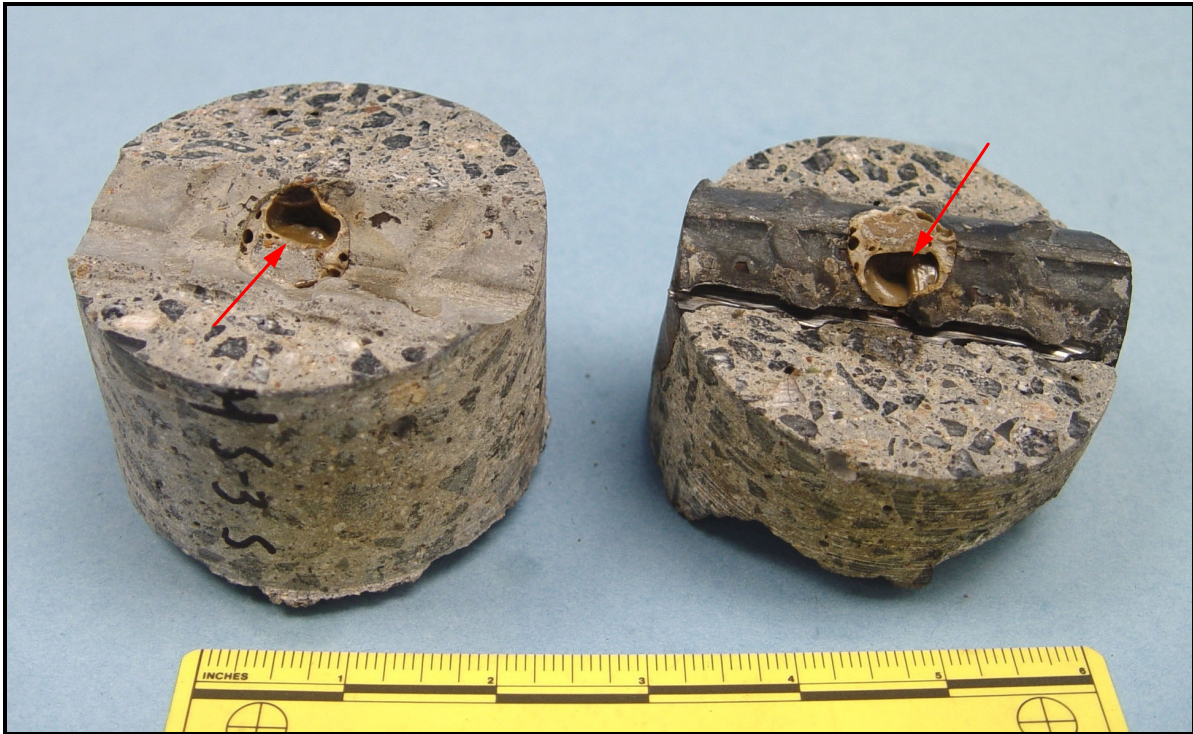
As can be seen in figure 1, core sample “WB084-S-3 south” extended above the top of the drilled anchor hole. In order to expose the top of the drilled hole, lateral cuts were made through the upper portion of the core sample just into or just short of the upper edge of the #11 rebar. Figure 11 shows the upper portion of this section after the concrete was fractured away from the upper surface of this rebar. The upper end of the anchor hole was contained in the piece shown on the left in this figure. As can be seen in figure 11, a large void was found in the epoxy located above the upper end of the anchor.

Figure 11. Upper portion of core sample "WB084-S-3 south" after cutting near the upper side of the #11 rebar in order to expose the upper end of the drilled hole. The arrows indicate the two sides of a void in the epoxy.

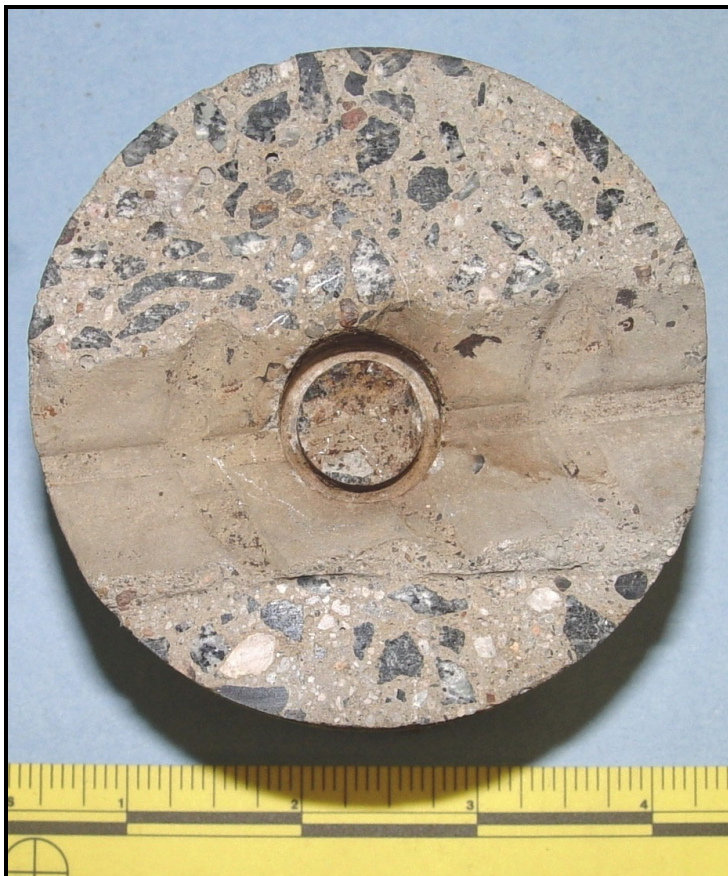
In order to more easily show the characteristics of the upper end of the anchor hole, the piece of core sample “WB084-S-3 south” shown on the left in figure 11 was heated to 100° C and held for 1 hour to remove moisture from the sample, then heated to approximately 300° C and held for 1 hour. This thermal exposure degraded the epoxy in the upper end of the hole, and the epoxy was then scraped out using a slender wooden rod. A closer view of the upper end of the hole is shown in figure 12. As can be seen in this figure, the perimeter of the hole was deeper than the central portion, which appeared to be the remnant of a fractured  $\frac{3}{4}$  inch diameter core section created when the anchor hole was cut. Measurement of the depth of the drilled hole showed that it extended about 5.54 inches above the ceiling of the tunnel, leaving a space of about 0.35 inch above the upper end of the anchor. The physical characteristics of the upper end of the hole were consistent with creation of the hole using a diamond coring bit.

Figure 12. Closer view of the upper end of the drilled hole from core sample "WB084-S-3 south" (from the piece shown on the left in figure 9) after baking and removal of the epoxy.

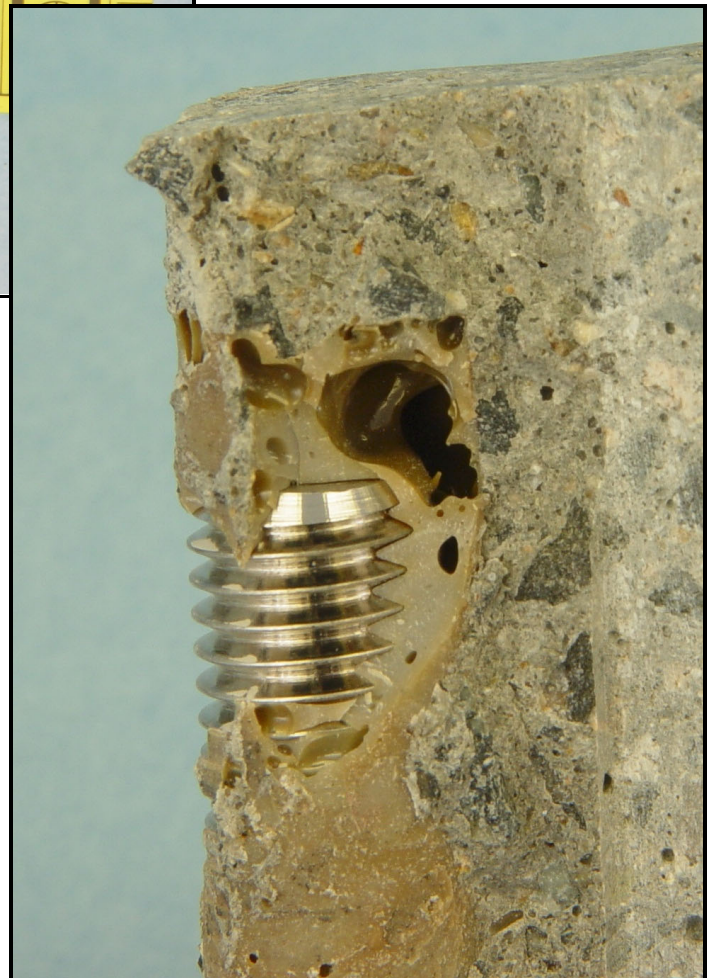
Figure 14. Opened core sample "WB083-S-8 north" (before final removal of the anchor) showing a large void and several smaller voids at and above the upper end of the anchor.

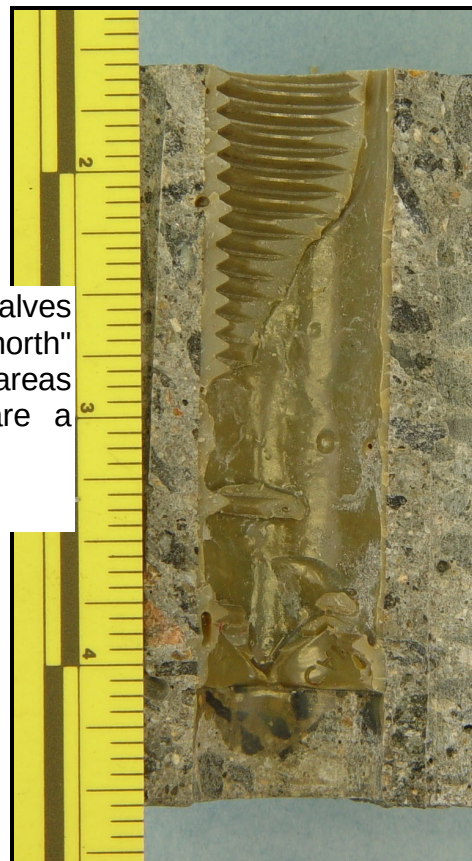
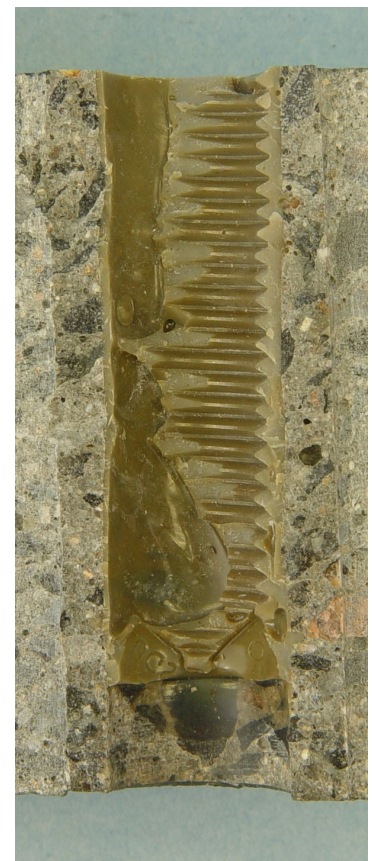
from the sample half to which it remained attached in order to also examine that portion of the epoxy. The maximum extent of the voids was revealed by chipping away the epoxy on the anchor side of void areas. Examination of the opened section revealed a single continuous void, as shown in figure 16.

Figure 16. Views of the two halves of core sample "WB083-N-3 north" below the #11 rebar. Smooth areas without thread impressions are a single continuous void.

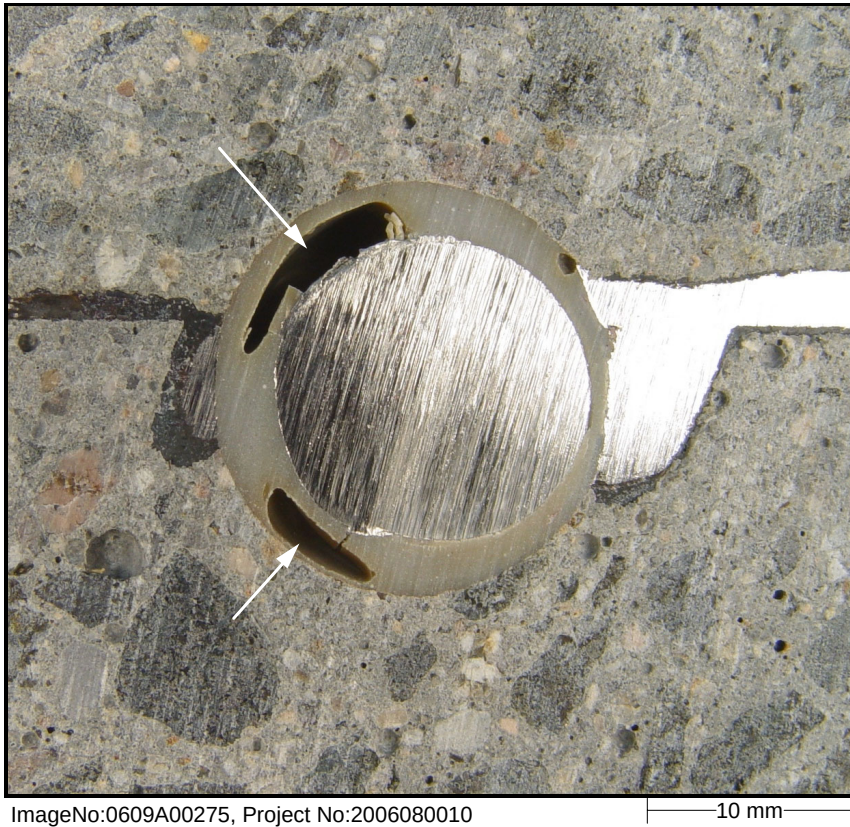
It was also noted that void areas extended up into the area where the anchor passed through the rebar. Figure 17 shows a closer view of the anchor at the transverse cut located at the lower edge of the rebar. The void areas extending further up are indicated in this figure. Also, it was noted that the anchor was not concentrically located within the hole, and that the voids were more predominant on the side of the anchor with greater distance between the anchor and the hole surface. Voids were also noted on the same side of the anchor where the anchor extended out of the upper edge of the rebar piece.

Figure 17. Transverse cut just below the #11 rebar on core sample "WB083-N-3 north". Arrows indicate void areas.

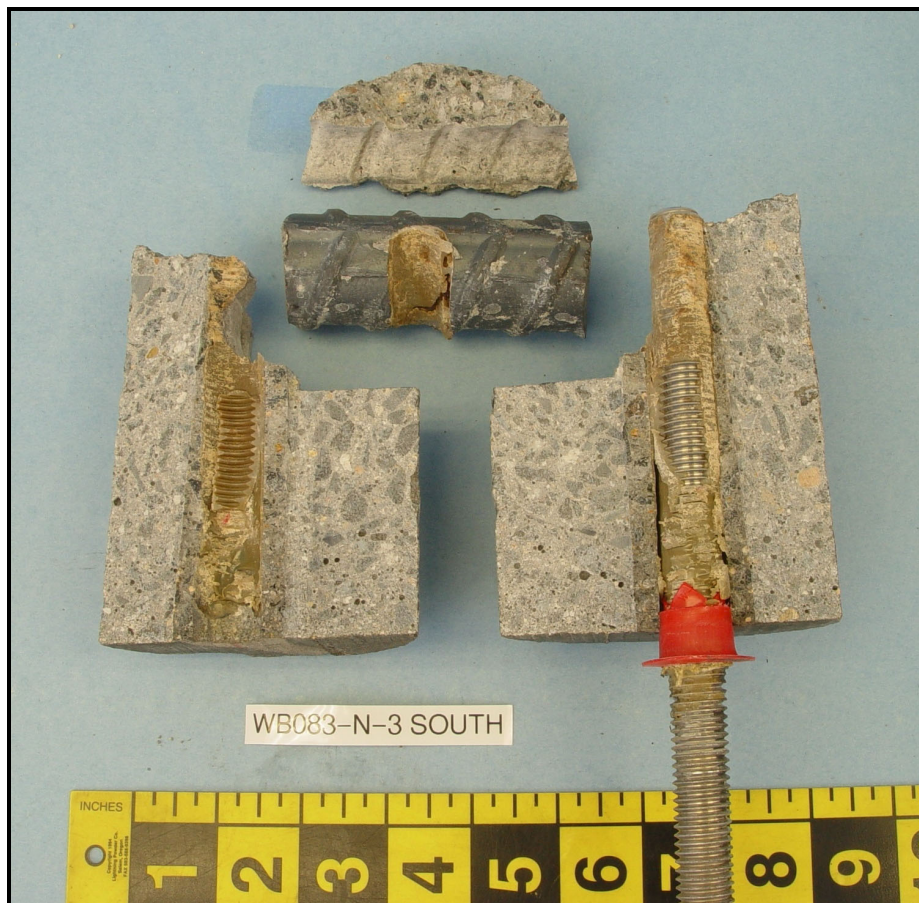
Figure 18. Core sample "WB083-N-3 south" after cutting.

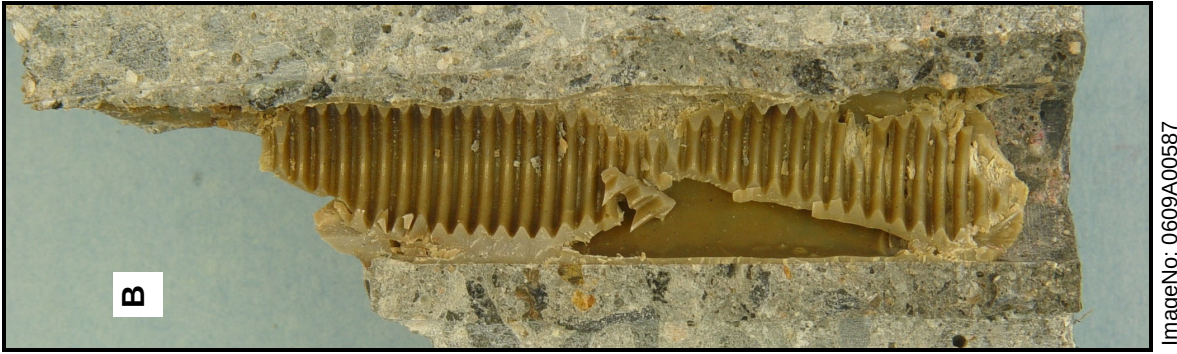
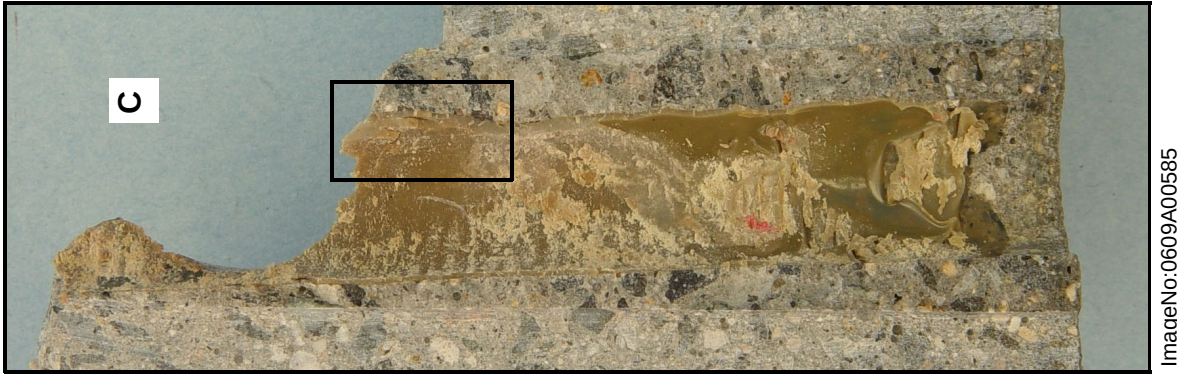
The anchor was removed from the sample half to which it remained attached in order to also examine that portion of the epoxy. The two left images in figure 19 (photographs "A" and "B") show closer views of the section halves after removal of the anchor. The two right images in figure 19 (photographs "C" and "D") show views of the section halves after chipping away epoxy to show the full extent of the voids.<sup>6</sup>

During the removal of epoxy to show the full extent of the voids, a large piece of epoxy with the imprint of the anchor threads separated from one half of the sample (compare photographs "A" and "C" in figure 19). On the other half of the sample, the epoxy was chipped away where it protruded over void areas, but no bigger pieces of epoxy were easily separated from the sample half, compare photographs "B" and "D" in figure 19.

Figure 19. Views of core sample "WB083-N-3 south" after removal of the #11 rebar and splitting in half. Two left photographs were taken before epoxy was chipped away to reveal the extent of void areas, and two right photographs were taken after epoxy was chipped away.

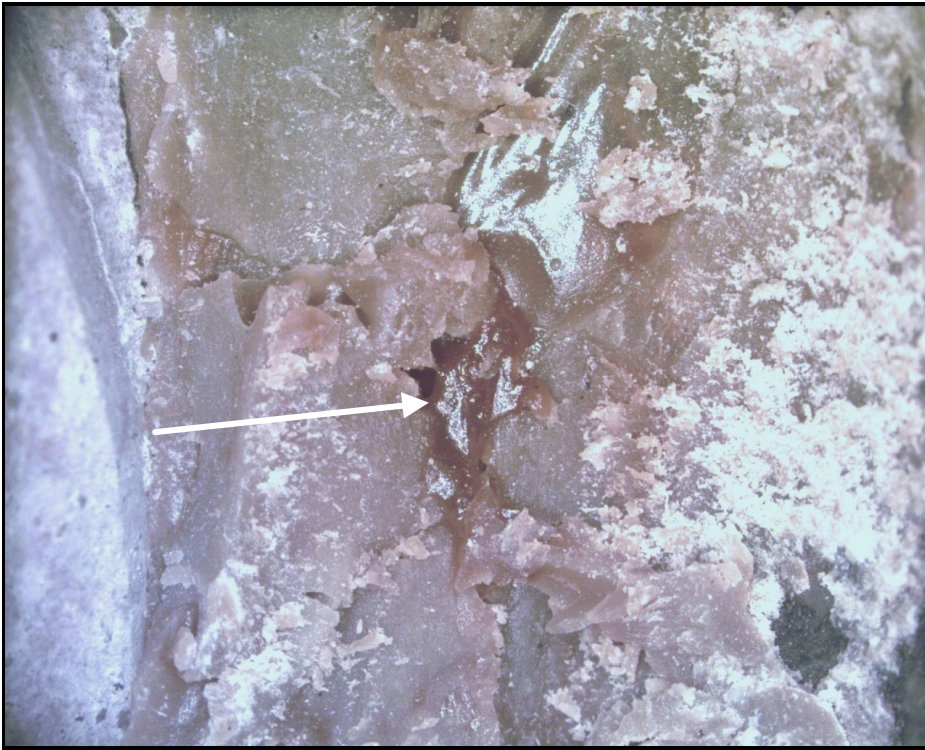
Figure 24. Closer view of the darkest discolored area, located on the epoxy attached to the anchor hole on core sample "WB083-N-3 south", at the position indicated by the larger white arrow in figure 23.

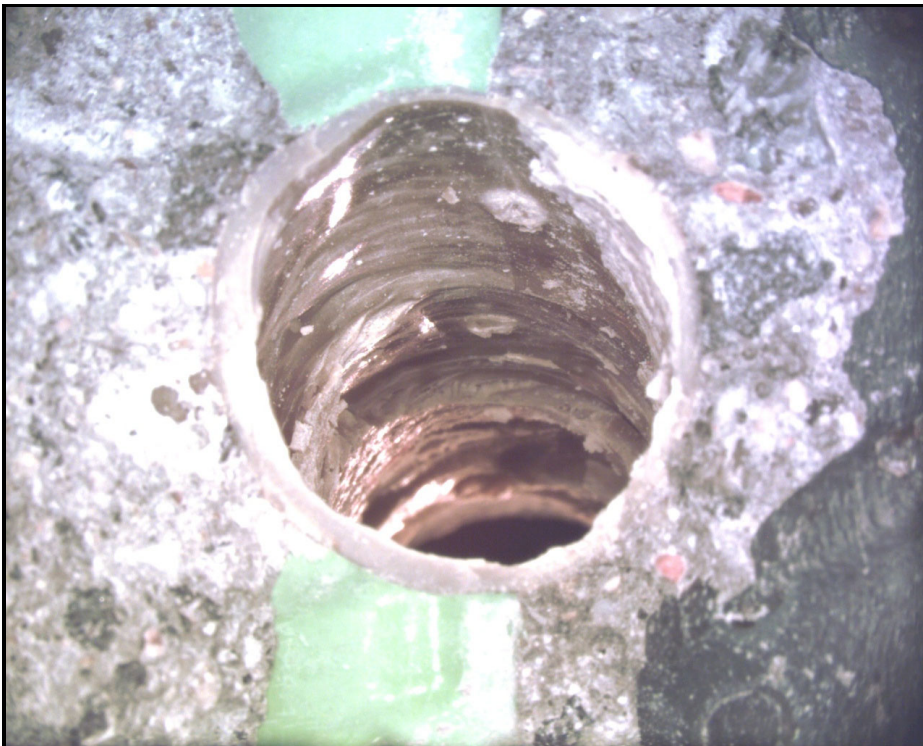
Figure 25. View looking down inside the anchor hole on the lower portion of core sample "WB083-N-1 north" showing a major void area. Photograph was taken after removal of loose epoxy. Compare to figure 5.
