# NATIONAL TRANSPORTATION SAFETY BOARD

MATERIALS LABORATORY STUDY

Report No. 06-092

Place : Boston, Massachusetts.  
Date : July 10, 2006.  
Vehicle : Connector Tunnel to Ted Williams Tunnel.  
NTSB No. : HWY06MH024.  
Investigator : Mark Bagnard.

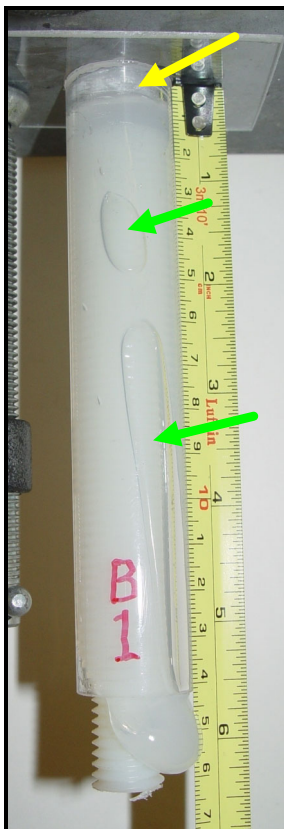
For test hole “B1”, the air gap is illustrated in the left image of figure 3 and indicated by the yellow arrow. The total volume of the air gap was calculated to be 0.26 cubic inch (4.26 milliliters) and consisted of 0.04 cubic inch for the 0.25 inch deep groove around the central disk and 0.22 cubic inch for the 0.5-inch long portion of the cylinder.<sup>3</sup> After anchor insertion, a small void remained in the top of the hole, and longitudinally oriented voids were produced along the side of the hole. The right image in figure 3 illustrates the hole after anchor insertion, with a yellow arrow indicating a void that remained in the top of the hole. The upper green arrow indicates a void at the side of the hole similar to that produced in hole “A2”, and the lower green arrow indicates a longer void at the side of the hole that was approximately 3 1/8 inches long and intersected the bottom of the hole. Some of the air in the air gap at the beginning of the test escaped from the bottom of the test hole as the nylon anchor was inserted, producing a distinctive sound as it did so. The voids at the upper end and side of the hole, as before, were produced during the last inch of anchor insertion. Along the side of the hole, the upper void encompassed an area of approximately 0.19 square inch and the lower void had an area of approximately 1.1 square inches.

Figure 3. Test hole "B1" before anchor insertion (left) and after anchor insertion (right).

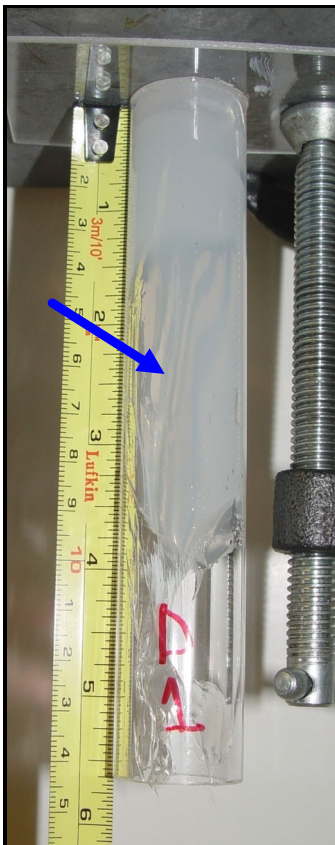
The “D1” test repeated the conditions of the “A2” test, but the nozzle was not extracted any amount until after injection of the caulk. As the nozzle was extracted, some caulk adhered to the nozzle, and some was deposited on the sides of the hole below the half way mark. Test hole “D1” is illustrated in the left image of figure 6, prior to anchor insertion, with a blue arrow indicating the caulk deposited on the sides of the hole. During insertion of the anchor, caulk flowed around the anchor leaving a void at the top of the hole, a small void on the side of the hole, and a longitudinal band of small isolated voids in the thread roots of the anchor. The right image of figure 6 illustrates test hole “D1” after anchor insertion, with a yellow arrow indicating the void at the top of the hole, a green arrow indicating the small void at the side of the hole, and a red arrow indicating the location of the thread root void cluster. The approximate area of the side void was 0.03 square inch, and the band containing the thread root void cluster was approximately 1.7 inches long and 0.1 inch wide.

Figure 6. Test hole "D1" before anchor insertion (left) and after anchor insertion (right).

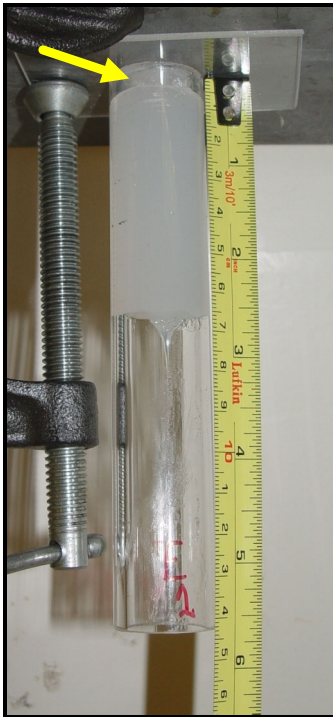
In test hole “E1”, 6.0 milliliters of air were injected after anchor insertion. The injection needle was extracted during the air injection process. The left image of figure 7 illustrates the test hole, prior to anchor insertion, with a yellow arrow indicating the air trapped around the center disk at the top of the hole. The center image of figure 7 illustrates the test hole with the anchor inserted and the injector needle inserted. The yellow arrow indicates the void at the top of the hole, which appeared similar to the top void produced during tests “A1” and “A2” and indicated by the yellow arrows in figure 2. The blue arrow indicates the injector needle. The right image of figure 7 illustrates the test hole, after removal of the injector needle, with the green arrows indicating the longitudinal void that was produced at the side of the hole and the blue arrow indicating the thin extraction path of the needle after the 6.0 milliliters of air had been injected. The approximate area of the void produced was 0.87 square inch. The red arrow in the right image of figure 7 indicates a portion of an area where clusters of small voids were observed in the roots of the threads. The cluster of small voids in the thread roots was shaped similar to a riding boot approximately 2 inches long and encompassed an area of approximately 0.38 square inch.

Figure 7. Test hole "E1" before anchor insertion (left), after anchor insertion followed by air injector needle insertion (center) and after air injection (right).

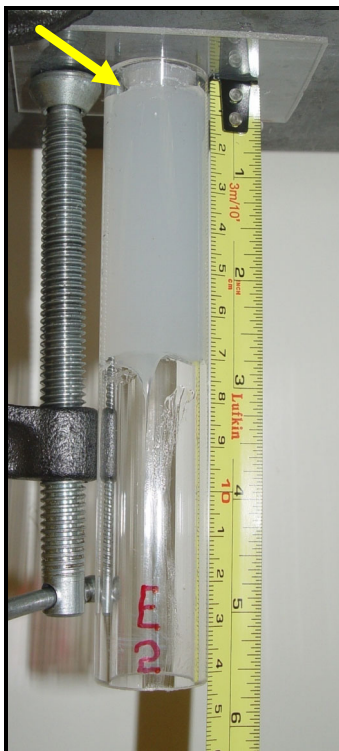
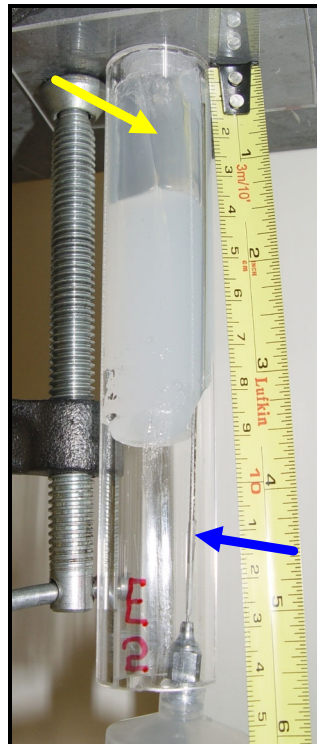
In test hole “E2” 7.0 milliliters of air were injected into the top of the hole before anchor insertion. The left image of figure 8 illustrates the test hole, prior to air injection, with a yellow arrow indicating the air trapped around the center disk in the top of the hole. The center image of figure 8 illustrates the test hole, after air injection, with a yellow arrow indicating the air gap produced by the air injection. The blue arrow indicates the injection needle still in the hole after the air injection was completed. The right image of figure 8 illustrates the test hole, after anchor insertion, with a yellow arrow indicating the void at the top of the hole and green arrows indicating four distinct voids along the side of the hole that were produced during the last inch of anchor insertion. The approximate area of the four voids along the side of the hole, from top to bottom, were 0.14, 0.04, 0.23 and 0.23 square inch, a total of 0.64 square inch.

Figure 8. Test hole "E2" before air injection (left), after air injection (center) and after anchor insertion (right).

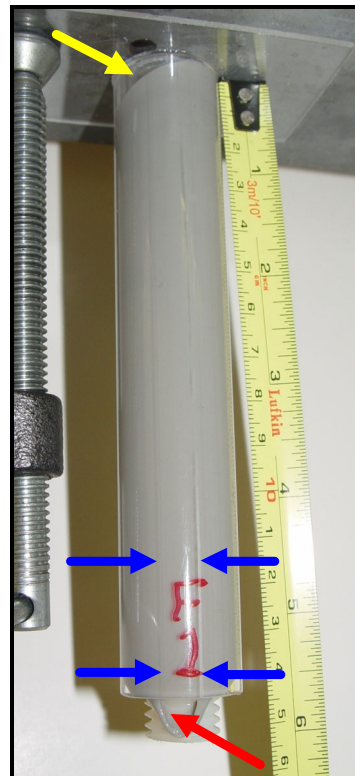
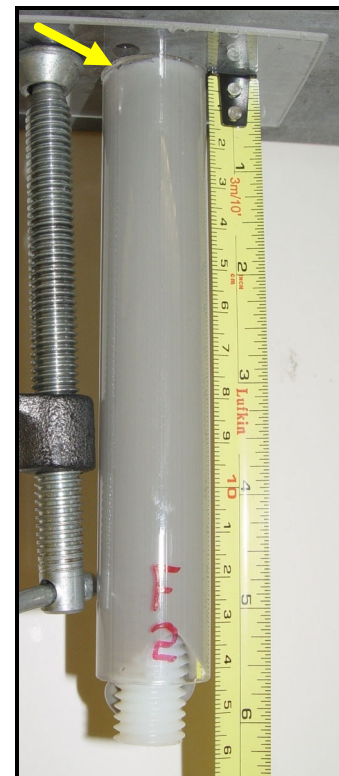
Test hole “F1” was a repeat of test hole “B1” conditions with a significant air gap produced at the top of the hole prior to insertion of the threaded rod. The left image of figure 9 illustrates the test hole, prior to anchor insertion, with a yellow arrow indicating the

air gap produced at the top of the hole. The total volume of air above the epoxy was calculated at 0.32 cubic inch (5.2 milliliters). During the anchor insertion process, it was noted that the epoxy flowed around the anchor easier than the caulk, and a bubble of air escaped from the open end of the test hole during the last inch of insertion. The center image of figure 9 illustrates the test hole after the anchor had been inserted, with a yellow arrow indicating the void produced at the upper end of the hole. A red arrow indicates where the air bubble escaped, and blue arrows indicate two faint lines that appeared to connect to the edges of the bubble and continued up the test hole. Confirmation of voids in test hole "F1" is described later under "sectioning of the "F" test holes".

Test hole "F2" was a repeat of test hole "D1" conditions with the epoxy fully inserted without extracting the nozzle, the nozzle extracted, and then the anchor inserted. Prior to insertion of the anchor, the test hole appeared similar to test hole "D1", illustrated in the left image of figure 6, but the contents of the hole were gray. The right image of figure 9 illustrates the test hole after anchor insertion with a yellow arrow indicating the void produced at the upper end of the hole. A visual examination did not reveal any evidence of the presence of voids along the side of the hole. Confirmation of voids in test hole "F2" is described later under "sectioning of the "F" test holes".

Figure 9. Test hole "F1" before anchor insertion (left) and after anchor insertion (right). Test hole "F2" after anchor insertion (right).
