# NATIONAL TRANSPORTATION SAFETY BOARD

MATERIALS LABORATORY FACTUAL REPORT

Report No. 06-091

Place : Boston, Massachusetts  
Date : July 10, 2006  
Vehicle : Connector tunnel to Ted Williams Tunnel  
NTSB No. : HWY06MH024  
Investigator : Mark Bagnard

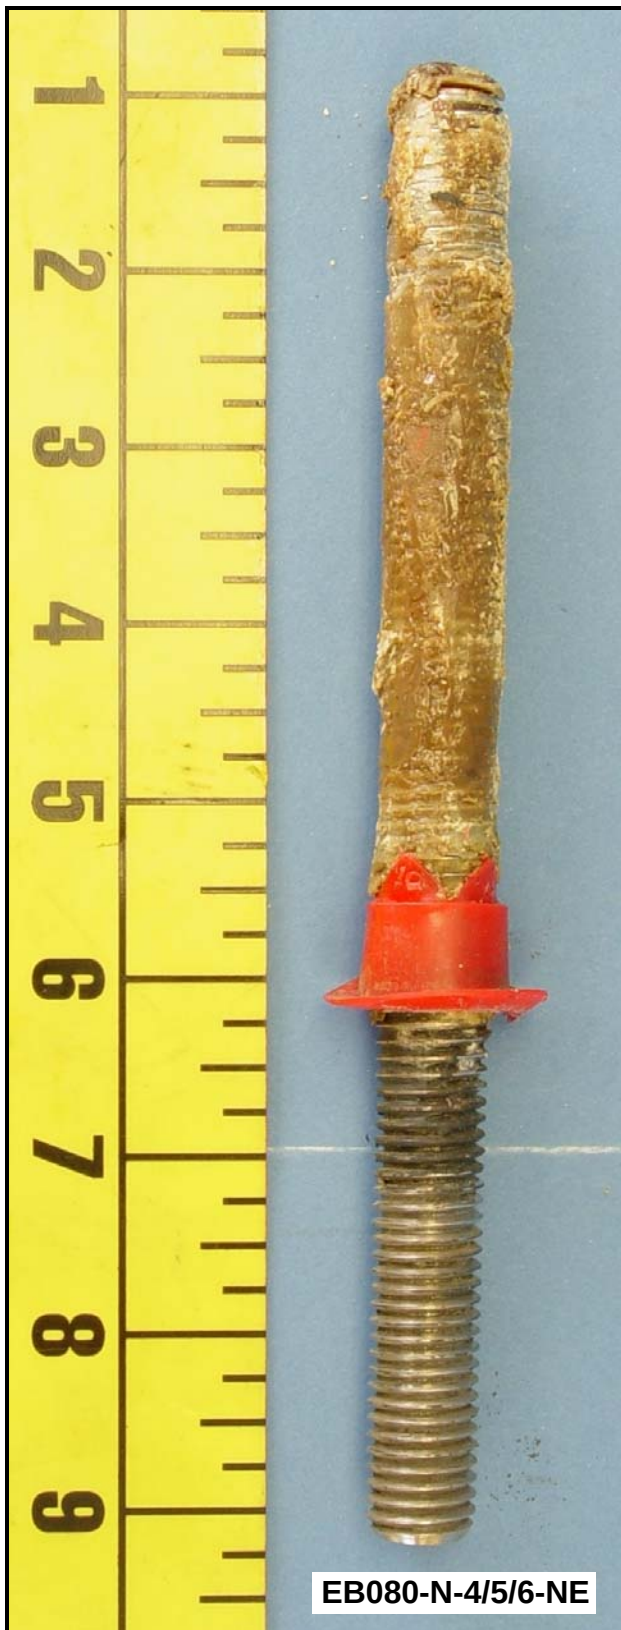
“EB080-N-4/5/6-NE” Cap in place. Most of the surface of the epoxy on this anchor has a unique smooth appearance with a diameter less than the hole and therefore was classified as void. Surface had a glassy or “wet” appearance that was very soft when removed from the ceiling and that remained somewhat soft as of the date of this report. Darker brown epoxy material found at the top of the anchor. Anchor originally placed in a plastic bag because of the soft material. No yellowed epoxy. See photographs in figure 11.

Figure 11. The anchor from position  
EB080-N-4/5/6-NE.

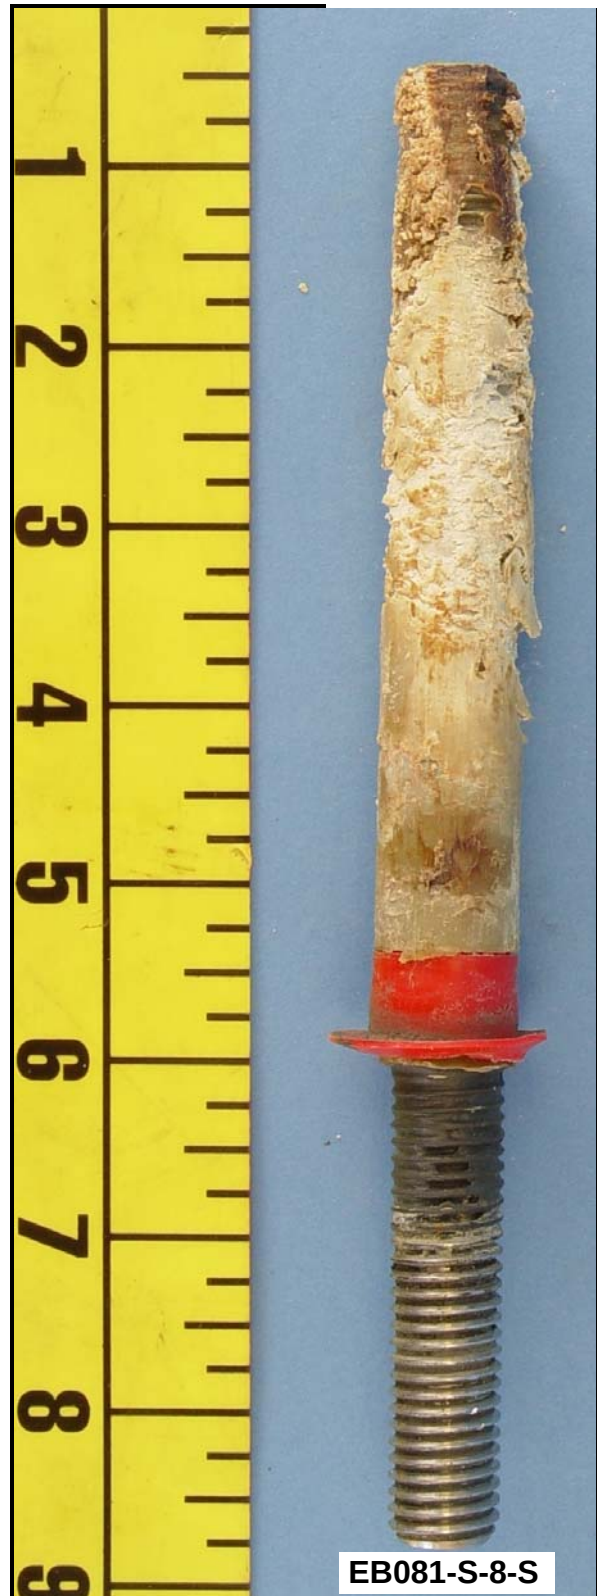
- “EB081-M2-2/3/4-SW” Cap in place. Few voids, some missing epoxy. No yellowed epoxy.
- “EB081-S-8-S” Cap in place. Larger areas of adhesive failure, especially the lower portion of the embedment depth. Dark brown to light brown discoloration of the epoxy noted in various areas, see figure 12. Yellowed epoxy noted up to 0.7 inch, slightly above cap area.

Figure 12. The anchor from positon  
EB081-S-8-S.

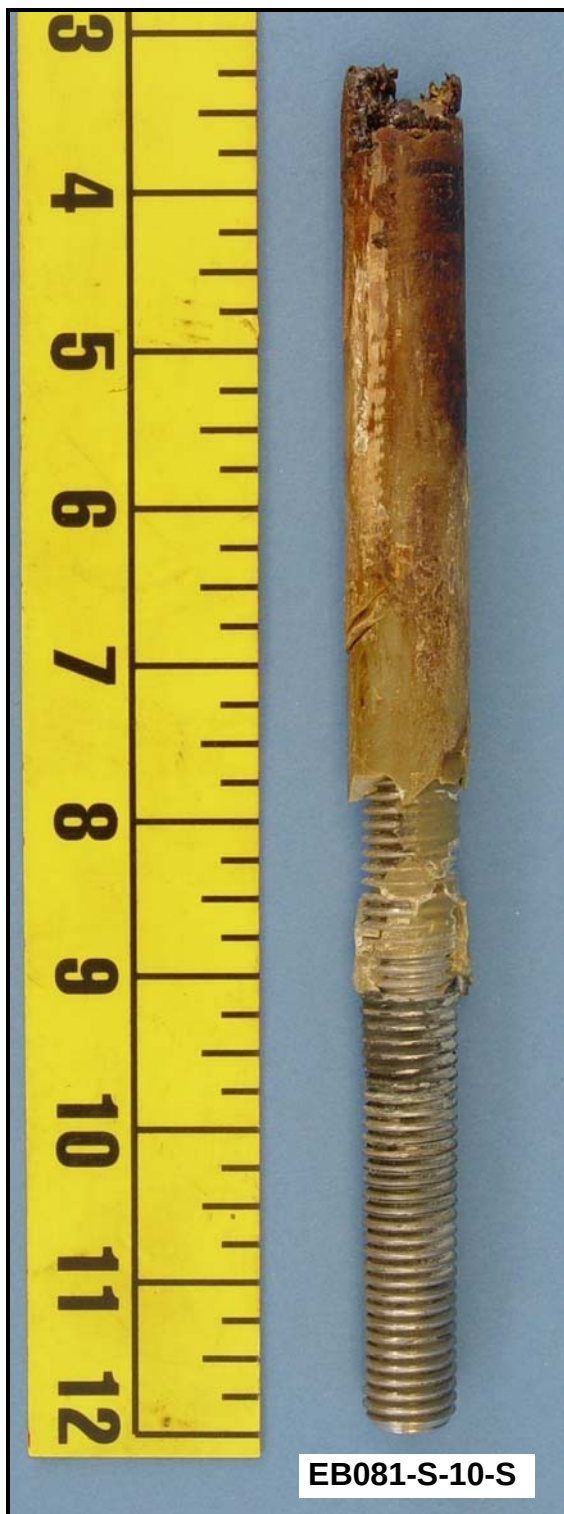
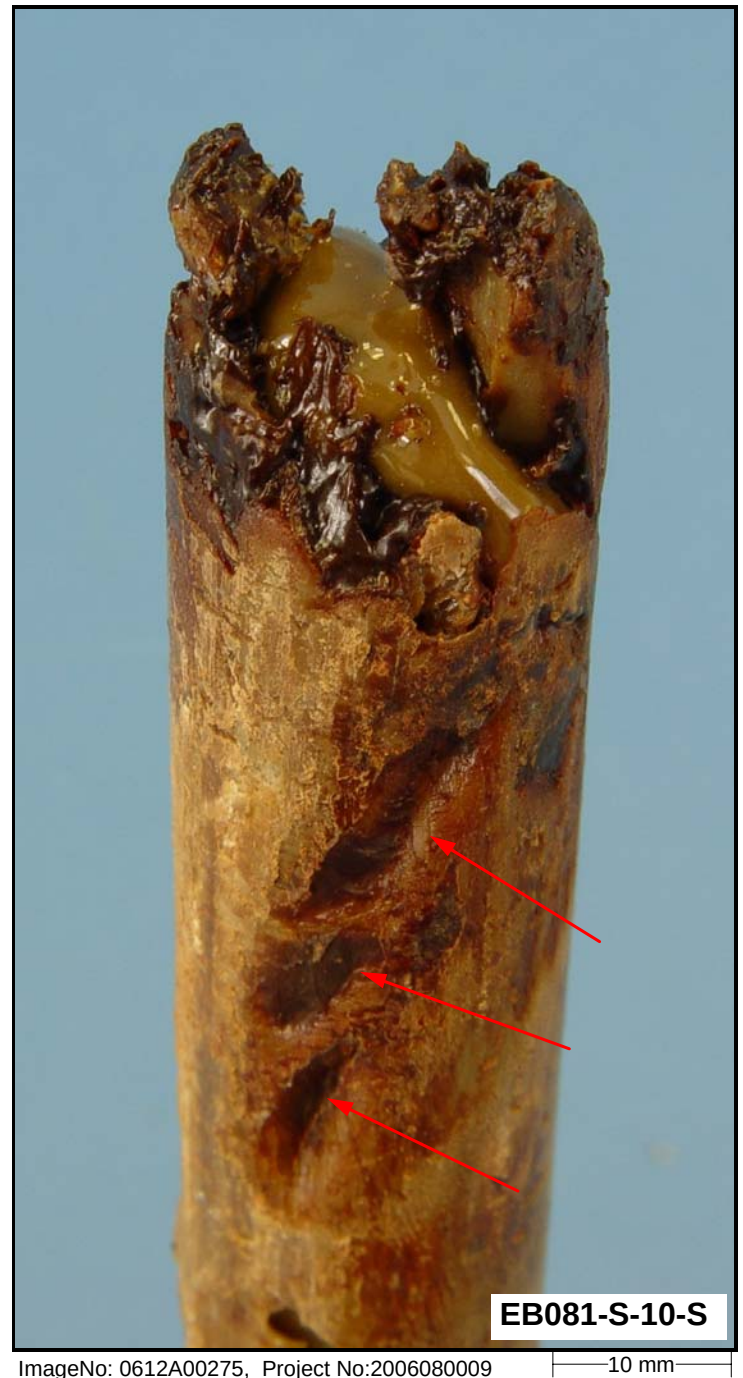
Figure 13. Overall view of the anchor from position EB081-S-10-S (left photograph) and a closer view of the soft epoxy at the top of this anchor (right photograph). The dark streaks along the shank of the anchor visible in the right photograph (indicated by the unlabeled arrows) are areas where the epoxy was apparently originally against the concrete surface of the hole, then moved radially inward at a void region.

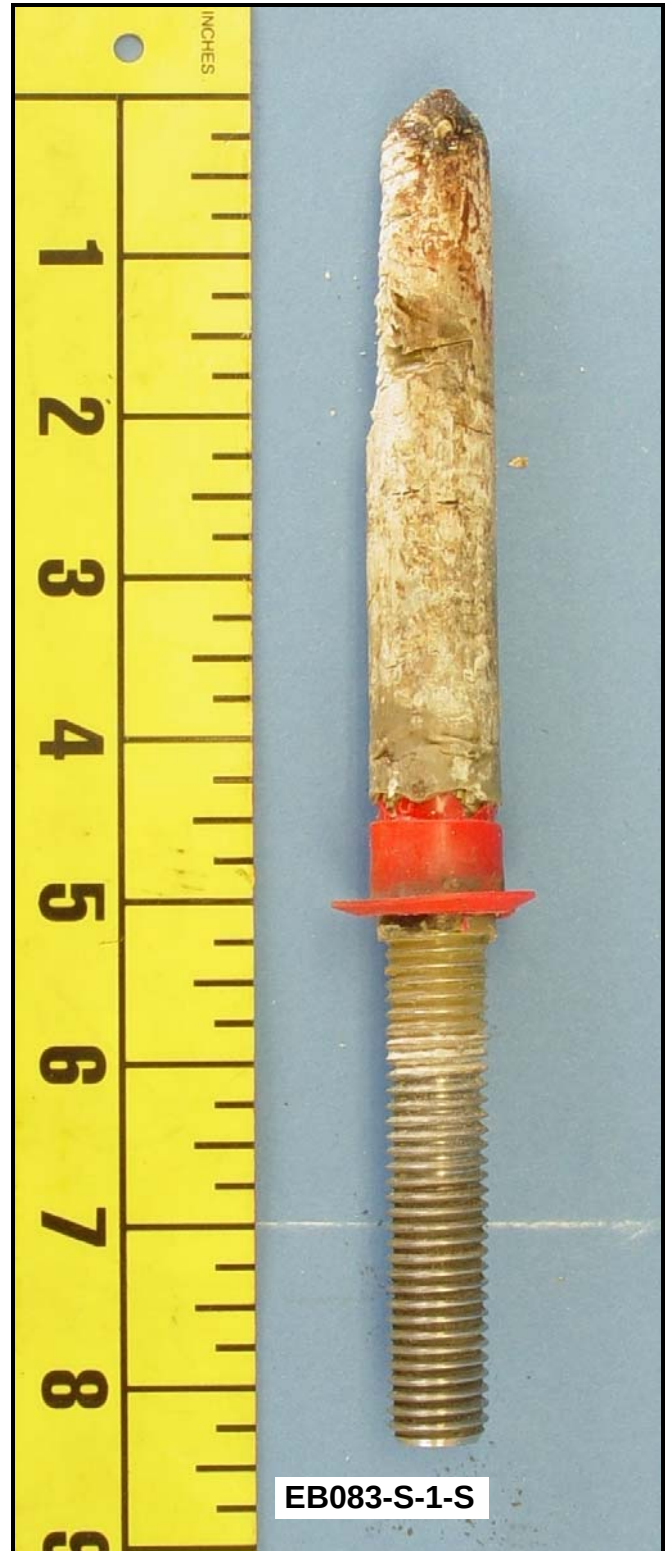
Figure 15. The anchor from position EB083-S-1-S. The dark brown epoxy extends above the top of the anchor and is also present in streaks along the anchor's length.

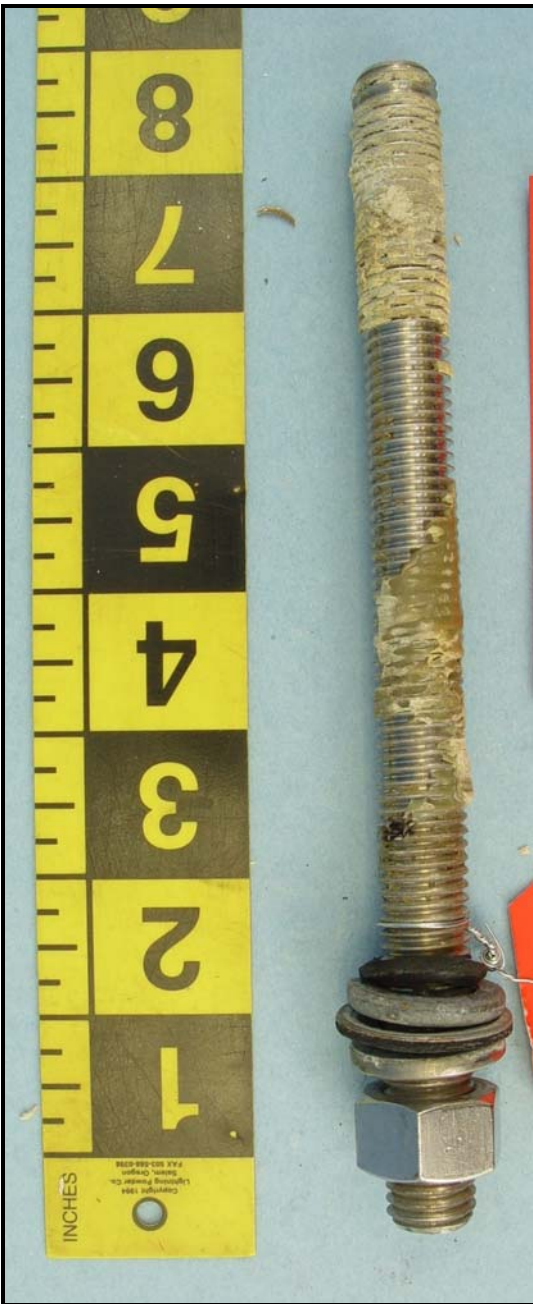
Four views of anchor E1-1 after removal of the red polyethylene cap.

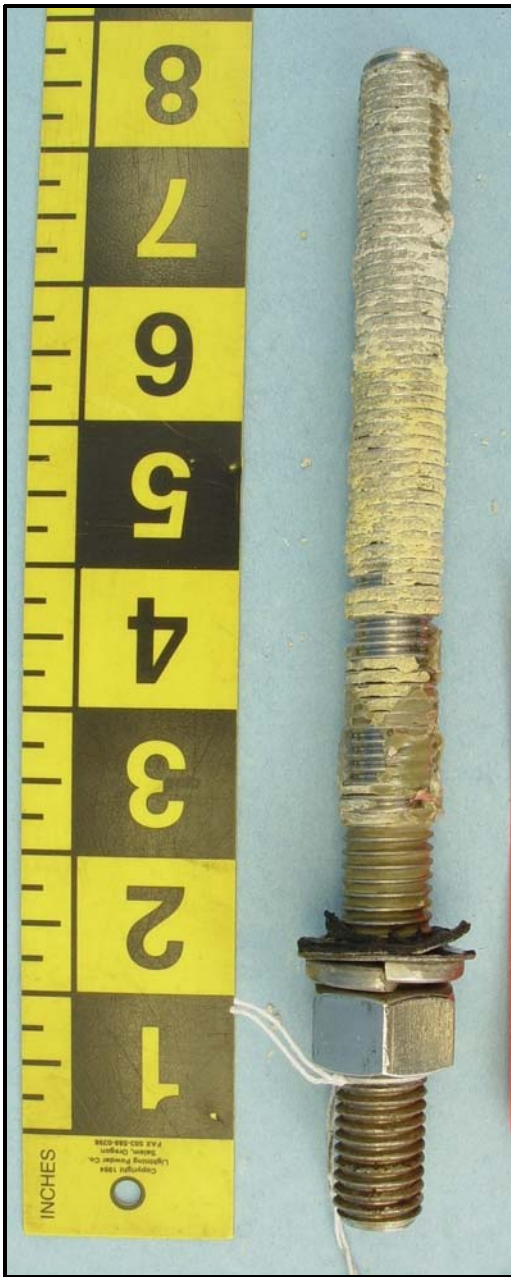
Four views of anchor 1-2.

Anchor 1-2. The red polyethylene cap for this anchor was not received with the anchor. The anchor was not visibly bent, and it did not exhibit any significant mechanical damage. Epoxy was present over most of the embedment length. Void areas were noted above the cap area and along one side of the anchor along the top half of the embedment length. In other areas the epoxy was fractured. Yellowed epoxy extended up to about 3.8 inches above the position corresponding to the bottom of the red polyethylene cap, with white fractured epoxy above this position. The anchor was received with (starting from the lowest item) a nut, lock washer, and sealing washer. The rubber portion of the sealing washer had been compressed into and remained trapped on the anchor threads. The lock washer was partially compressed between the sealing washer and nut, and the nut could not be turned on the anchor using hand forces. Overflow epoxy extended approximately 3/4 inch below the cap position, and there was no evidence that the nut had been threaded onto the overflow epoxy. A black ink mark was noted on the overflow epoxy.

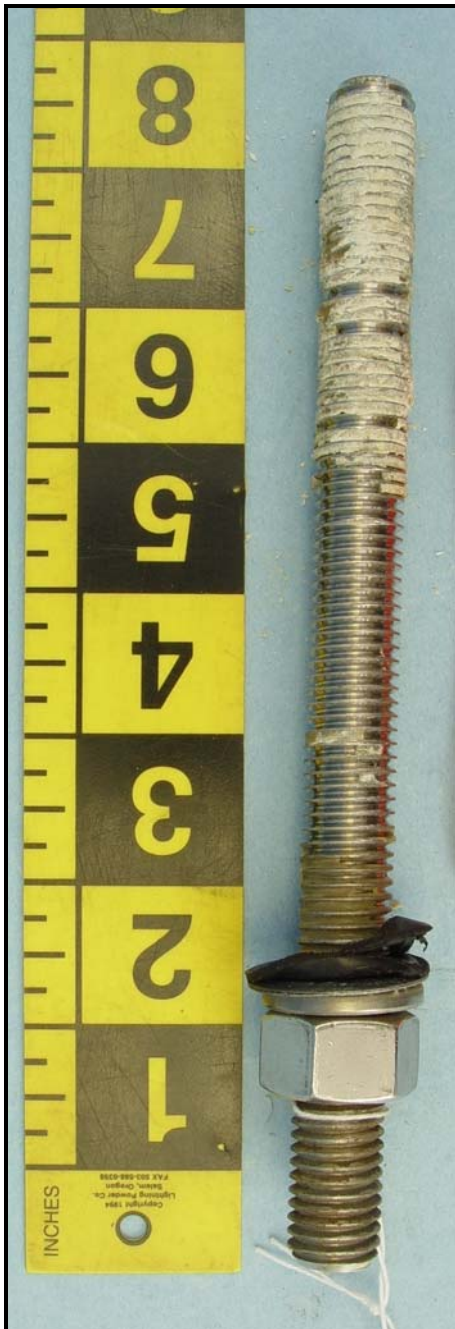
Four views of anchor 2-1.

Anchor 2-1. The red polyethylene cap for this anchor was not received with the anchor. The anchor was bent 2 degrees, with the center of the bend approximately 4 inches above the anchor's lower end. The anchor contained a heavy impact mark on the corner of its upper end on the outside of the bend. Epoxy was almost entirely missing over the lower 2 to 2.5 inches of the embedment length, including the cap area. A few linear void areas were noted on one side of the upper portion of the embedment length. In most other areas, the epoxy was fractured, but one region of what appeared to be adhesive failure was also noted, as shown in figure 4. No evidence of yellowed epoxy was noted on the epoxy remaining on the anchor. The anchor was received with (starting from the lowest item) a nut, lock washer, and sealing washer. The rubber portion of the sealing washer had been compressed into and remained trapped on the anchor threads. The nut could be moved by hand, and it turned smoothly on the anchor threads. Overflow epoxy extended about  $\frac{3}{4}$  inch below the cap position, and there was no evidence that the nut had been threaded onto the overflow epoxy. A black ink mark was found on the overflow epoxy.

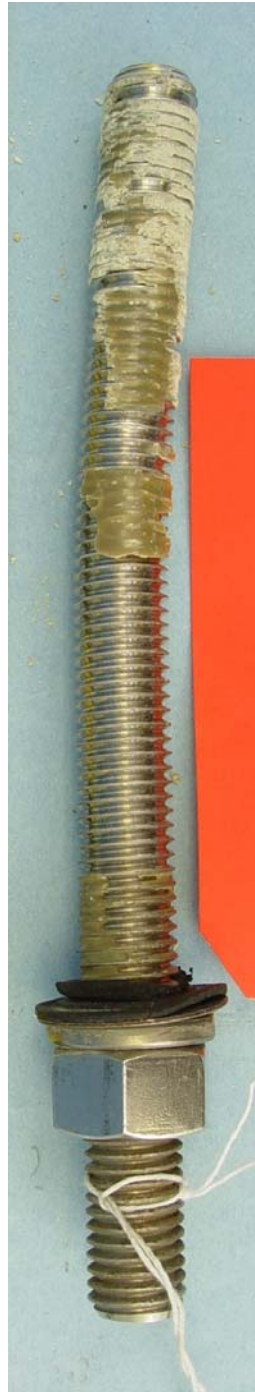
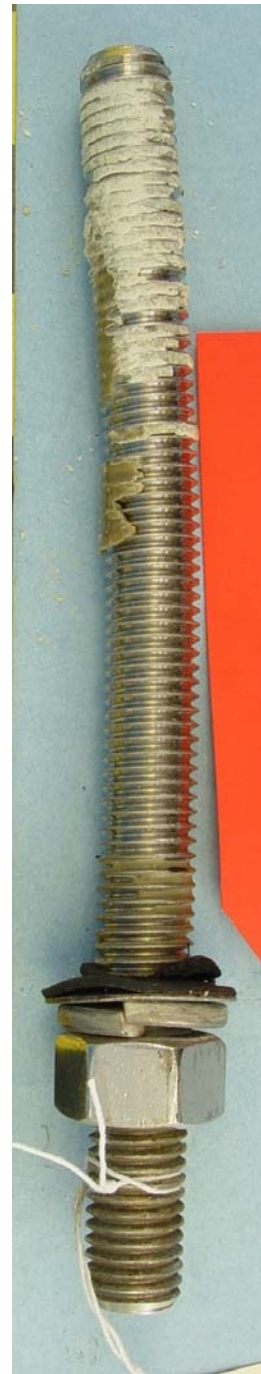
Four views of anchor 2-3.

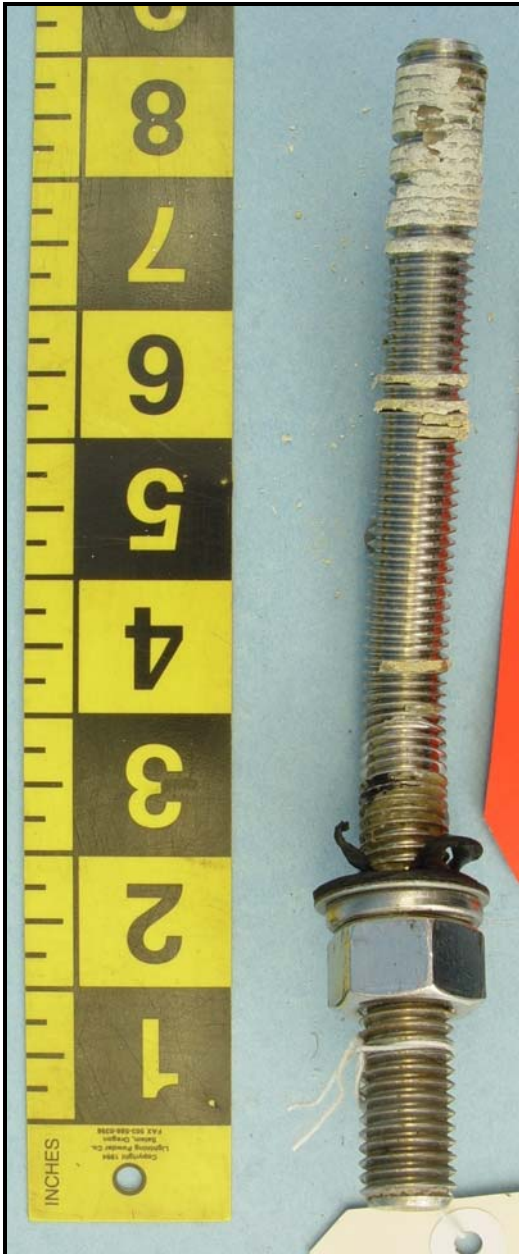
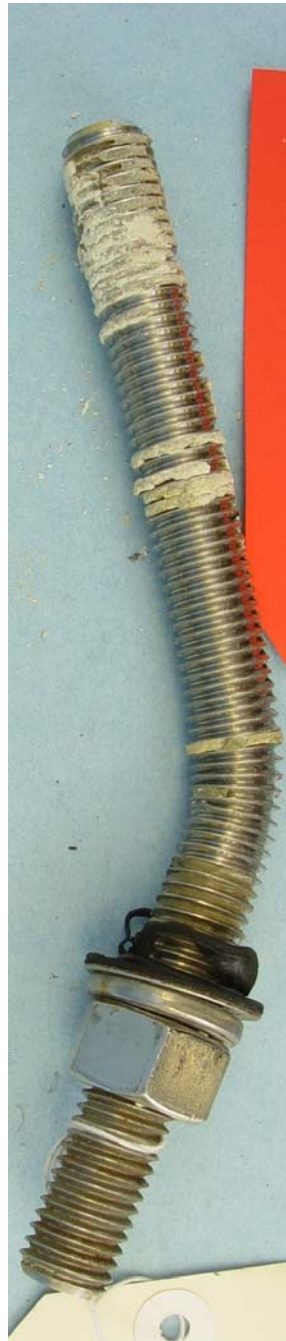
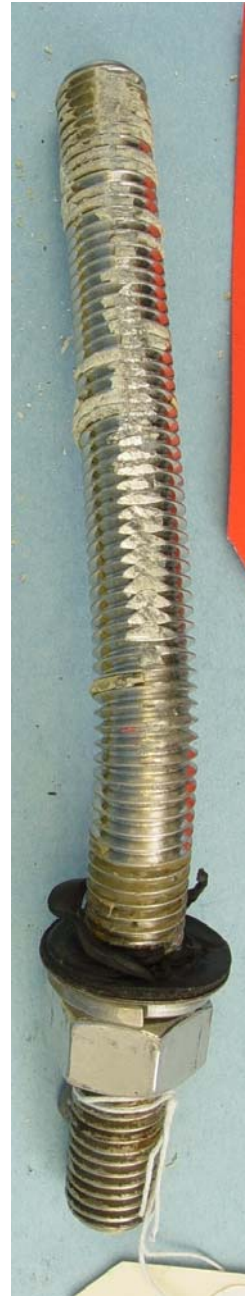
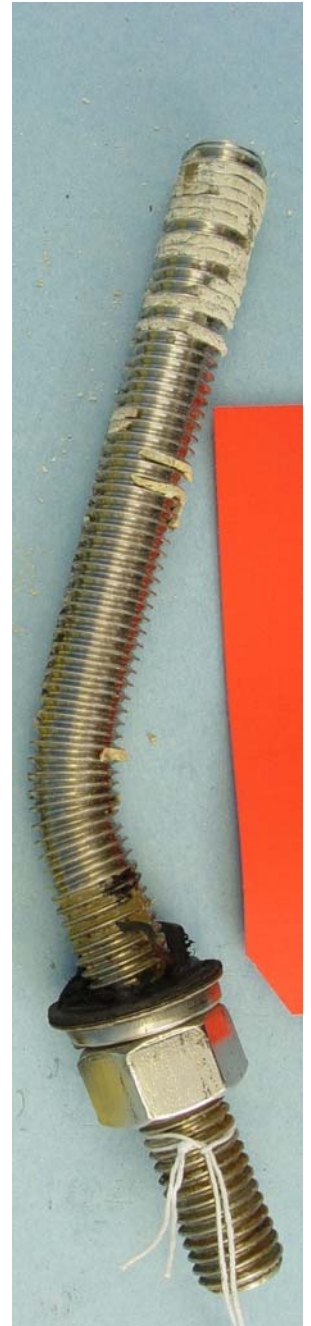
Four views of anchor 2-4.

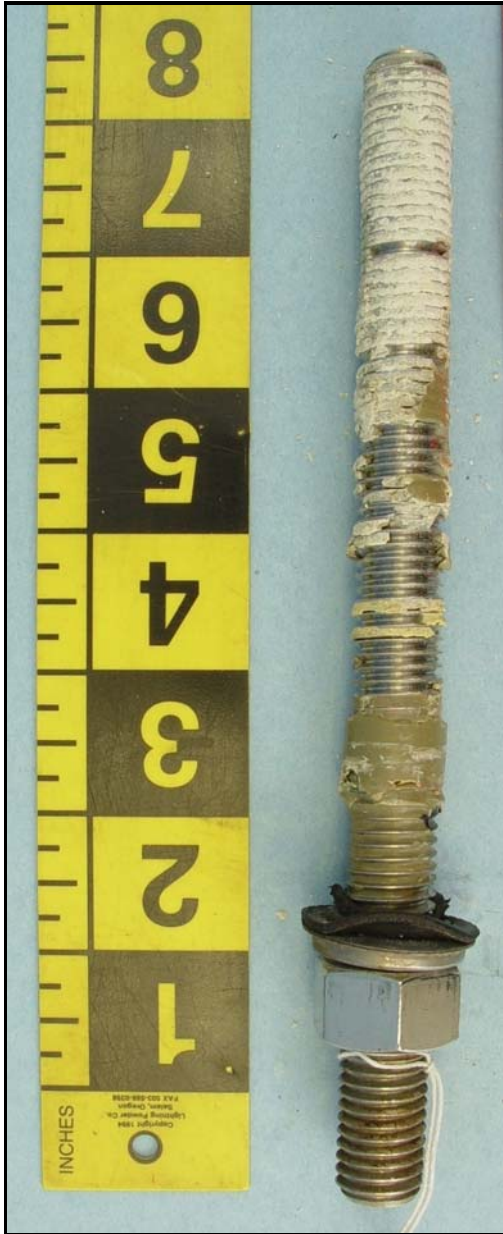
Four views of anchor 3-1.

Anchor 3-1. The red polyethylene cap for this anchor was not received with the anchor. The anchor was not visibly bent, and it did not exhibit any significant mechanical damage. The epoxy was missing from about half the thread area for about 2 inches above the cap position, and from several individual threads above this area. Void areas, predominantly on one side of the anchor, were noted through most of the embedment length, and the remainder of the epoxy was fractured. An area of yellowed epoxy was noted up to about

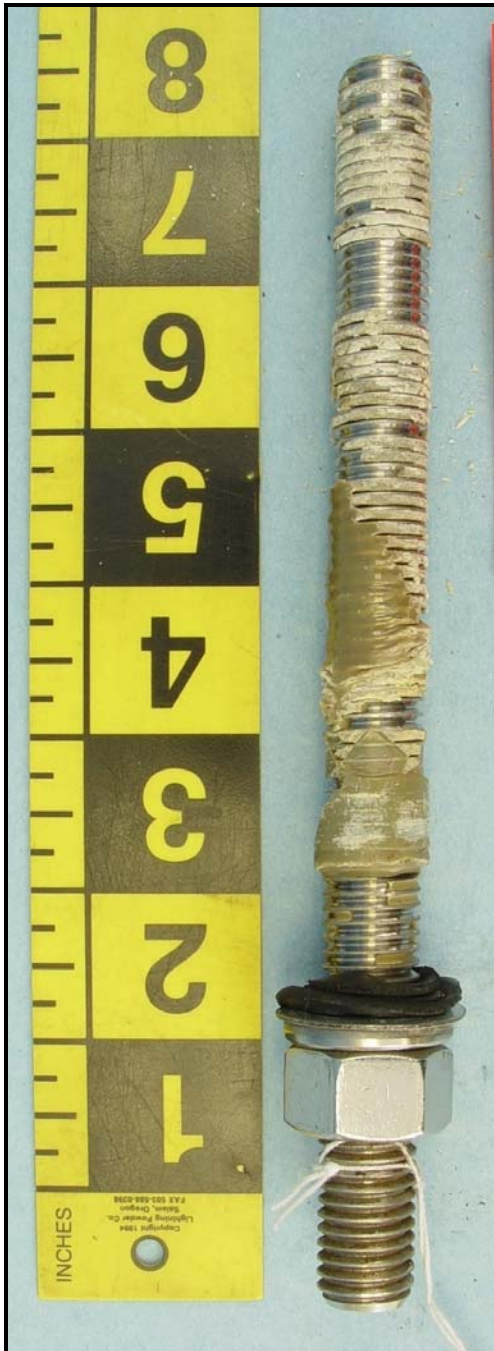
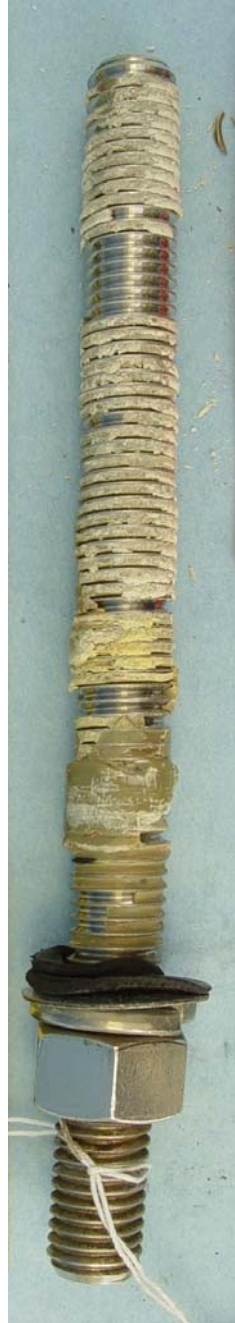
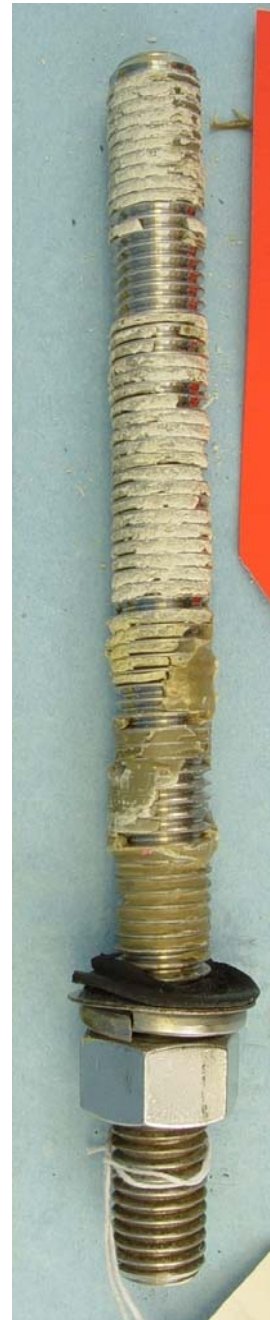
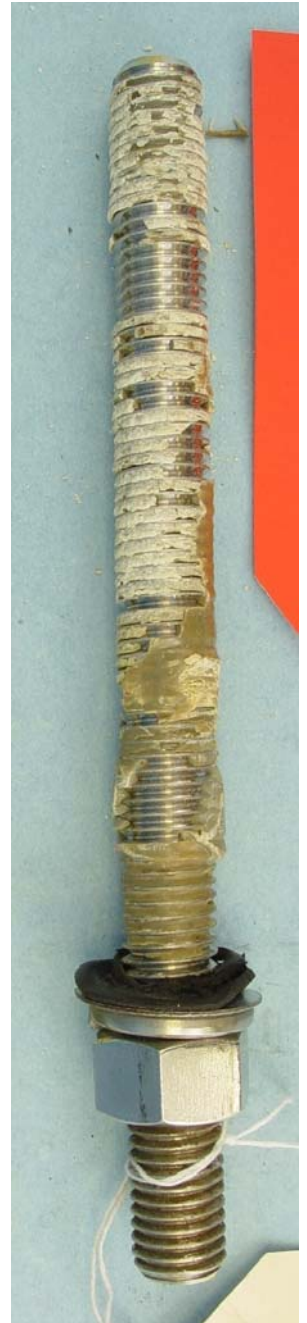
Four views of anchor 3-4.

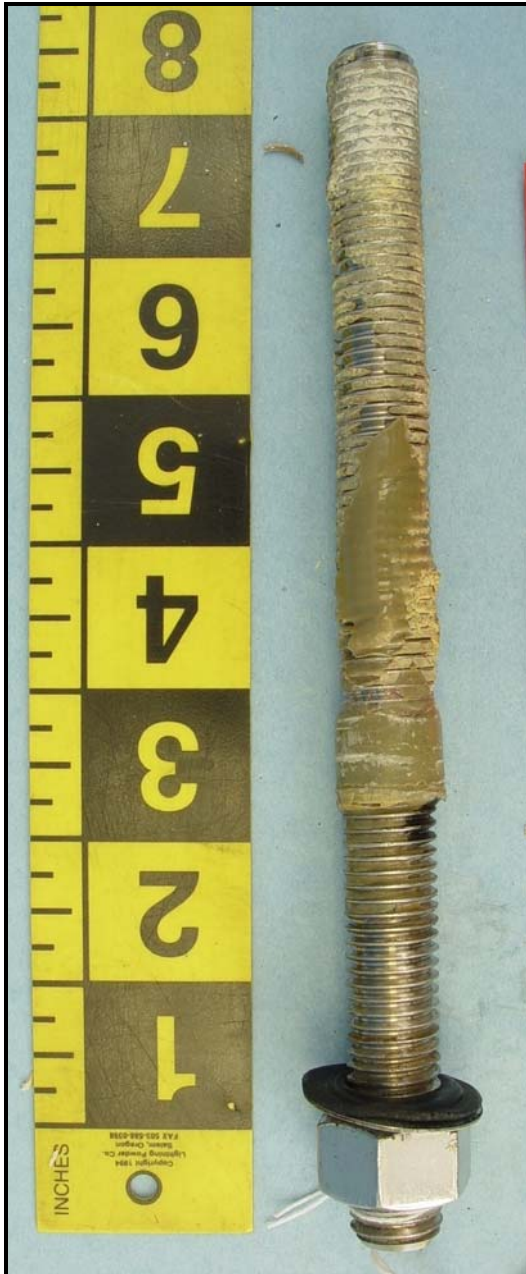
Anchor 5-1. The red polyethylene cap for this anchor was received with the anchor, and the cap was located on the anchor approximately in its installed position. The anchor was not visibly bent, and it did not exhibit any significant mechanical damage. An area of missing epoxy was noted on one side of the anchor from about 1.4 to 2.7 inches from the anchor's upper end. Void areas were found over about three fourths of the anchor within 2 inches above the cap, and a void area extended down through the cap position. The remainder of the anchor, including the upper 2.5 inches of the embedment length, contained fractured epoxy, except for a void area within about 1 inch of the top. The fractured epoxy was yellowed up to about 4 inches above the position corresponding to the

bottom of the red polyethylene cap. The anchor was received with (starting from the lower item) a nut and sealing washer. The rubber portion of the sealing washer had been compressed into and remained trapped on the anchor threads. The nut was loose on the threads. Overflow epoxy extended  $\frac{3}{4}$  inch below the cap position, and there was no evidence that the nut had been threaded onto the overflow epoxy. A black ink mark was found on the overflow epoxy.

Four views of anchor 5-1 shown after removal of the red polyethylene cap.

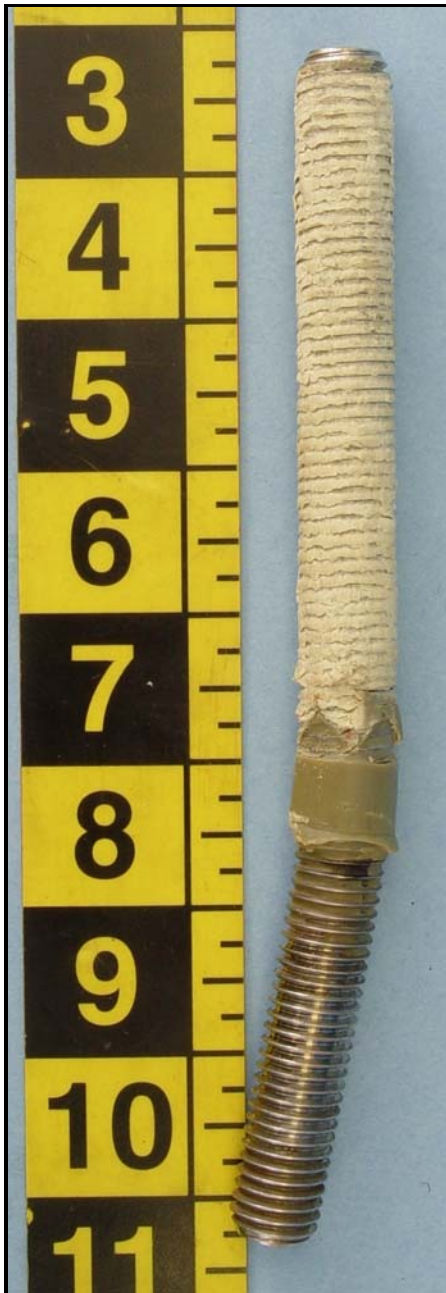
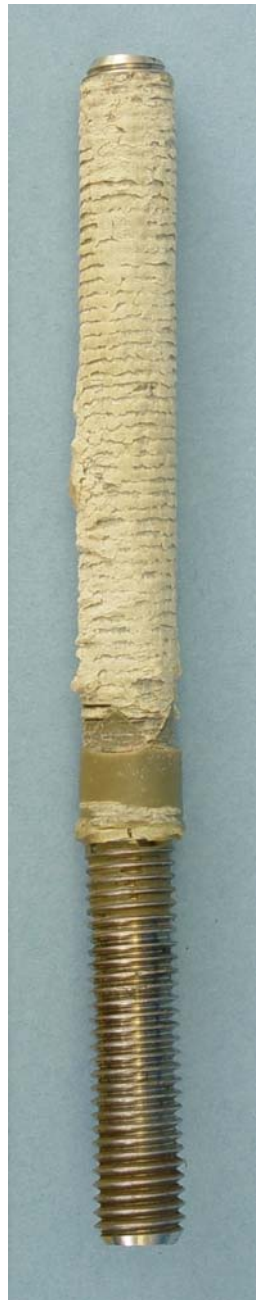
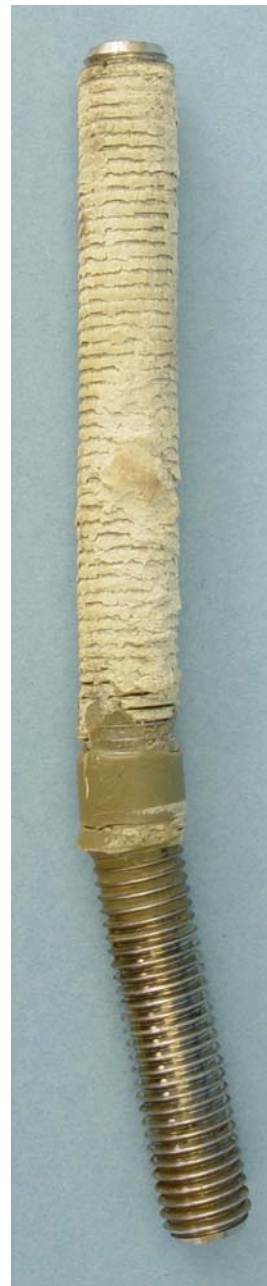
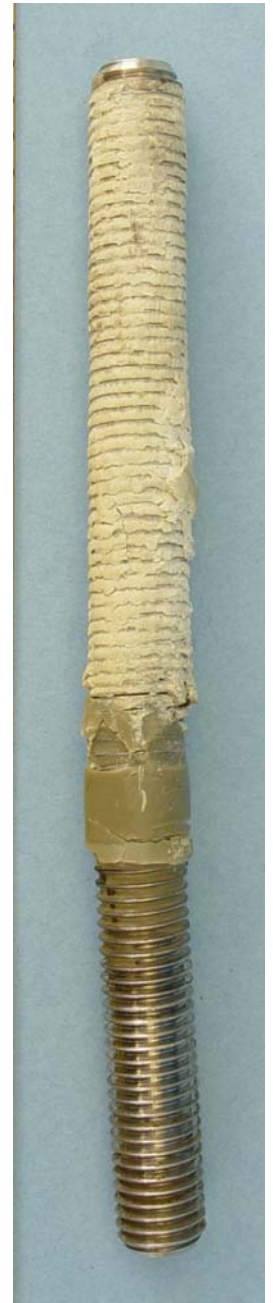
Four views of anchor 6-2 shown after removal of the red polyethylene cap, sealing washer, lock washer, and nut.

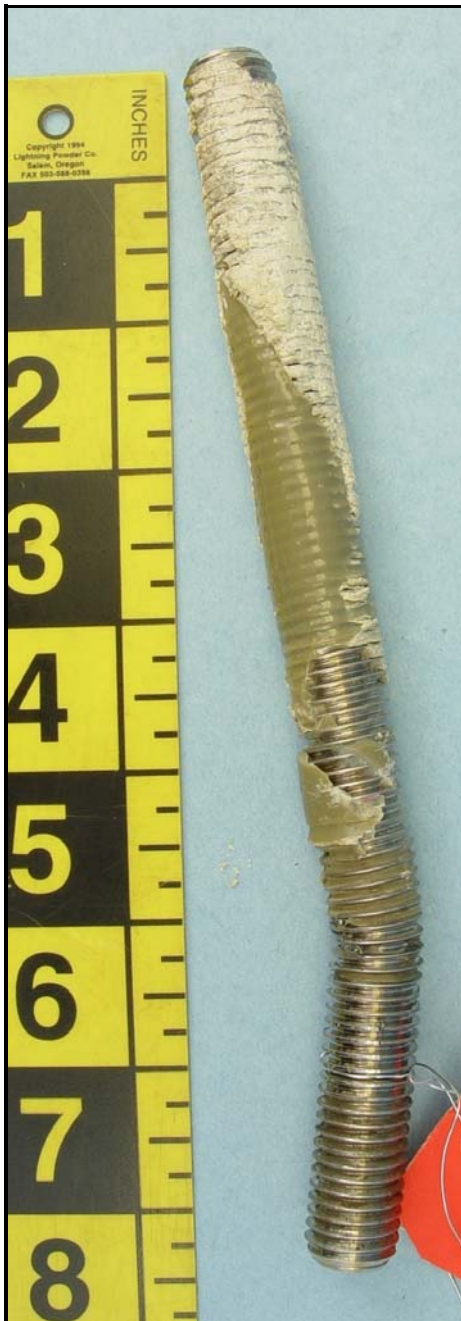
Four views of anchor 6-3 shown after removal of the red polyethylene cap, sealing washer, lock washer, and nut.

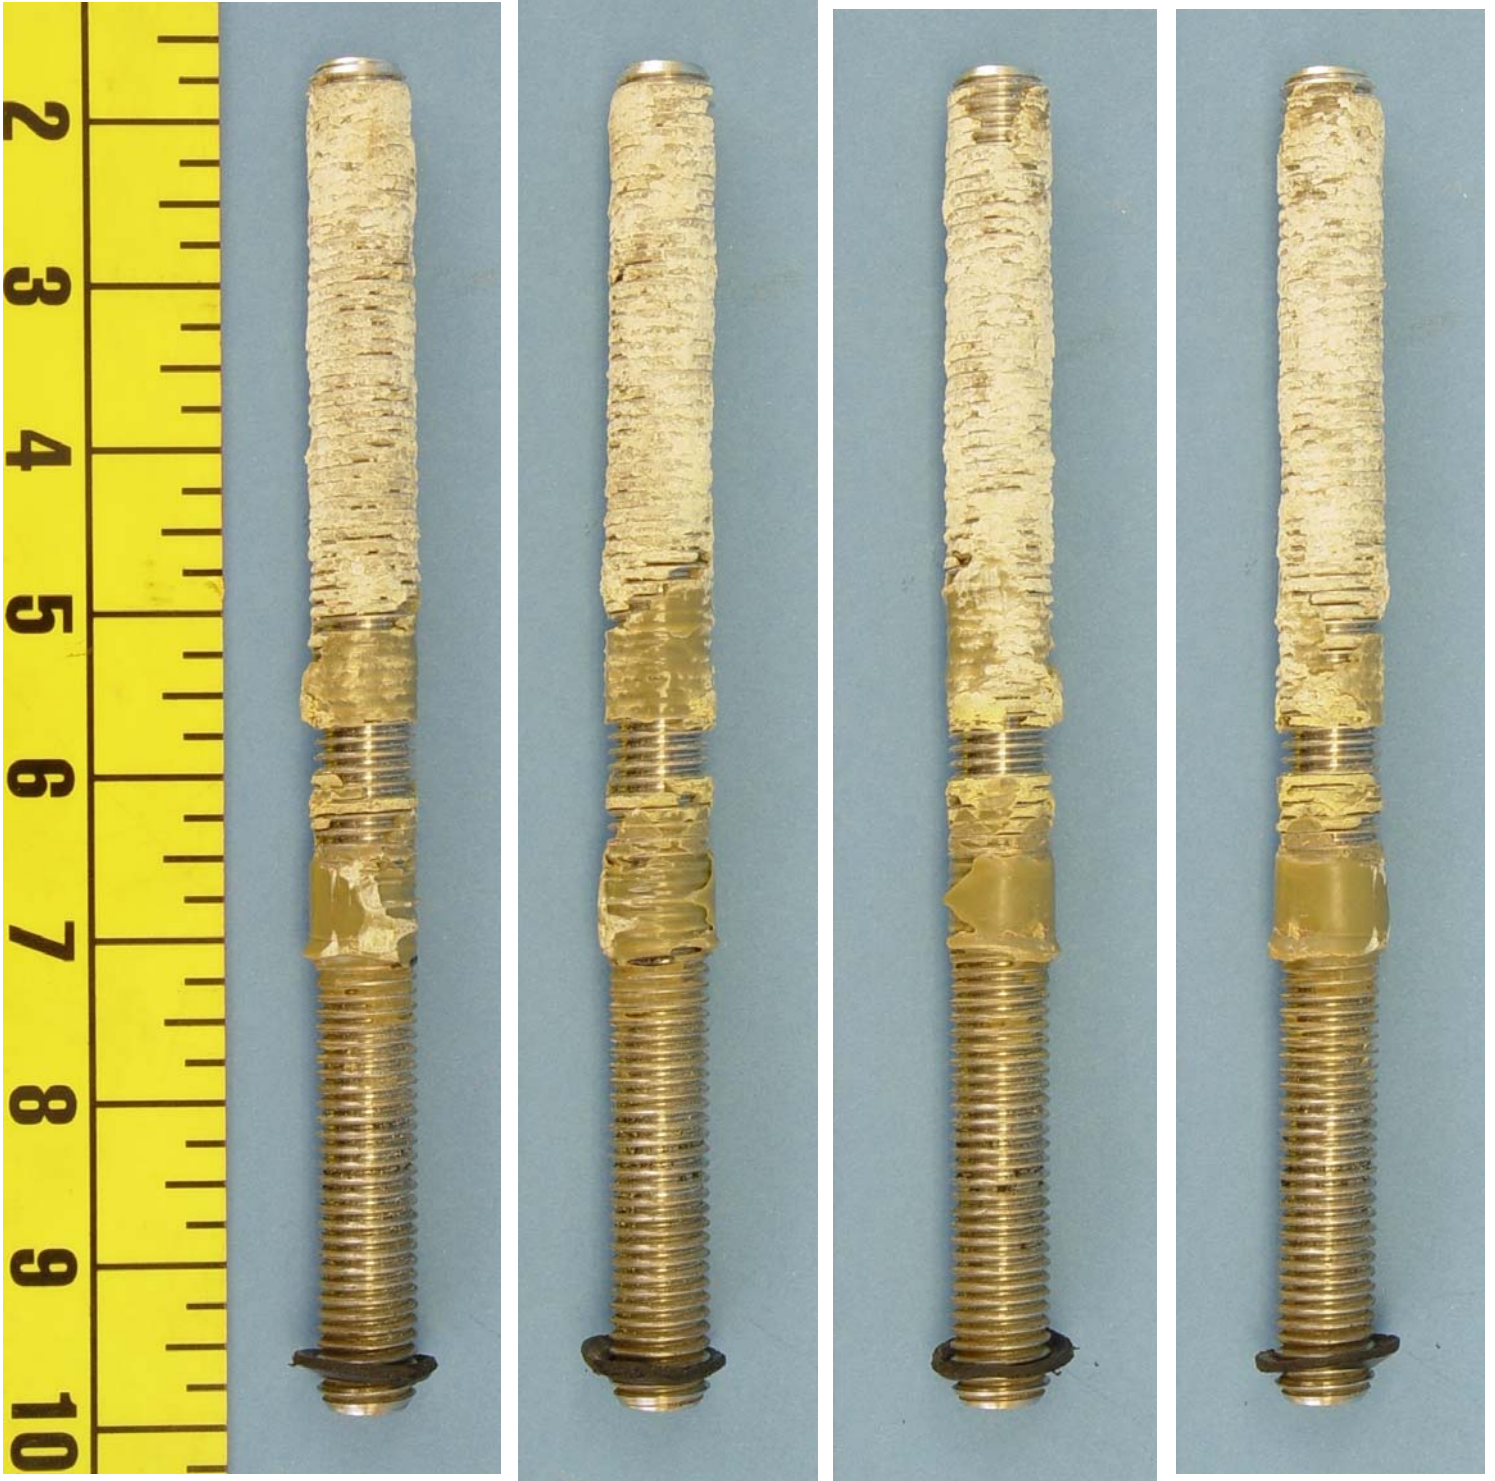
| Anchor Position | Notes | Upper Extent of Yellowed Epoxy (Inch) | Displaced Length (Inch) |
|---|---|---|---|
| 2. EB082-M1-12-S | Adj. to failure area | 1.5 | 2.5 |

Four views of the anchor at position "EB082-M1-12-S".
