**FEDERAL HIGHWAY ADMINISTRATION**

**TURNER-FAIRBANK HIGHWAY RESEARCH CENTER REPORT**

***I-90 Seaport Portal Tunnel Partial Ceiling Collapse Investigation:  
Mechanical Behavior of Powers Fasteners Power-Fast+ Adhesive Anchors***

**APRIL 2007**

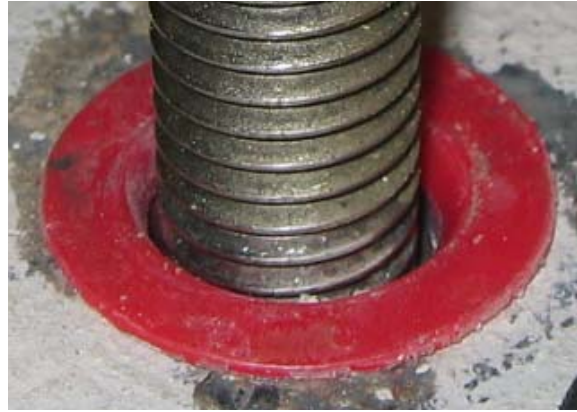
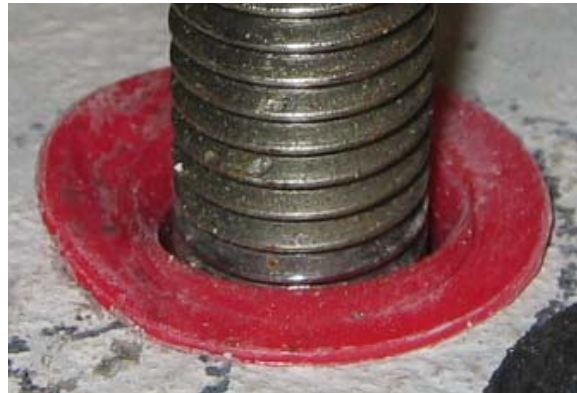
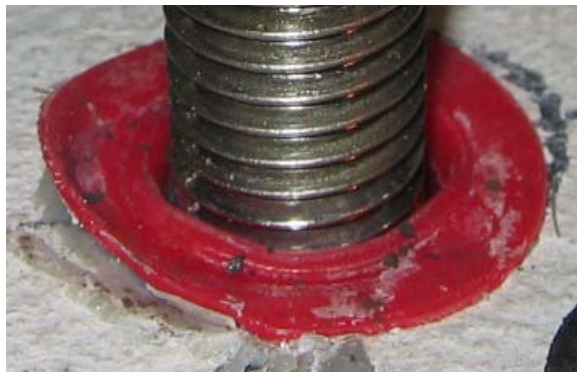
Figure 28. Contrasting difference between red caps after torque. Top: 50 ft-lbs. Middle: 90 ft-lbs. Bottom: 125 ft-lbs.

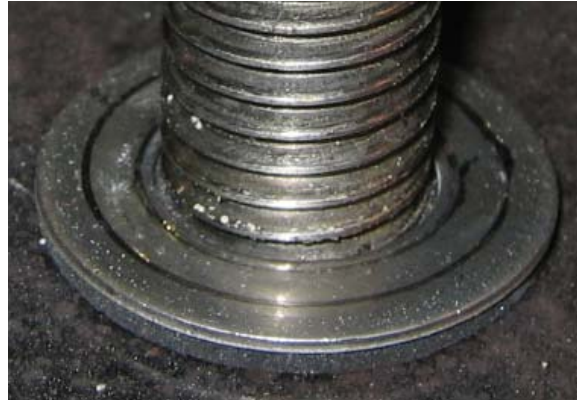
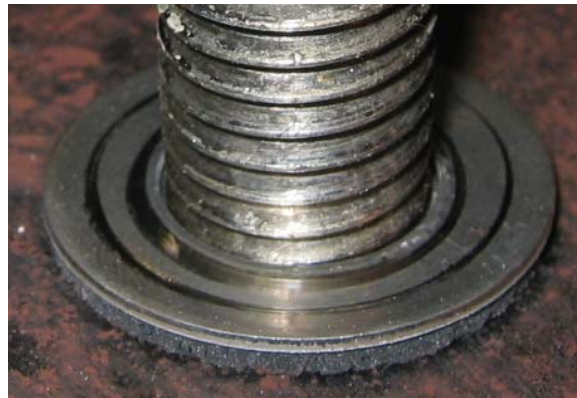
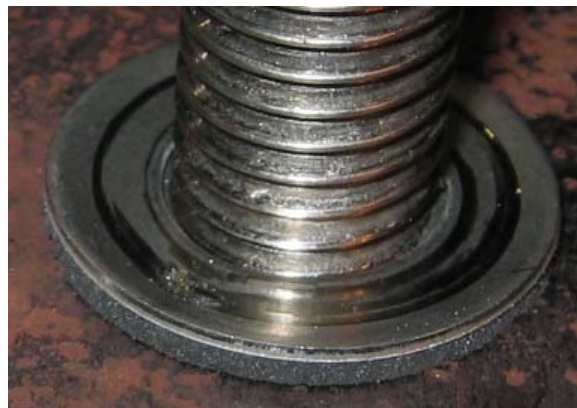
Figure 29. Contrasting difference between sealing washers after torque. Top: 50 ft-lbs. Middle: 90 ft-lbs. Bottom: 125 ft-lbs.

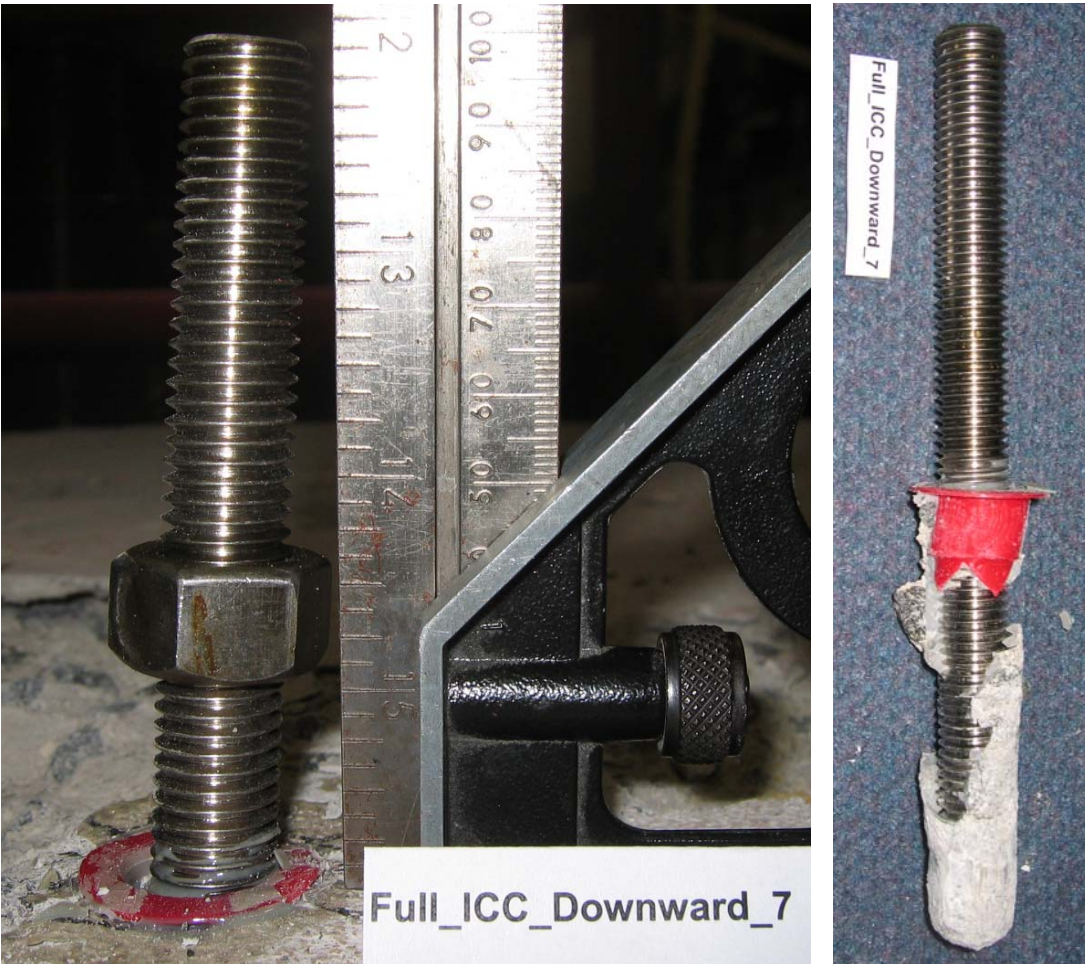
Table 38 Full ICC Downward 7

| <div></div> | | | | |
|---|---|---|---|---|
| <p>Load/displacement data not collect because power outage cause a hydraulic spike that suddenly pulled the anchor to failure without time to start data collection.</p> | | | | |

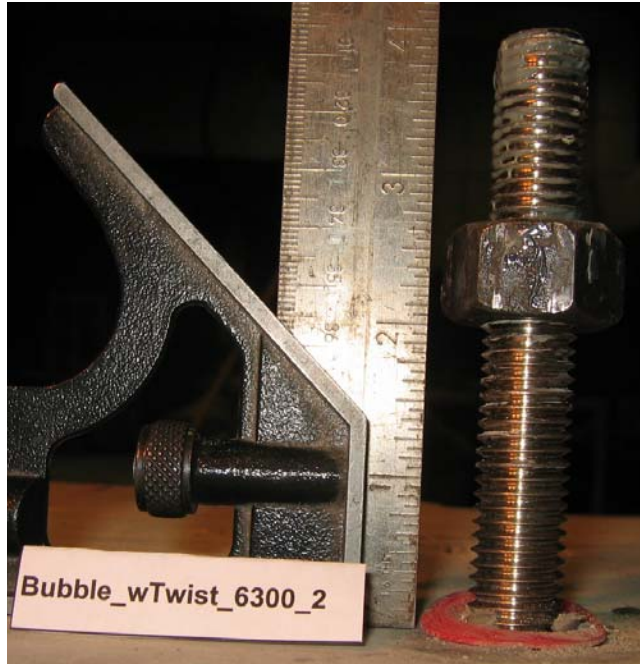
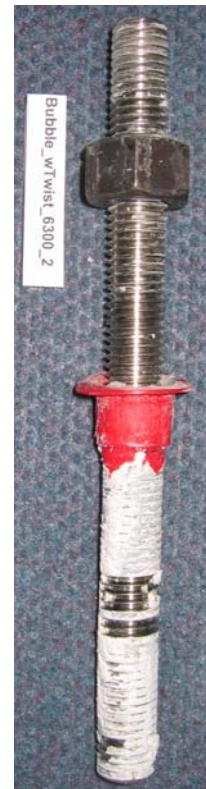
Table 123 Void with Twist and 6300lb Proof 2

This was accidentally overtorqued trying to remove the nut used during the anchor installation and freely spun within its hole. The anchor was thus considered damaged. Since the nut could not be removed, the LVDT bracket also not be used therefore displacements were not collected.
