# DDR Touble Shooting

ID: RK-PC-YF-043

This document provides the DRAM debug method, which is suitable to all Rockchip chips.

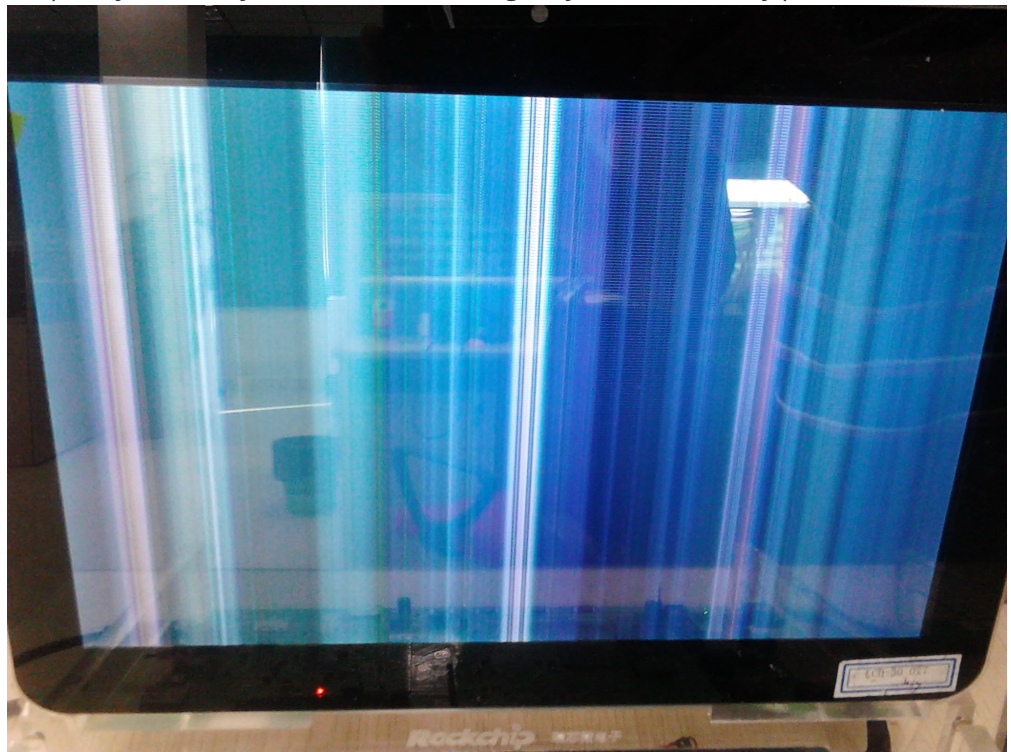
- As the picture as shown below, it may be that the DDR is in an inaccessible state during the DDR frequency scaling process. At this time, you can try fixing the DDR frequency. Or it may be DDR controller logically error caused by power issue.

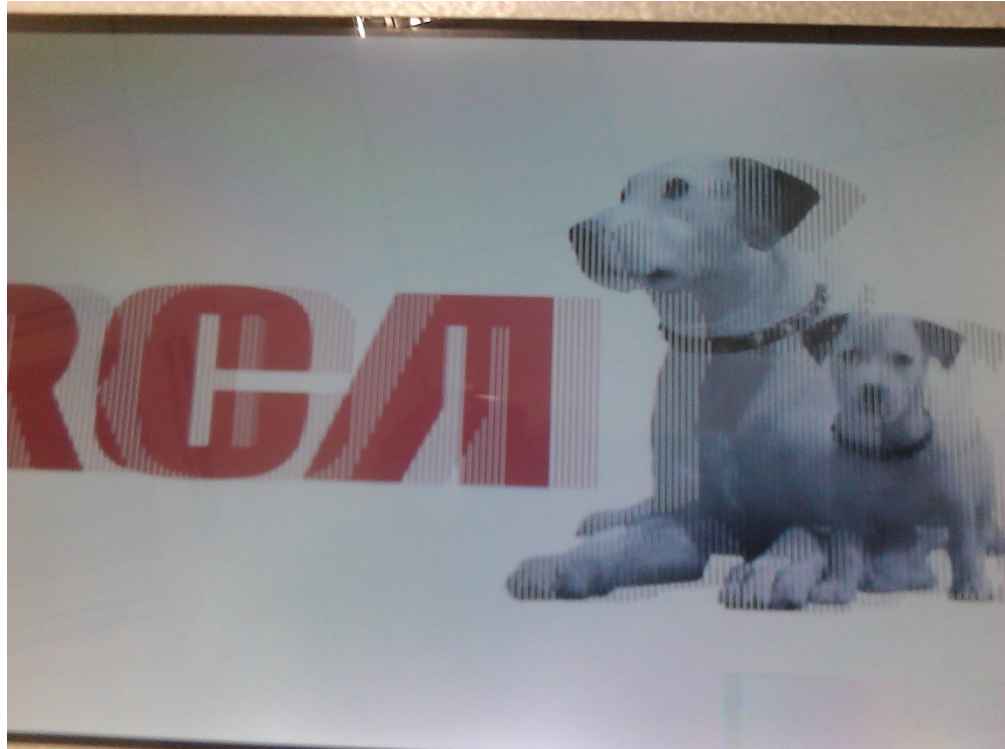
- As shown picture below, we call it "Ghosting", there is a similar situation triggered by the incompleted reference layer of the board. The way to fix it is trying raise the

VCC\_DDR voltage to 1.6V or bypassing the dll of DDR.
