# HW Testing

## Electronics Projects

This document serves the purpose of planning, testing and documenting the developed hardware in the project module 3.

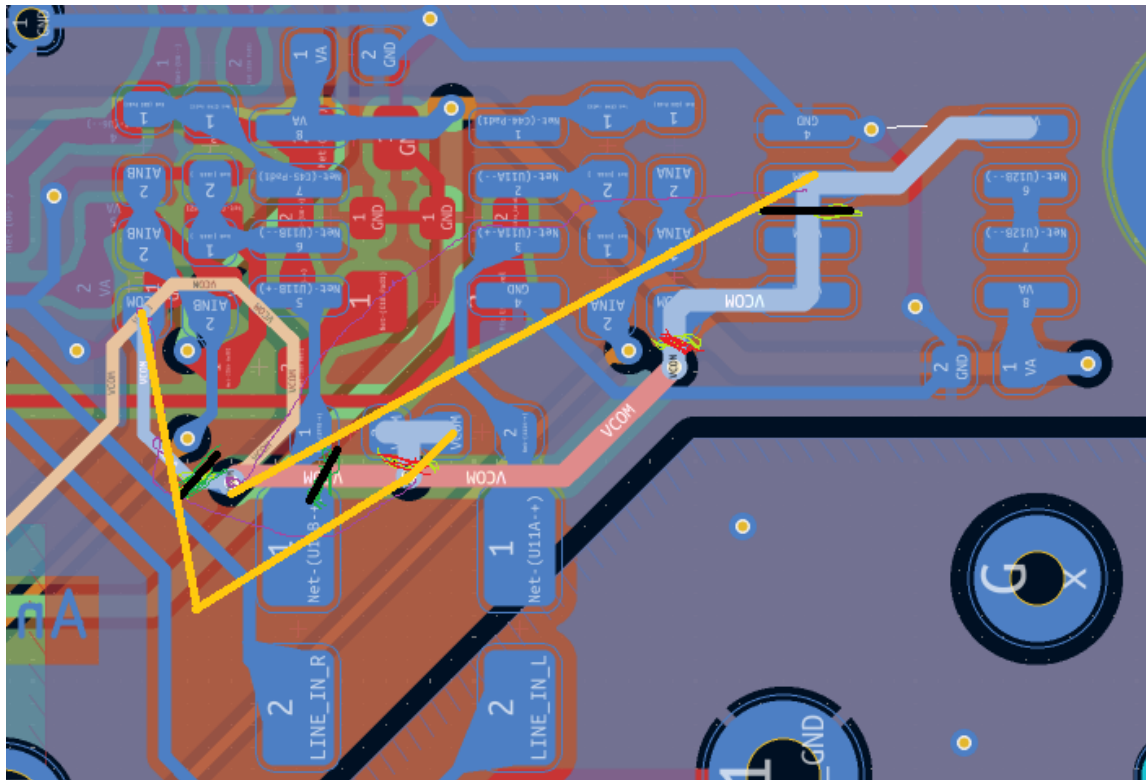
### **Problem 2: Reference-voltage (VCOM) buffer of the input filter**

Similar to Problem 1, the signal flags for the VCOM reference voltage were mixed up. This caused an unintended bridging of the buffer stage and led to a short between the codec and filter VCOM pins.

Modifications for the VCOM (cuts drawn in **black** and connections made in **orange**)

**Solution:** The affected PCB traces were cut in three locations, and two patch wires were added: one from the codec's VCOM output (via) to the input pin of the buffer op-amp, and another from R37 to C37.

After implementing these changes, both the codec VCOM output and the buffer output showed correct levels, restoring proper operation of the input filter.

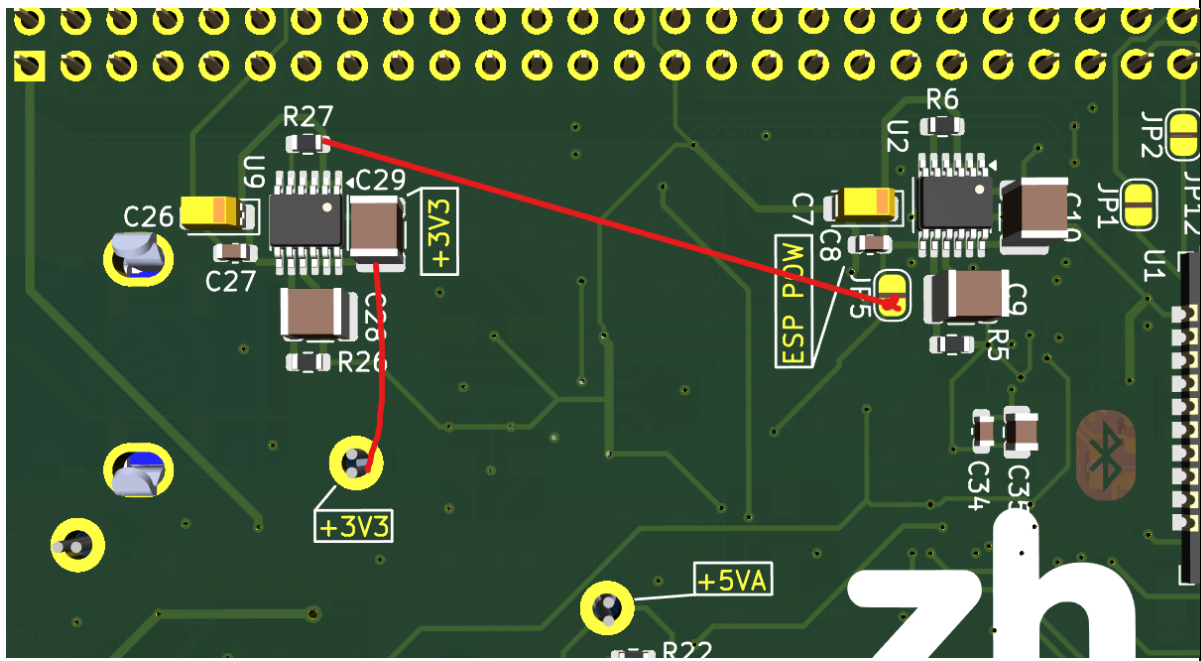
### **Problem 1: Incorrect power-supply flag naming**

During schematic design, some power-supply flags were inconsistently named across different sheets. As a result, the corresponding nets were not connected in the PCB layout.

Modifications for the missing power flags (connections made in **red**)

**Solution:** Two patch wires were added: one from the 3.3 V line to C29 and another from JP5 to R27.

After applying these modifications, the power-supply functioned correctly throughout the entire device.
