オリジナルMADC(TopLevel\_20200317.bit)によるテスト @2020年3月24日

TopLevel\_20200319.bit によるテスト @2020年3月20日

# TopLevel\_20200321.bit によるテスト @2020年3月21日

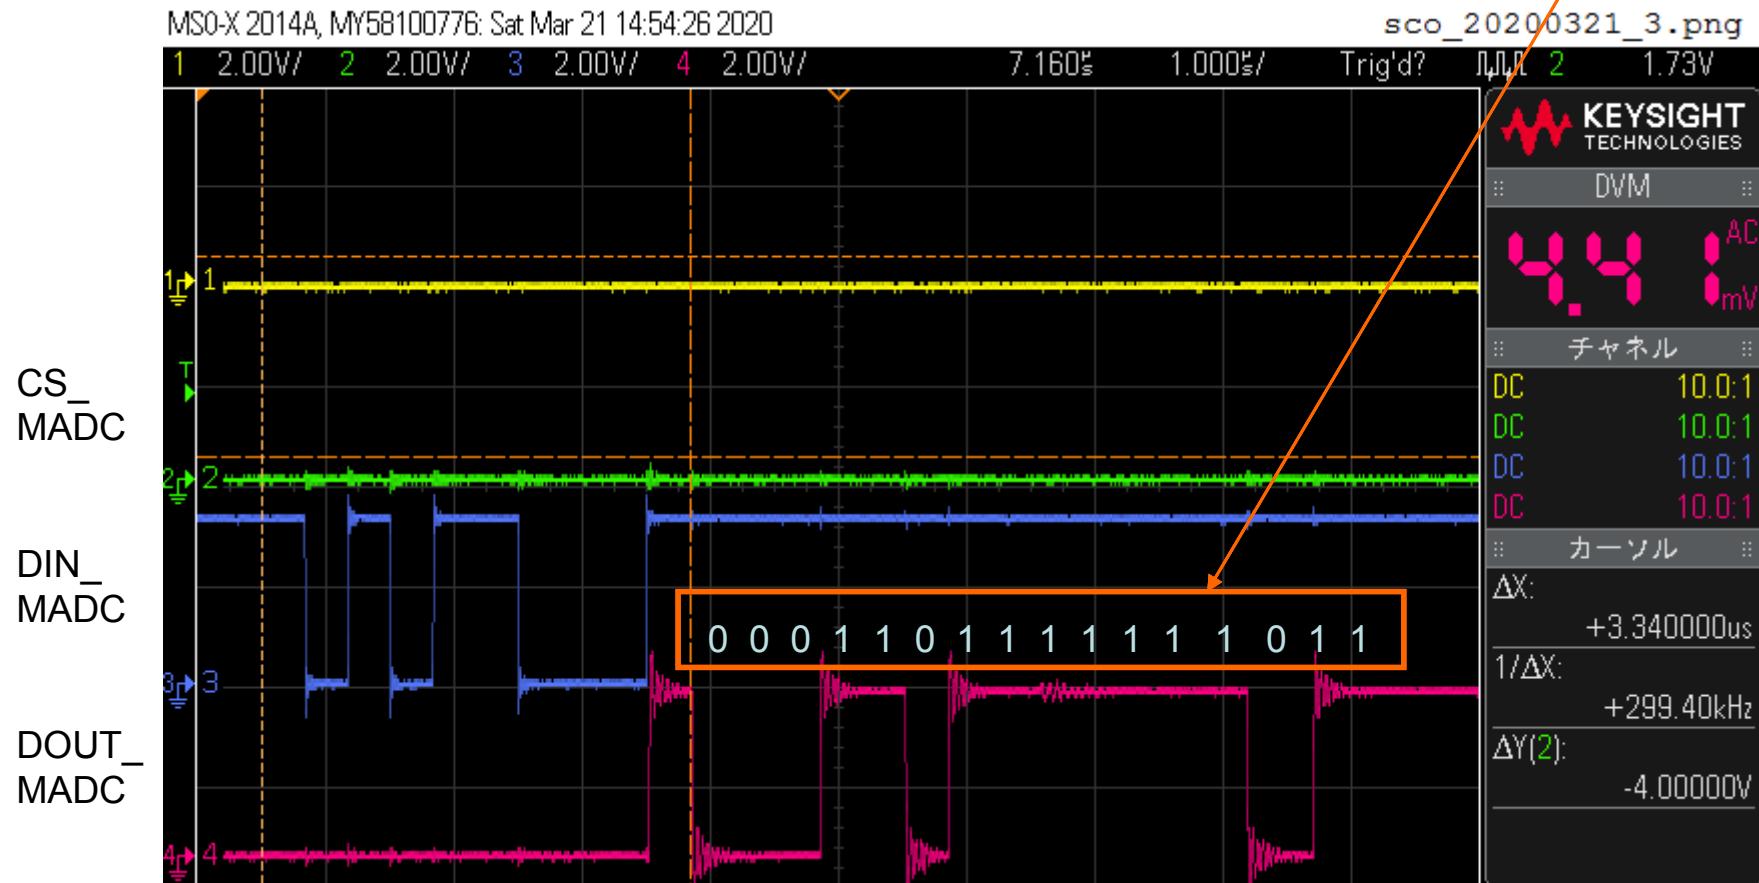
read operation in the statusHV command, extHV=15.0V

readDAC=7163.0 Bias Voltage >> 14.93V

(7163=0x1BFB)

一致
