# Cooperbruca site visit 20th June 2024

This document established record for FSVP compliance requirements of our site visit to Cooperbruca facility

- Supplier name visited: Cooperbruca
- Date: 20th June 2024

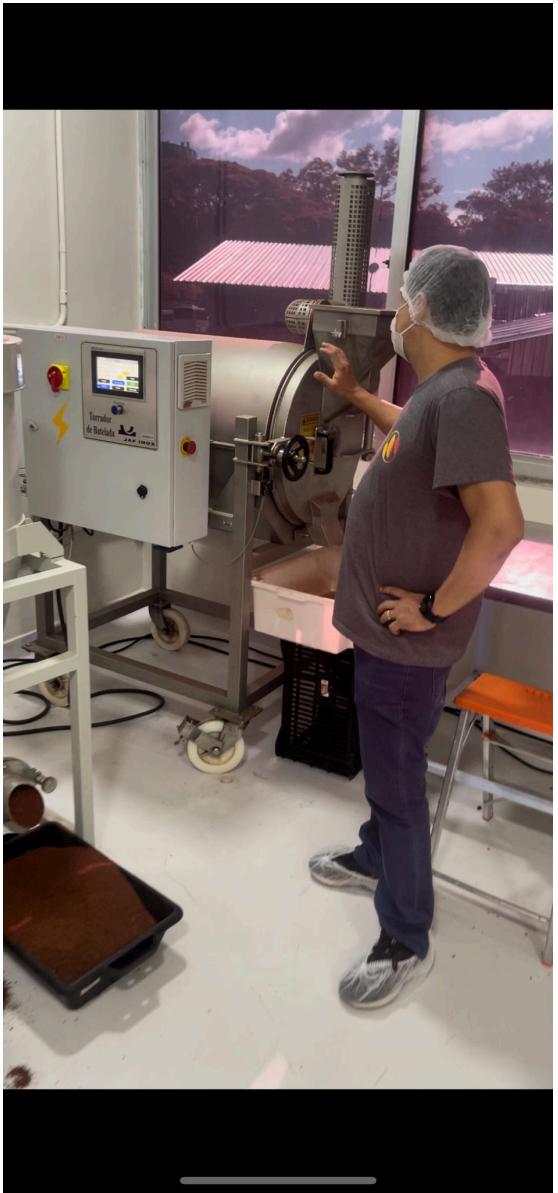
The roasting process itself will kill off the microbial growth.

The internal temperature of the cacao nibs during roasting reaches 180°C for 30 minutes.

Equipment observed to be in working order.

It's been confirmed that equipment is able to heat up to indicated temperature level and time

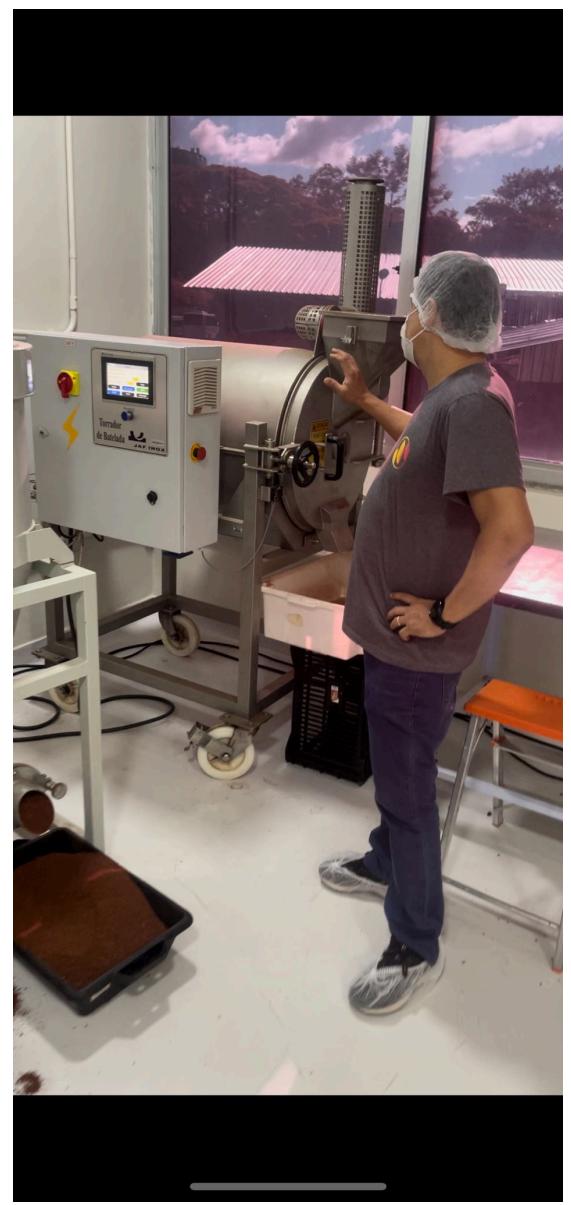
<p>Entire machine is maintained every year</p> <p>Each part of the machine is maintained every 3 months</p> <p>Daily cleaning to ensure properly functioning equipment</p> <p>Required maintenance is performed when malfunction is observed before cacao nibs are processed</p>	<p>Equipment is observed to be in good working order</p>
--	--	--

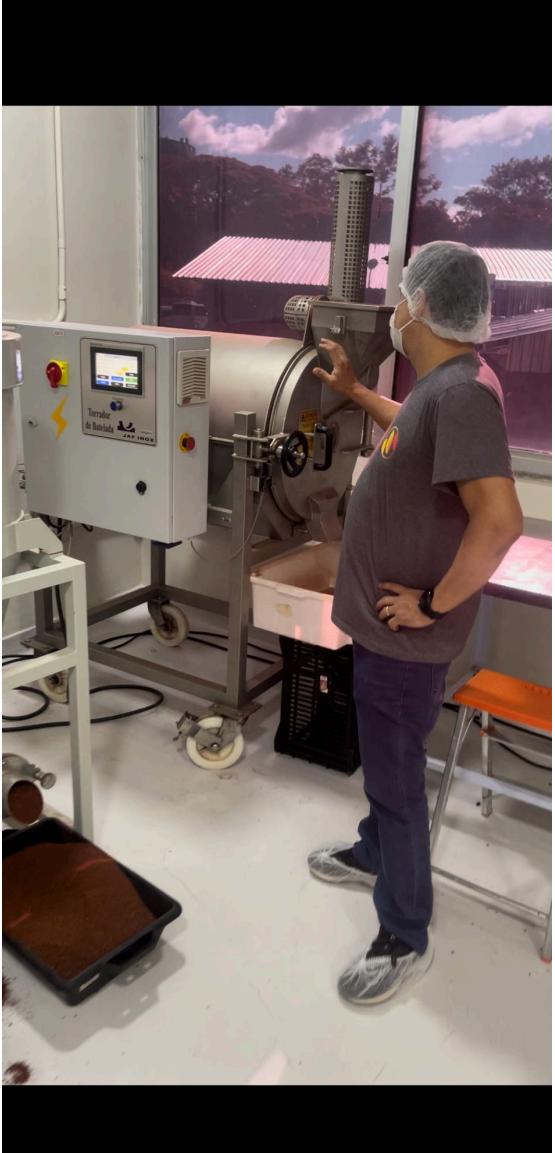
<p>The stove is sealed during roasting Regular maintenance is done on the stove.</p>	<p>Equipment is observed to be in good working order Equipment is observed to be sealed during operations</p>
--	--	---

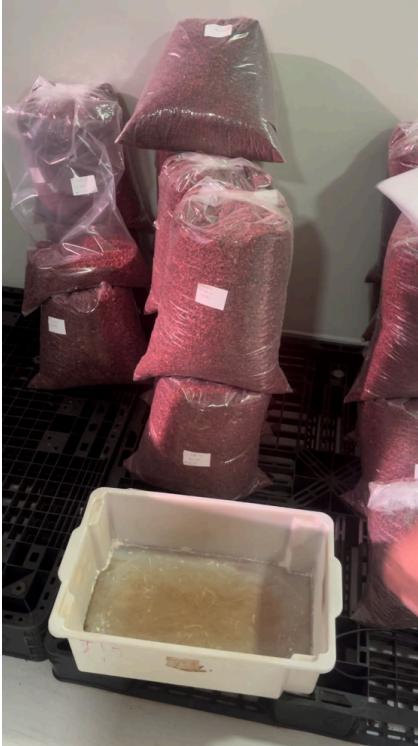
<p>Implement proper drying and storage practices to prevent mold growth. Regularly test for mycotoxins and reject contaminated batches.</p>	<p>Storage area is observed to be dry and above ground level with plenty of air below storage area to prevent growth of mold</p>

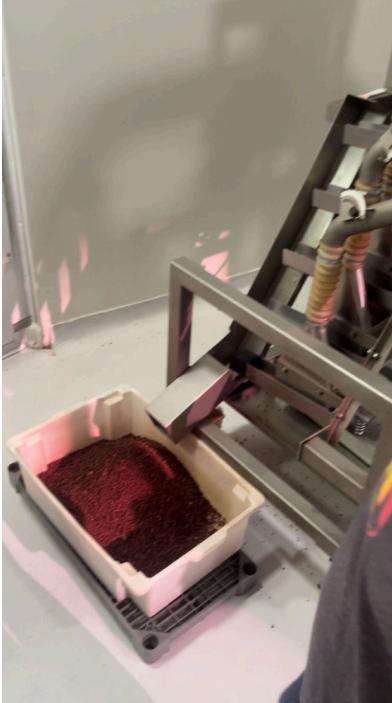
<p>Implement effective quality control measures to detect and remove foreign objects during processing. Regularly inspect equipment for signs of wear or damage.</p>	<p>Container that allows for each monitoring and observation of foreign particles during process of winnowing and cracking of cacao almonds into nibs</p> <p>Machine is observed to be in well maintained condition</p>

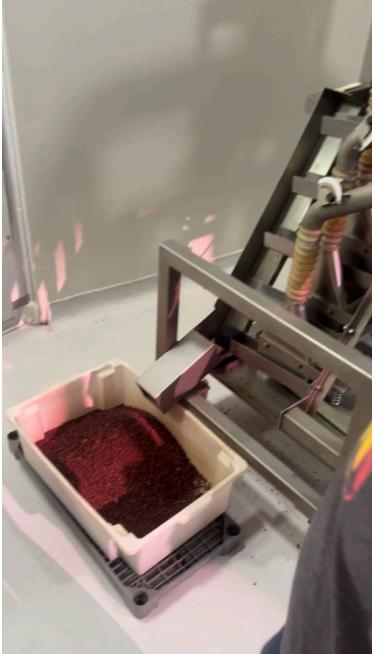
<p>Implement controls to prevent foreign objects from entering packaging materials. Use metal detectors or sieves to catch any contaminants before sealing.</p>	<p>Container that allows for each monitoring and observation of foreign particles during process of winnowing and cracking of cacao almonds into nibs</p> <p>Sieve is built into machine</p>
	<p>Implement a rigorous cleaning and sanitation program to ensure that heavy metals are not introduced during the packing and process of cacao nibs in the facilities.</p>	<p>No dirt or dust particles at observed at venue where cacao almonds are processed into nibs and then packed</p>
