CEPOTX site visit 8th Sept 2025

This document established record for FSVP compliance requirements of our site visit to CEPOTX facility

- Supplier name visited: Black King
- Site name: Jesus Da Deus
- Date: 8th Sep 2025

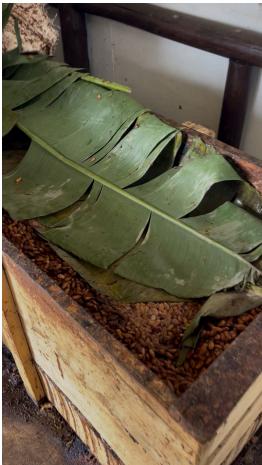
| Visual Observation | Remarks |
|---|--|
| | <p>Undesirable Fermentation</p> <p>There are three traditional organic measures for this</p> <p>Measure 1: Smell test. Ensure there are no traces of putrefy smell</p> <p>Measure 2: Ensure PH is below 6. The batch cannot be too alkaline. 4.8 to 5.8PH is ideal</p> <p>Measure 3: Professional taste test.</p> |
