Coopercabruca visit 2nd June 2023 - 7th June 2023

This document established record for FSVP compliance requirements of our initial site visit to Coopercabruca facility

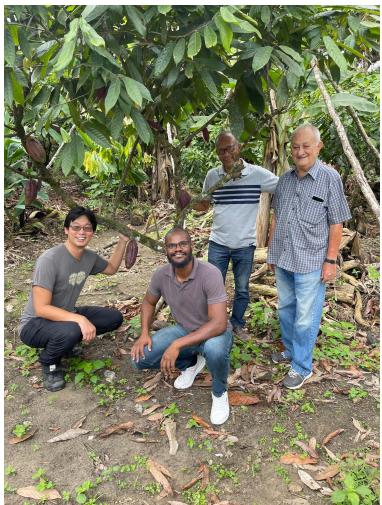
Site A - Cacao farm

- Some cacao have been observed to be infected with witch bloom fungus.
- Infected cacao pods are observed left in the fields and not harvested
- Only perfectly formed ripe cacao pods are harvested.
- Method of handling to ensure against damage to cacao pod skin during harvest to prevent introduction of vectors for microbial growth on actual cacao fruit therein observed in use

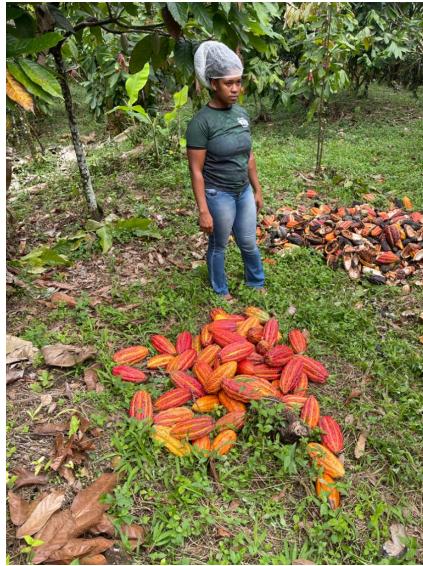
Site B - Cacao farm

Only well shaped cacao pods are harvested and consolidated in their own pile. Badly shaped or formed cacao pods are discarded in a separate pile.

Minimal signs of leaf litter is observed

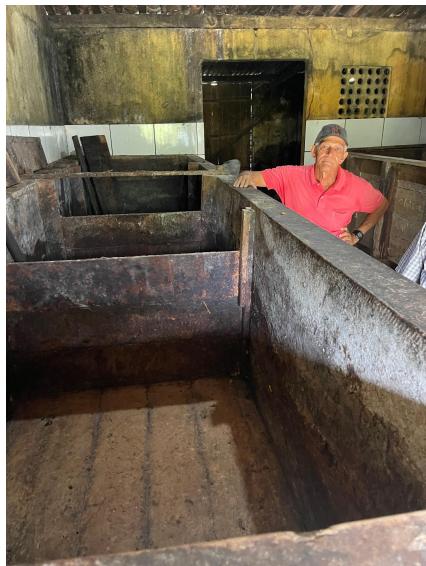
Site C - Fermentation facility

- No signs of objects that are not essential for part of the fermentation process are observed in the facility.
- No signs of chemical or pesticide equipment is present
- Equipment used for fermentation is observed to be in a well kept order
- Unused fermentation tank are observed to be clean and well maintained

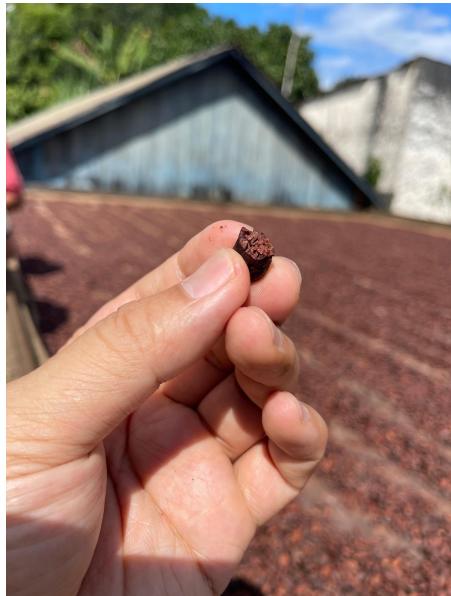
Site D - Drying facility

Staff actively attends to the cacao nibs being dried under the sun

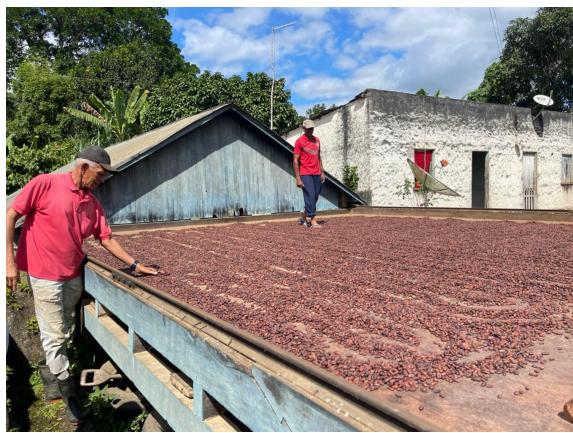
- No traces of foreign objects observed amongst cacao nibs drying under the sun.
- No signs of objects that are not essential for part of the fermentation process are observed in the facility.
- No signs of chemical or pesticide equipment is present
- Equipment used for drying cacao nibs under the sun are observed to be clean and well maintained.
- No visible signs of rust are observed in the equipment used.

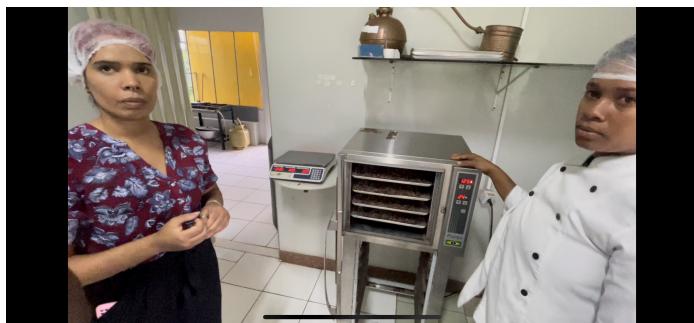
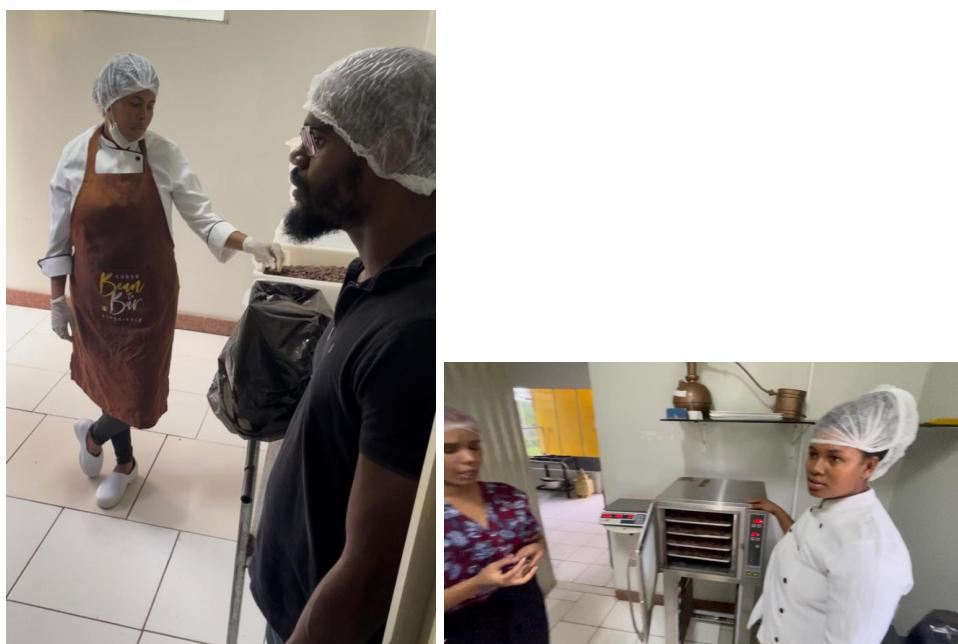
Site E - Roasting, cracking and winnowing processing facility

- Staff processing cacao nibs are observed to be wearing hair mesh
- Staff processing cacao nibs are observed to be wearing gloves at all times
- Floor of the facility is observed to be free from objects that are not required for processing
- Facility is visually observed to be free from dust particles
- Equipment for roasting is observed to be well maintained
- Equipment for roasting is observed to be in working order
