# CEPOTX site visit 2nd July 2024

This document established record for FSVP compliance requirements of our site visit to CEPOTX facility

- Supplier name visited: CEPOTX
- Site name: Cleide Maris Suk
- Site code: B-06-108
- Date: 2nd July 2024

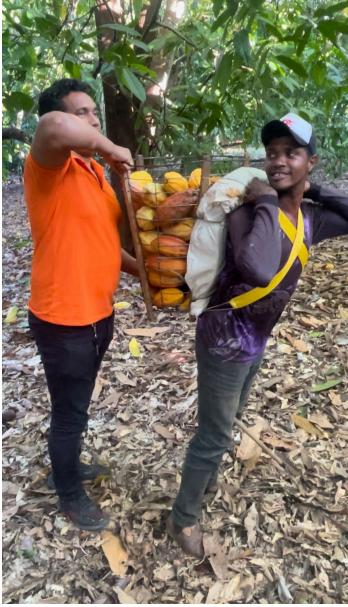
<p><b>Microbial Contamination (salmonella)</b></p> <p>We only harvest mature and perfect fruit directly from the tree.</p> <p>We utilize Garra tool to handle the fruit to ensure against broken skin which is a vector for contamination.</p>

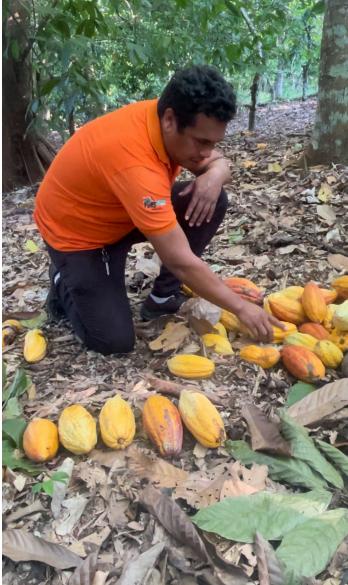
<p><b>Insect Infestation</b></p> <p>For organic cacao, natural organic insect repellents are used.</p> <p>When the environment is balance insect infestation is unlikely</p>

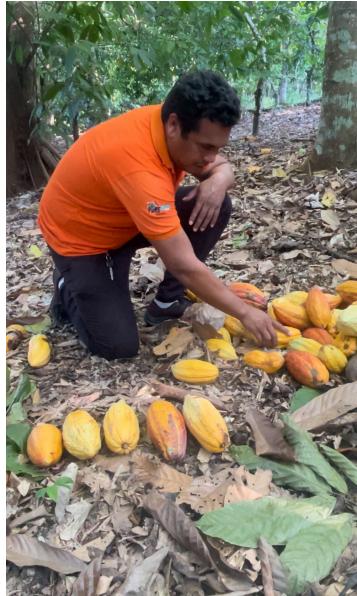
**Foreign objects like rocks, dirt, or debris from the field**

When fruits are harvested and broken and the beans are extracted. But the actual removal of this foreign objects are done at the later stage during drying

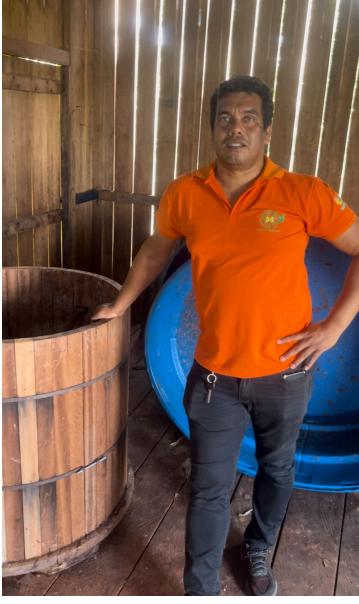
<p><b>Undesirable Fermentation</b></p> <p>There are three traditional organic measures for this</p> <p>Measure 1: Smell test. Ensure there are no traces of putrefy smell</p> <p>Measure 2: Ensure PH is below 6. The batch cannot be too alkaline. 4.8 to 5.8PH is ideal</p> <p>Measure 3: Professional taste test.</p>

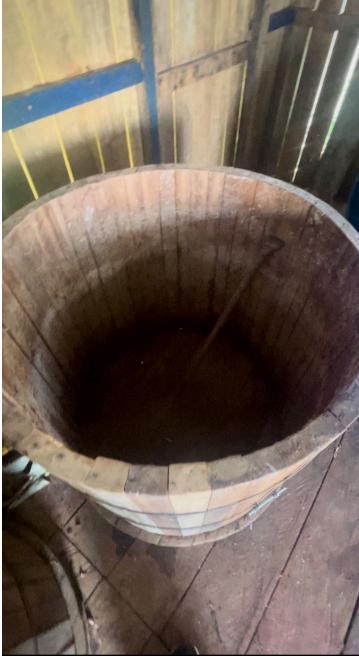
<p><b>Inclusion of non-cacao materials in fermentation containers</b></p> <p>Fermentation is done in a wood box in the house of fermentation.</p> <p>Nothing else is allowed in the house besides the cacao almonds to be fermentation</p>

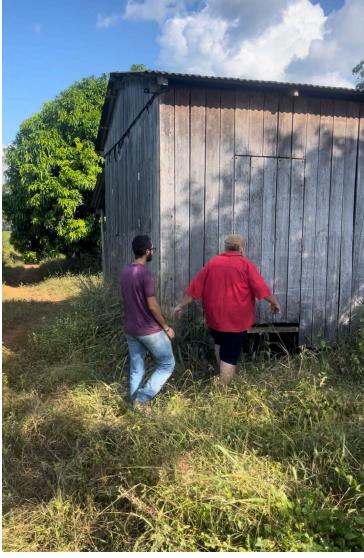
<p><b>Contamination from pesticides or chemicals used in cacao plantations</b></p> <p>The facility will be located on the farm which has been organically certified. There will be no pesticide or artificial chemicals on the premise</p>
---	--

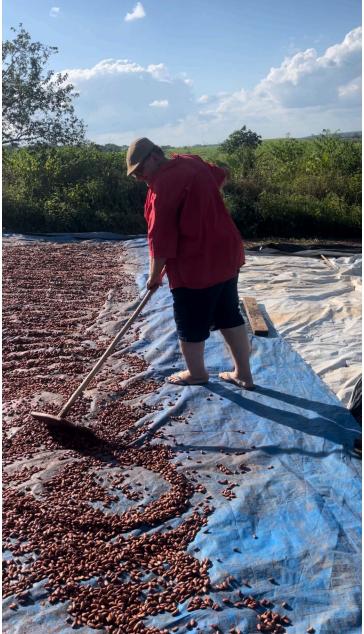
<p><b>Mold growth due to improper drying practices.</b></p> <p>Turnover the beans frequently in the sun which still contain humidity often to ensure against mold.</p> <p>First 2 days: When sample of cacao almonds is squeezed, if there is humidity, there is the liquid dropped</p> <p>Beans will be turned over every 30 minutes in the sun</p> <p>When sample of cacao almonds is hand squeezed, it cracks</p> <p>3rd day: Beans will be turned over every 1 hour in the sun</p> <p>4th to 7th day: 4 to 5 times a day.</p>
