# Coopercabruca site visit 14th Aug 2024

This document established record for FSVP compliance requirements of our site visit to Coopercabruca facility

- Supplier name visited: Coopercabruca
- Date: 14th Aug 2024

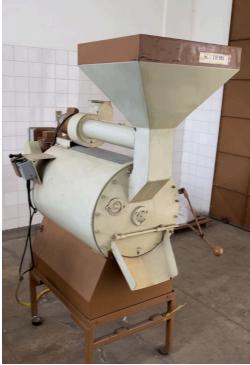
<p>The roasting process itself will kill off the microbial growth.</p> <p>The internal temperature of the cacao nibs during roasting reaches 180°C for 30 minutes.</p>	<p>Equipment observed to be in working order.</p> <p>It's been confirmed that equipment is able to heat up to indicated temperature level and time</p>

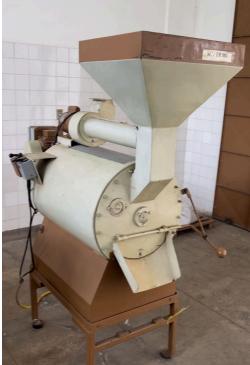
<p>Entire machine is maintained every year</p> <p>Each part of the machine is maintained every 3 months</p> <p>Daily cleaning to ensure properly functioning equipment</p> <p>Required maintenance is performed when malfunction is observed before cacao nibs are processed</p>	<p>Equipment is observed to be in good working order</p>

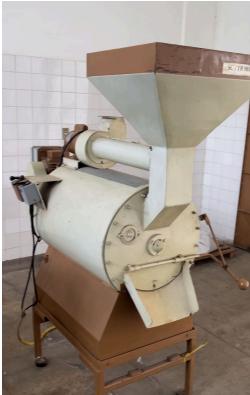
<p>The stove is sealed during roasting</p> <p>Regular maintenance is done on the stove.</p>	<p>Equipment is observed to be in good working order</p> <p>Equipment is observed to be sealed during operations</p>

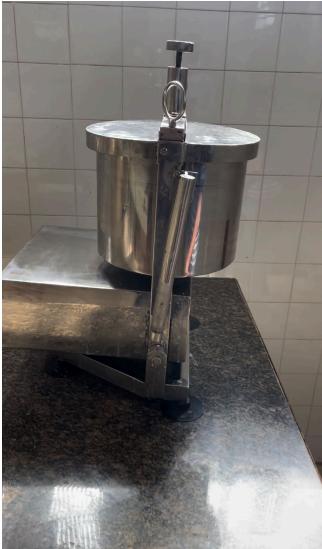
## Melanger C - 10KG / 45 minutes

Proper maintenance, metal detection	Machine is observed to be in good working conditions with zero metal fragments in cacao mass

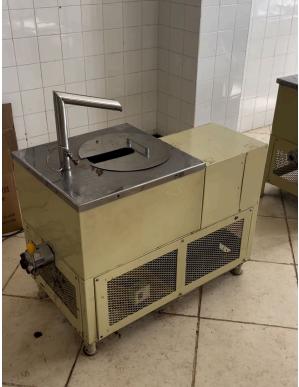
## Tempering machine A

Proper maintenance, metal detection	Machine is observed to be in good working conditions with zero metal fragments in cacao mass
---	-------------------------------------	--

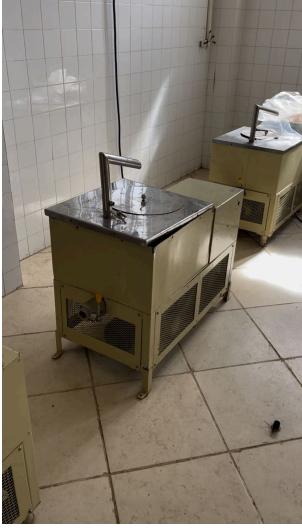
## Tempering machine B

Proper maintenance, metal detection	Machine is observed to be in good working conditions with zero metal fragments in cacao mass
---	-------------------------------------	--

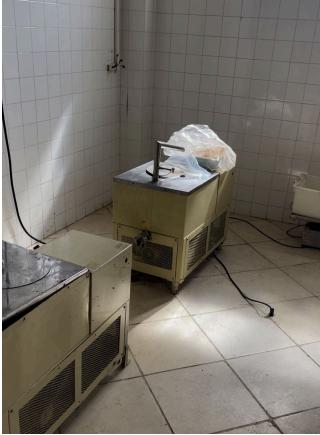
## Tempering machine C

Proper maintenance, metal detection	Machine is observed to be in good working conditions with zero metal fragments in cacao mass
---	-------------------------------------	--

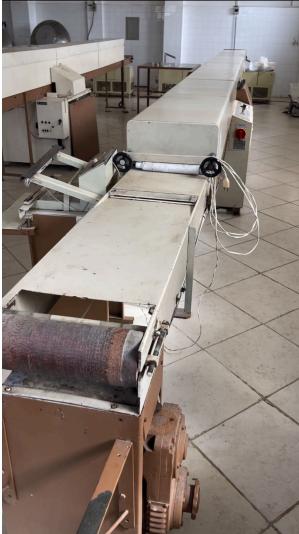
## cooling tunnel A

Proper maintenance, metal detection	Machine is observed to be in good working conditions with zero metal fragments in cacao mass
---	-------------------------------------	--

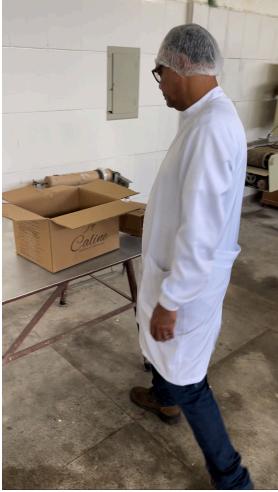
<p>Implement proper drying and storage practices to prevent mold growth. Regularly test for mycotoxins and reject contaminated batches.</p> <p>Package is sealed properly to ensure against moisture content</p>	<p>Facility is observed to be clean and in a well maintained condition</p>

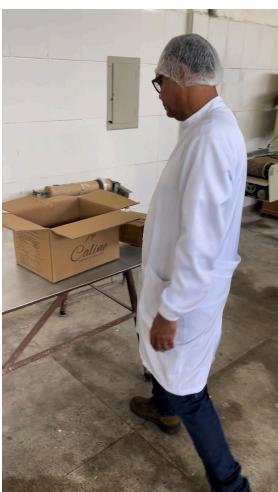
<p>Implement effective quality control measures to detect and remove foreign objects during processing. Regularly inspect equipment for signs of wear or damage.</p>	<p>Facility is observed to be clean and in a well maintained condition</p>

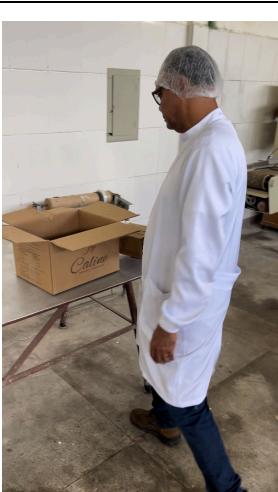
<p>Implement a rigorous cleaning and sanitation program to ensure that heavy metals are not introduced during the packing and process of cacao nibs in the facilities.</p>	<p>Facility is observed to be clean and in a well maintained condition</p>
