Cooperabruca site visit 21st June 2024

This document established record for FSVP compliance requirements of our site visit to Cooperabruca facility

- Supplier name visited: Cooperabruca
- Date: 21st June 2024

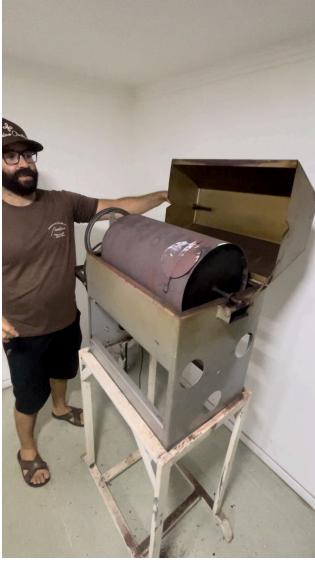
<p>The roasting process itself will kill off the microbial growth.</p> <p>The internal temperature of the cacao nibs during roasting reaches 180°C for 30 minutes.</p>	<p>Equipment observed to be in working order.</p> <p>It's been confirmed that equipment is able to heat up to indicated temperature level and time</p>

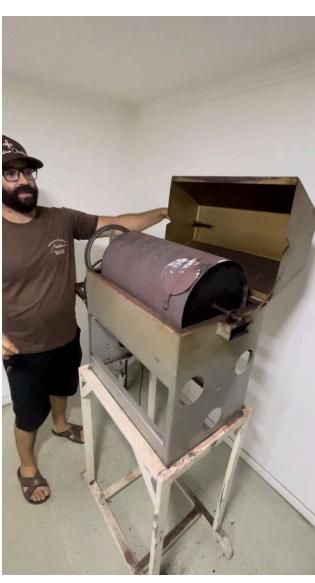
<p>Entire machine is maintained every year</p> <p>Each part of the machine is maintained every 3 months</p> <p>Daily cleaning to ensure properly functioning equipment</p> <p>Required maintenance is performed when malfunction is observed before cacao nibs are processed</p>	<p>Equipment is observed to be in good working order</p>

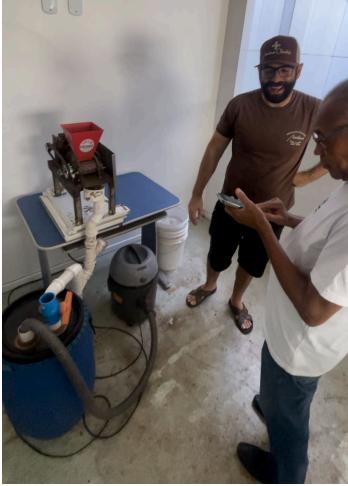
<p>The machine is sealed.</p> <p>Daily cleaning to ensure properly functioning equipment</p> <p>Full maintenance is conducted every year</p> <p>Specific part maintenance is done every 3 months</p> <p>Required maintenance is performed when malfunction is observed before cacao nibs are processed</p>	<p>Machine itself is fully sealed ensuring no external contaminants can enter</p>

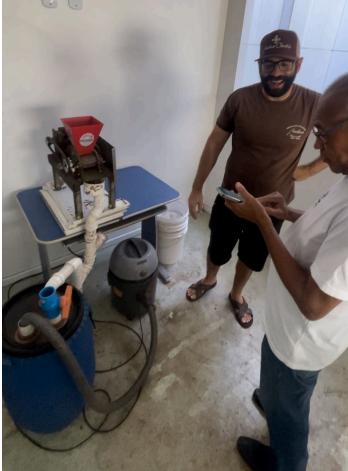
<p>Clean and sanitize winnowing equipment between batches.</p> <p>Implement proper allergen controls to prevent cross-contact.</p> <p>The facility only processes cacao nibs</p>	<p>No other materials were observed to be processed at operating facility other than cacao nibs</p>

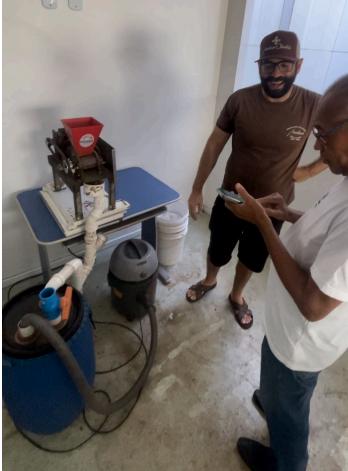
<p>Use proper cracking and winnowing equipment to minimize shell fragments.</p> <p>Implement visual inspections and sieving to remove foreign materials.</p> <p>Workers are to wear hair mesh and gloves.</p>	<p>Its been observed proper cracking and winnowing equipment is in use to automate removal of shell fragment</p> <p>Hair mesh was seen worn and shoe mesh were observed to be in use.</p>

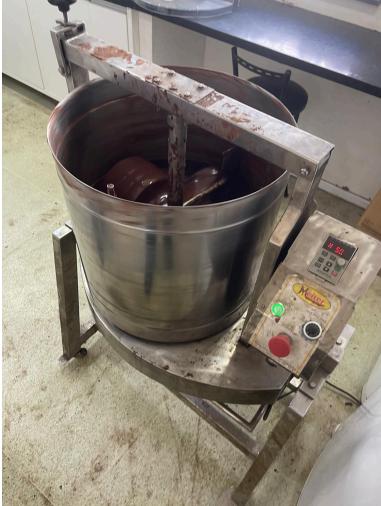
Proper maintenance, metal detection	Machine is observed to be in good working conditions with zero metal fragments in cacao mass

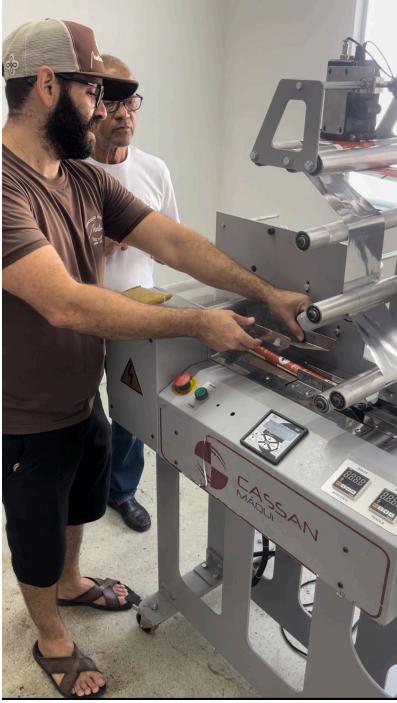
<p>Implement controls to prevent foreign objects from entering packaging materials. Use metal detectors or sieves to catch any contaminants before sealing.</p>	<p>Container that allows for each monitoring and observation of foreign particles during process of winnowing and cracking of cacao almonds into nibs</p> <p>Sieve is built into machine</p>

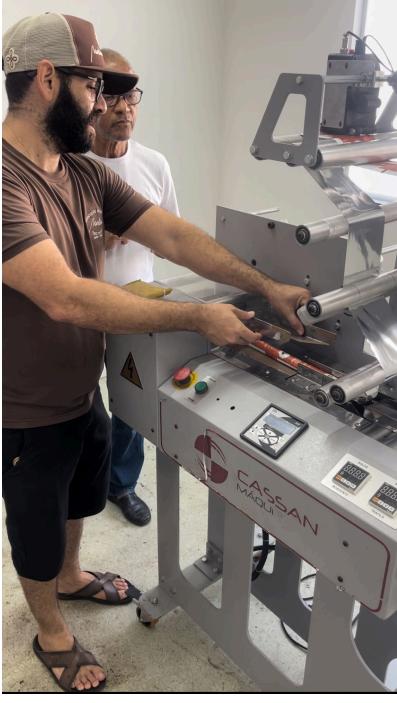
<p>Implement a rigorous cleaning and sanitation program to ensure that heavy metals are not introduced during the packing and process of cacao nibs in the facilities.</p>	<p>No dirt or dust particles at observed at venue where cacao almonds are processed into nibs and then packed</p>
