## CEPOTX site visit — 07 September 2026

This document establishes the record for FSVP compliance requirements of our site visit to the CEPOTX member farm and bean-to-bar processing facility at **La do Sitio** (site code **V-06-29**), operated by Paulo Barbosa do Nascimento and family, on 7 September 2026. The visit documented the farm post-harvest facilities and the **new bean-to-bar facility** (roasting, cracking/winnowing and cold-hold) under construction for chocolate-bar production. Evidence: six geo-located photographs captured at the time of the visit (five with embedded GPS).

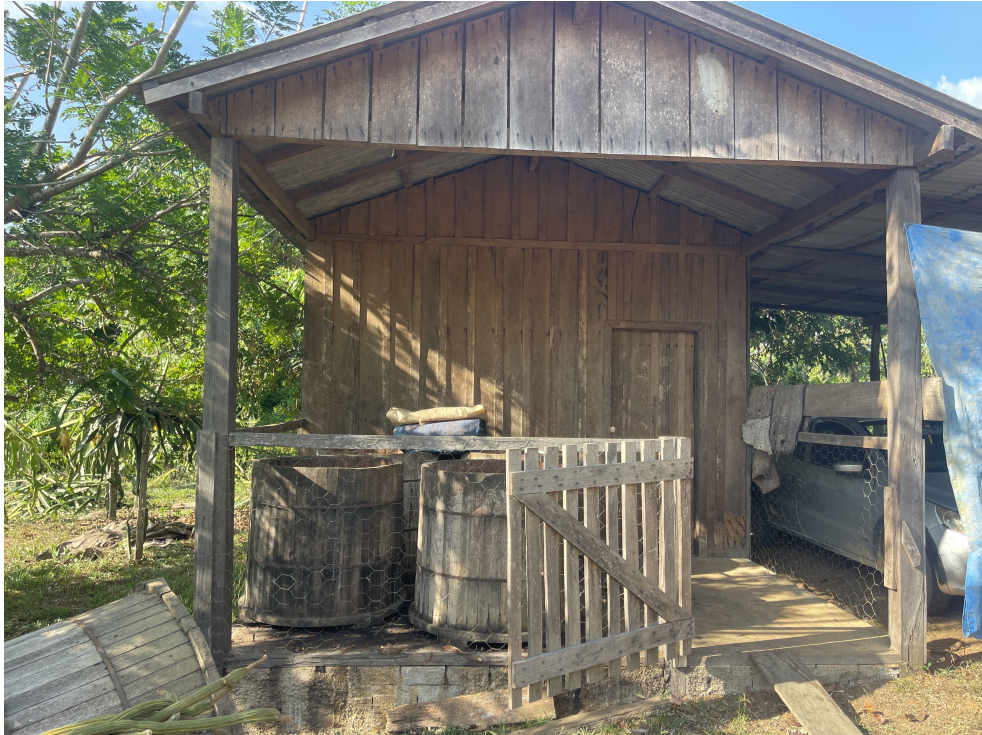
| Visual Observation | Remarks |
|---|---|
| Undesirable fermentation | Dedicated fermentation shed on a concrete plinth with stave-wood ~200 L barrels. One barrel was observed lying on bare soil beside the plinth at the time of the visit — noted for correction (barrels should be kept on the plinth / off soil) and recommended as a preventive-control follow-up. Fermentation practice detail (duration, turning) to be confirmed at first purchase. |
| Inclusion of non-cacao materials in fermentation containers | Shed is a dedicated fermentation area enclosed by wire; no non-cacao material observed inside the fermentation barrels. |
| Contamination from pesticides or chemicals | Farm is a CEPOTX organic-network member; no pesticide or artificial-chemical inputs observed at the shed or surrounds. |

Fermentation shed, La do Sitio – 07-Sep-2026 16:14 local, GPS -3.388417, -51.852633 (alt 179 m).

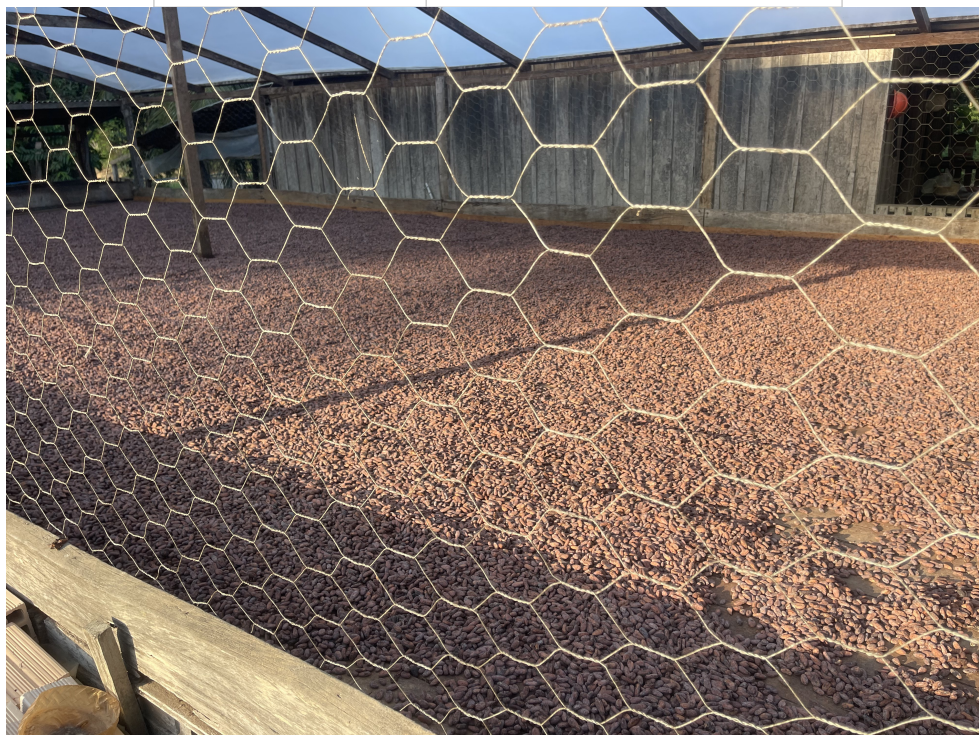
| Visual Observation | Remarks |
|---|---|
| Mold growth due to improper drying practices | Open-air roofed sun-drying floor with beans spread directly on a concrete slab framed by timber curbs, surrounded by chicken-wire animal exclusion. Drying surface swept; no mold observed in the captured media at the time of the visit. Drying practice (turning schedule, target moisture) to be confirmed at first purchase. |
| Inclusion of foreign objects during drying and sorting | Beans are handled on the drying surface only; the area is enclosed against animals. No debris or foreign objects observed in the captured media. |
| Residues from cleaning agents or pesticides | No cleaning-agent or pesticide-residue source observed at the drying floor or premises. |

Sun-drying floor, La do Sitio – 07-Sep-2026 17:24 local (photo without GPS; same premises, adjacent to new facility area).

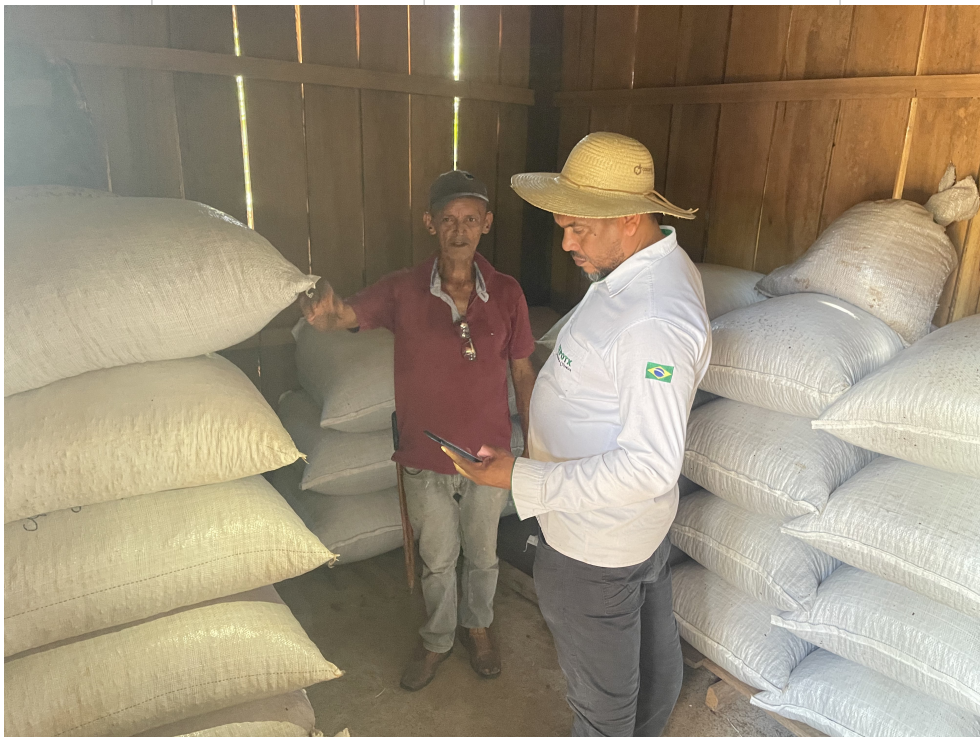
| Visual Observation | Remarks |
|---|---|
| Mold growth due to improper storage / moisture | Raw beans stored in PP sacks stacked on pallets in a dedicated shed. Shed was dry and under cover; one torn sack was noted (beans exposed) — flagged for repair/re-bagging. Dust/cobwebs present but no mold observed in the captured media. Storage practice to be confirmed at first purchase. |
| Foreign objects / contamination during storage | Sacks are stored on pallets (off the floor); shed is enclosed. A torn sack is a foreign-object / moisture entry risk — noted as a preventive-control follow-up. |
| Pest / insect ingress | Shed is enclosed but not pest-proofed; bags stored on pallets. No active infestation observed at the time of visit. |

Raw-bean storage shed, La do Sitio – 07-Sep-2026 16:16 local, GPS -3.388622, -51.852669 (alt 163 m).

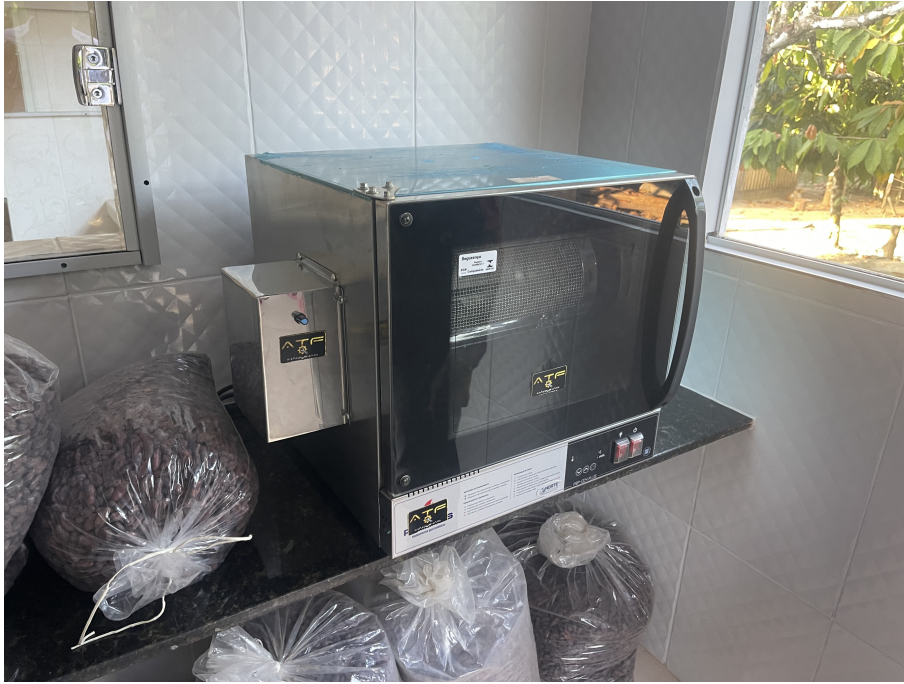
**Machine:** ATF Máquinas stainless-steel cacao roaster, model **FPR-20N PLUS** (electric drum roaster; NR12 machine-safety label present; protective film still fitted — recently installed). **Rated batch capacity: to be confirmed from manufacturer nameplate / data sheet** (model code suggests the “20” class, i.e. approx. 20 kg per batch; not yet verified). Roast temperature / time profile run on the day: **not recorded** — no instrument readout was photographed during the visit; the roaster is not yet commissioned for production.

| Visual Observation | Preventive Control | Examined | Remarks |
|---|---|---|---|
| Microbial contamination (salmonella) | The roasting process itself will kill off microbial growth; internal bean temperature must reach the validated kill-step profile (time/temperature). | Roaster model ATF FPR-20N PLUS observed installed and in clean, tiled room; not yet commissioned — kill-step profile to be validated at first production run. | Equipment new (protective film fitted). Roast time/temperature profile to be confirmed and recorded at commissioning. |
| Equipment hygiene / maintenance | Daily cleaning to ensure properly functioning equipment; required maintenance performed when malfunction is observed before cacao is processed. | Machine observed in clean condition, recently installed in a dedicated tiled room. | Roaster is new; maintenance schedule to be established at commissioning. |
| Foreign-object contamination | Implement visual inspections / sieving to remove foreign materials; keep the roaster area clean. | Roasting room clean and tiled; window onto cacao trees. No foreign-object source observed. | Sacks of dry beans stored adjacent to roaster — keep covered between batches. |

ATF Máquinas FPR-20N PLUS cacao roaster, La do Sitio new facility – 07-Sep-2026 17:26 local, GPS -3.386436, -51.851325 (alt 140 m).

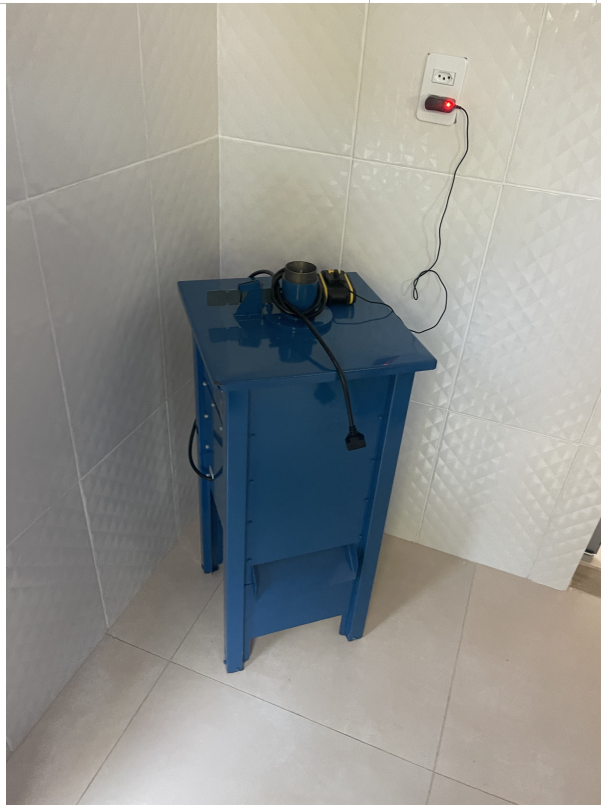
**Machine:** compact farm-scale cracker/winnower — royal-blue painted cabinet, stainless-steel top hopper, bottom-front discharge, no visible brand plate. Form factor matches the farm/craft class of cacao “beneficiadora de cacau nibs” machines (e.g. the FATOMQA class referenced in Agroverse’s bean-to-bar equipment research, 17–23 kg/h). **Brand and rated capacity: to be confirmed from nameplate** — no nameplate was visible in the photograph.

| Visual Observation | Preventive Control | Examined | Remarks |
|---|---|---|---|
| Shell-fragment / foreign-object contamination | Use proper cracking and winnowing equipment to minimize shell fragments; implement visual inspections and sieving to remove foreign materials. | Cracker/winnower installed in a tiled alcove, clean. Compact machine with hopper feed. | Unit appears new and unused in production; throughput to be confirmed at first run. |
| Microbial growth / hygiene | Clean and sanitize winnowing equipment between batches; keep machine openings sealed between uses. | Machine clean at time of visit; discharge chute open and clean. | No brand plate visible in the photograph — nameplate read to be captured on follow-up. |
| Cross-contact / allergens | The facility processes cacao only; no other material observed on the premises. | No non-cacao material observed in the facility. | Keep line cacao-only as bar production begins. |

Compact cracker/winnower, La do Sitio new facility – 07-Sep-2026 17:27 local, GPS -3.386556, -51.851233 (alt 136 m).

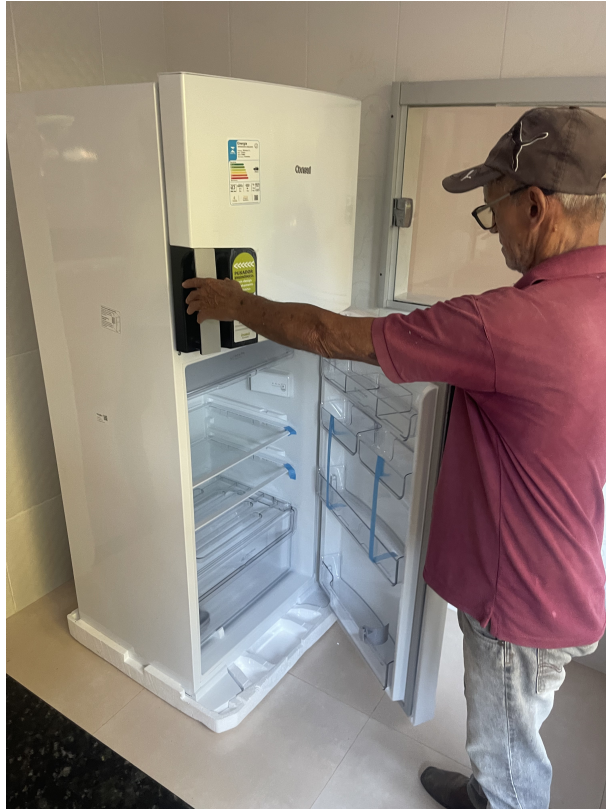
**Equipment:** domestic-grade Consul refrigerator/freezer in the bar-making utility room — intended cold storage for finished-bar / tempering hold. Domestic-grade cold storage is suitable for short-hold finished product only; temperature monitoring to be established before finished-bar storage begins.

| Visual Observation | Remarks |
|---|---|
| Temperature control / cold-hold | Dedicated refrigerator for bar-making (filename “fridge_for_making_bar”). Domestic-grade unit — appropriate for short-hold / small-batch finished product with a temperature log; a continuous monitoring thermometer should be added before finished-bar storage. |
| Cross-contamination | Refrigerator sits in a tiled utility room dedicated to bar-making. No non-cacao food observed stored with the unit at the time of the visit; keep bar cold-hold cacao-only. |
| Hygiene / cleaning | Unit and surrounds clean at the time of the visit. Domestic refrigerator interiors are non-commercial grade — cleaning schedule to be maintained. |

Cold-hold refrigerator for bar making, La do Sitio – 07-Sep-2026 17:28 local, GPS -3.386494, -51.851272 (alt 137 m).
