## CEPOTX site visit 9th September 2026 — Sítio Torres

This document establishes the record for FSVP compliance requirements (21 CFR 1.470–1.514) of our site visit to the CEPOTX facility at Sítio Torres — recorded on the farm as “Sítio 2” (plot code N-06-66), a member property of the COOPCAO cooperative (CEPOTX family), Pacajá/PA, on 9th September 2026. Evidence was captured on-site: 38 geotagged photographs, 35 locus-tagged walk videos and 8 artefacts, archived in the media-archive pipeline (farm\_media\_manifests/sitio-torres-pacaja-para.json + 20260909\_pacaje\_location\_2\_nursery.zip.archive.json).

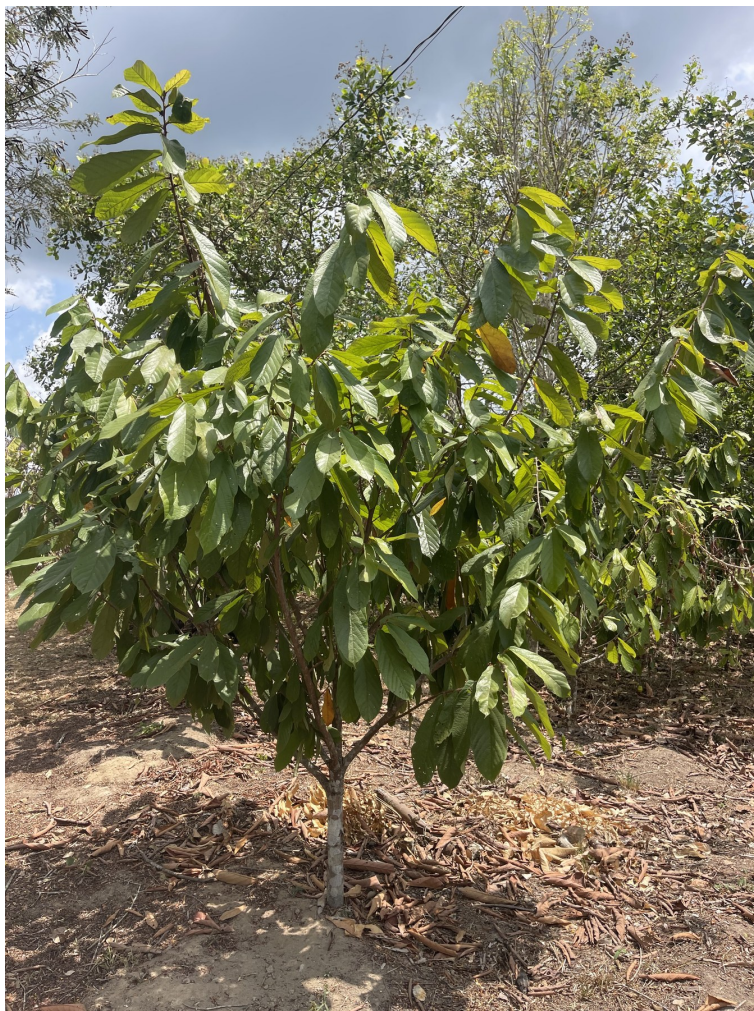
Sítio Torres – cacao plant growth: young cacao tree in vegetative stage (dense oblong-leaf canopy, slender trunk) within the grove – IMG\_9682.HEIC, captured 09-Sep-2026 13:27:44 local, GPS -3.5298, -51.1451.

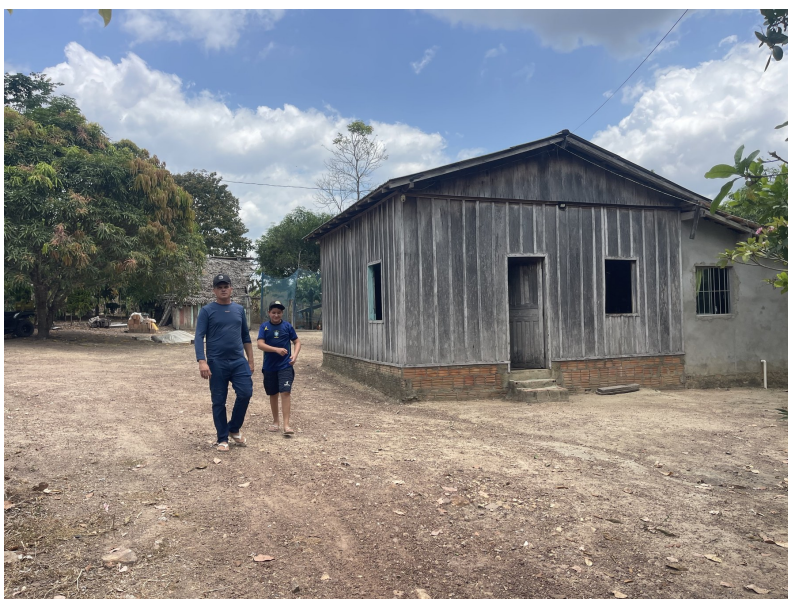
Reference image – Facility A cacao farm (existing grove), Sítio Torres; representative farm view from the 09-Sep-2026 site walk (IMG\_9622).

| Visual Observation | Remarks |
|---|---|
| Microbial Contamination (salmonella) | Existing cacao grove walked and inspected on 09-Sep-2026 (videos IMG_9623, IMG_9624, IMG_9630). Managed organically under the CEPOTX/CoopCao IBD NOP system. Cacao verdadeiro/híbrido across blocks aged 2/4/5 yr plus a >20 yr block (Alexandre's narration, IMG_9624). Enrichment planting ("enriquecimento") into standing capoeira (IMG_9630). |
| Insect Infestation | Organic agroforestry under native shade — cumaru (native Amazon) planted through the grove (IMG_9623/IMG_9624). No pest outbreak observed during the walk. |
| Foreign objects like rocks, dirt, or debris from the field | Pods harvested selectively by hand; grove floor clear during the walk. No foreign-object contamination source observed at the harvest area. |

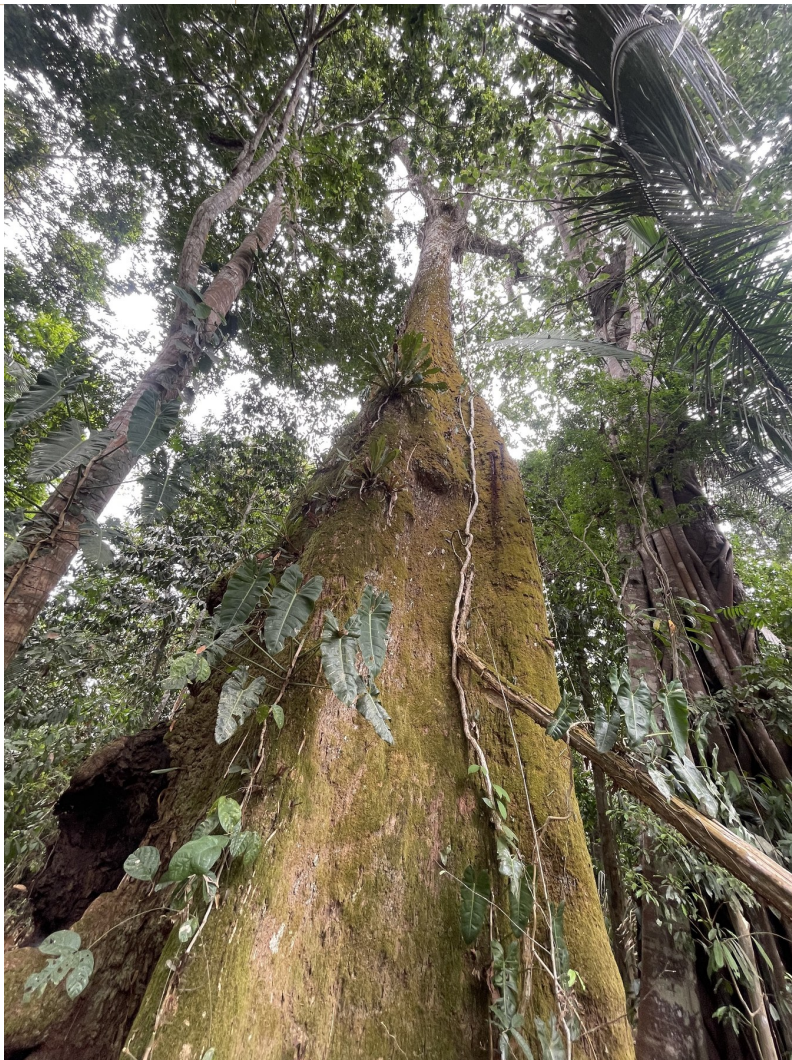
Facility A – cacao grove, Sítio Torres (photo from 09-Sep-2026 site walk; one of the 38 archived HEIC originals).

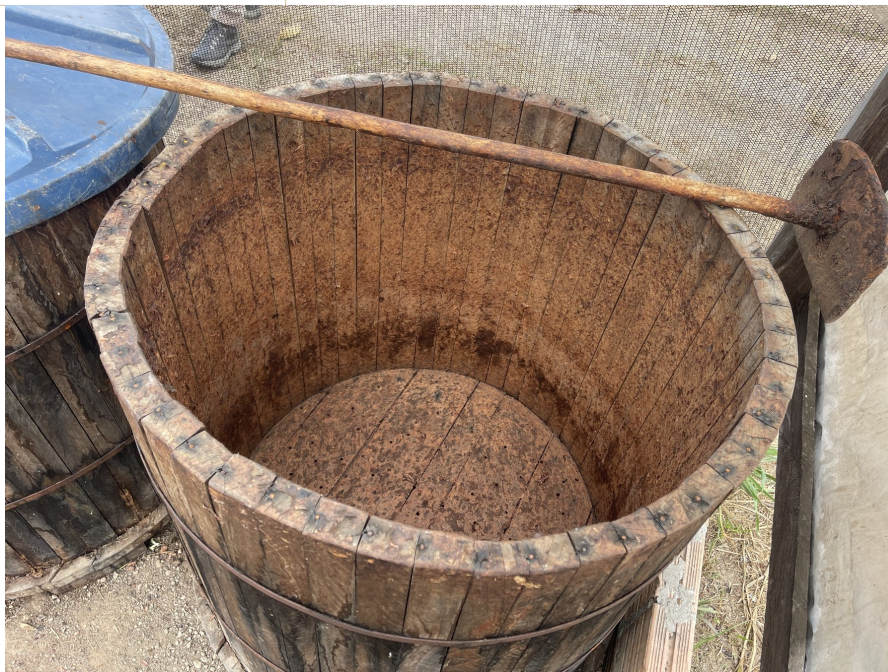
| Visual Observation | Remarks |
|---|---|
| Undesirable Fermentation | Fermentation is carried out in wooden vessels/tanks housed inside the on-site covered processing structure (screened walls, translucent roof over a brick footing) — the SAME physical structure used for sun-drying (see Facility C). Documented in photo evidence IMG_9677 (wooden fermentation vessel inside the structure) and IMG_9673 (the covered structure itself), plus walk clip IMG_9678 (“fermentação... tanque... este aberto”). Regime details (box construction, days, turning) to be confirmed — <i>[PENDING]</i> . |
| Inclusion of non-cacao materials in fermentation containers | Only cacao beans are placed in the fermentation vessels; the structure is dedicated to cacao processing (IMG_9677 vessel + IMG_9673 structure + IMG_9678 walk-through). No non-cacao material observed in the container during the visit. |

Facility B – wooden fermentation vessel (barrel/box) inside the covered processing structure, Sítio Torres – IMG\_9677.HEIC, captured 09-Sep-2026 13:22:07 local, GPS –3.5299, –51.1451 (alt 86.5 m).

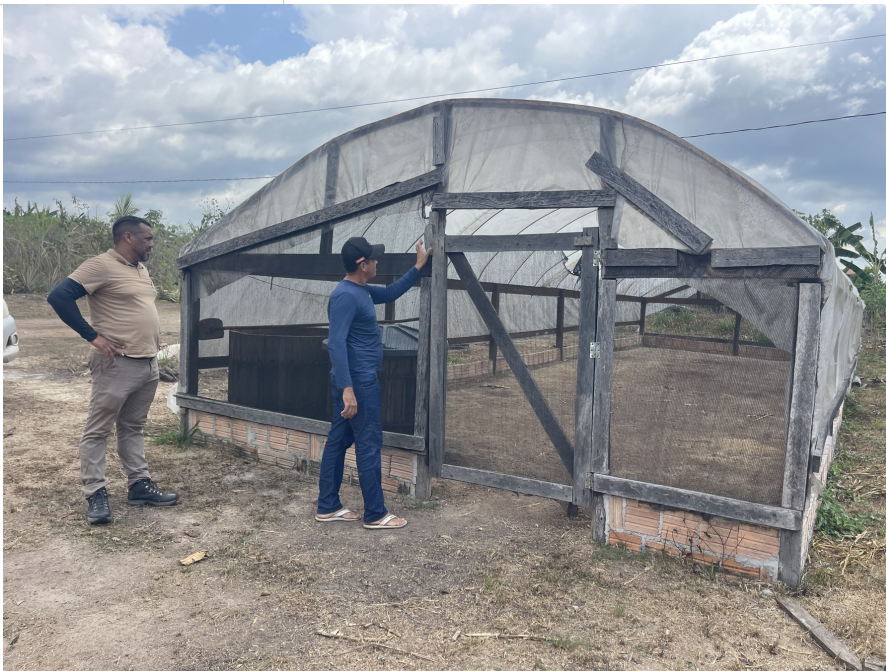
| Visual Observation | Remarks |
|---|---|
| Mold growth due to improper drying practices | Sun-drying (“secagem”, IMG_9703) is carried out on-site under the covered processing structure (screened walls, translucent roof, brick footing — IMG_9673), the SAME physical structure in which the fermentation vessels are housed (Facility B). No mold observed at the time of visit. Drying-regime details (bed surface, batch depth, turning) to be confirmed — <i>[PENDING]</i> . |
| Inclusion of foreign objects during drying and sorting process | Beans dried and sorted on-site under the covered structure; no debris or foreign objects observed. Dedicated clean drying-surface details to be confirmed — <i>[PENDING]</i> . |

Facility C – the covered processing structure (screened walls, translucent roof on a brick footing) under which sun-drying is carried out and in which the fermentation vessels are housed — the same structure shown under Facility B. Sítio Torres – IMG\_9673.HEIC, captured 09-Sep-2026 13:21:37 local, GPS –3.5298, –51.1451 (alt 83.2 m).
