# CEPOTX SUPPLIER SITE VISIT — FDA FSVP

## Site Visit Report

| Supplier: | CEPOTX — Cooperativa Central de Produção Orgânica da Transamazônica e Xingu |
| Site name: | Santa Anna Fazenda |

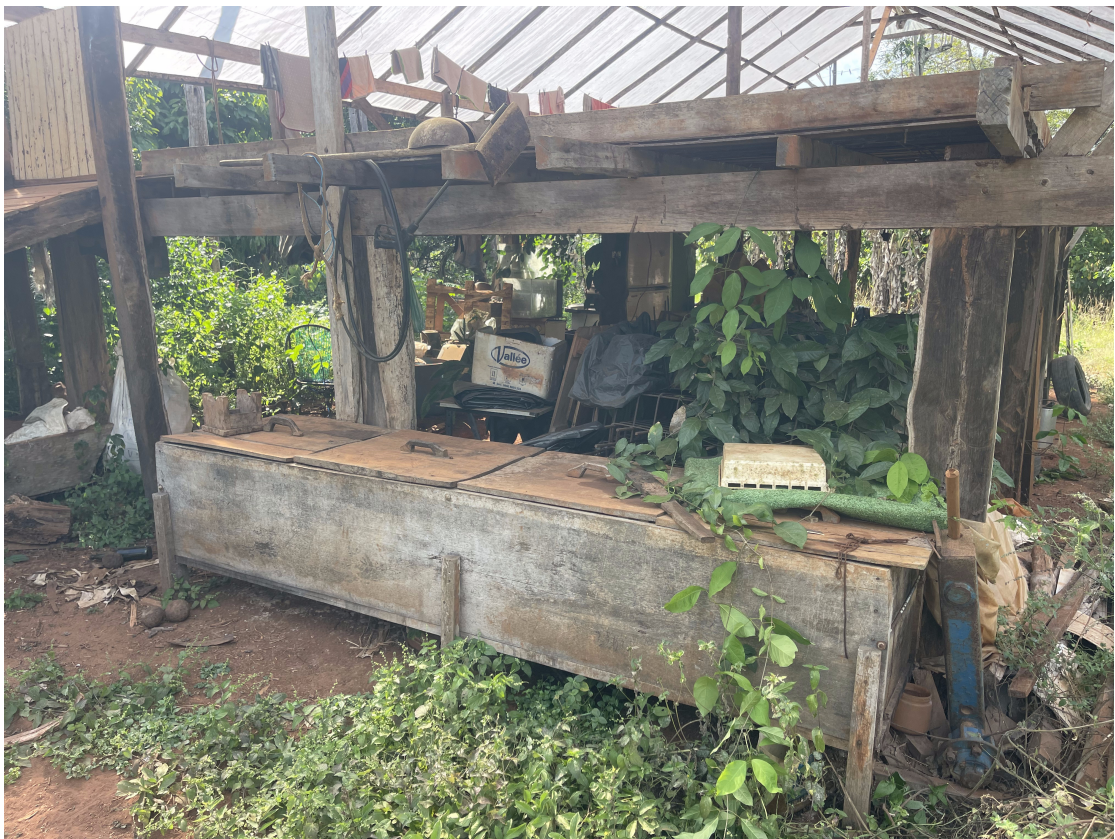
| Observation: | Wooden fermentation boxes; batch turned by hand; 5–7 day typical protocol; clean environment. |
| Hazards assessed: | Microbial contamination: low (controlled fermentation) · Insect infestation: low · Foreign objects: low · Mold: none observed |

Facility B — wooden fermentation boxes (IMG\_7735)

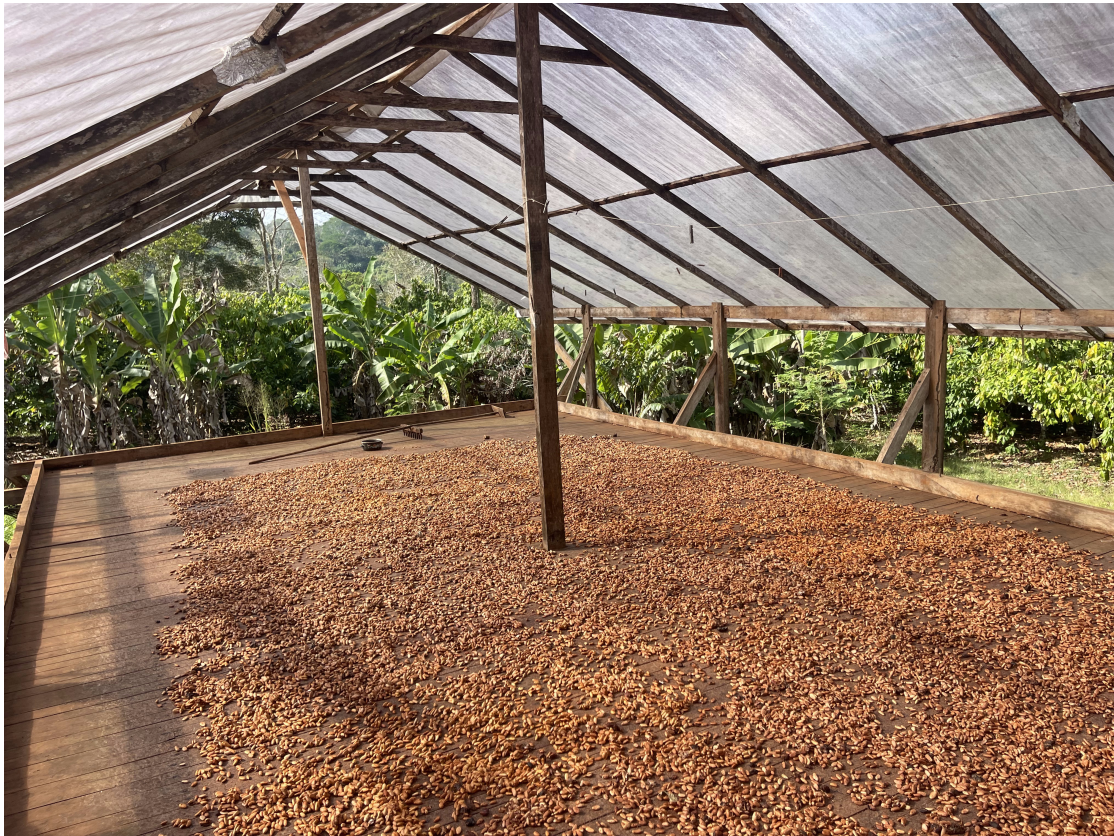
| Observation: | Open-sided drying shed, beans spread on floor in thin layer; airflow management; no contamination sources. |
| Hazards assessed: | Microbial contamination: low (low moisture) · Insect infestation: low · Foreign objects: none observed · Mold: none observed |

Facility C — drying shed (IMG\_7742)

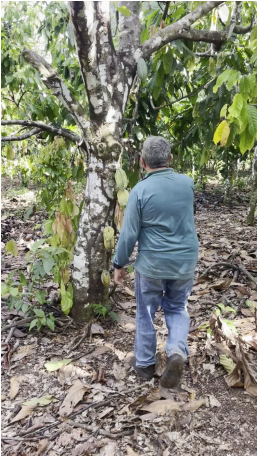
frame 1 — grove walk

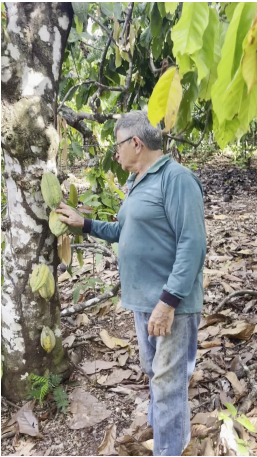
frame 2 — pods on trunk

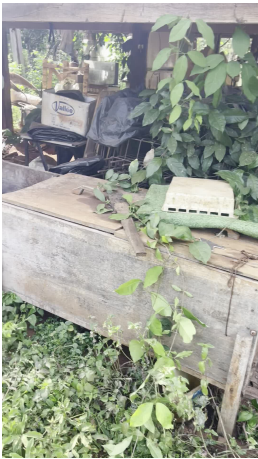
IMG\_7740 — fermentation box

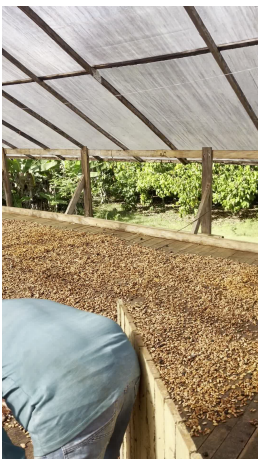
IMG\_7741 — drying shed
