Site Visit Report

| Supplier: | CEPOTX — Cooperativa Central de Produção Orgânica da Transamazônica e Xingu |
| Site name: | Santa Anna Fazenda |

# CEPOTX SUPPLIER SITE VISIT — FDA FSVP

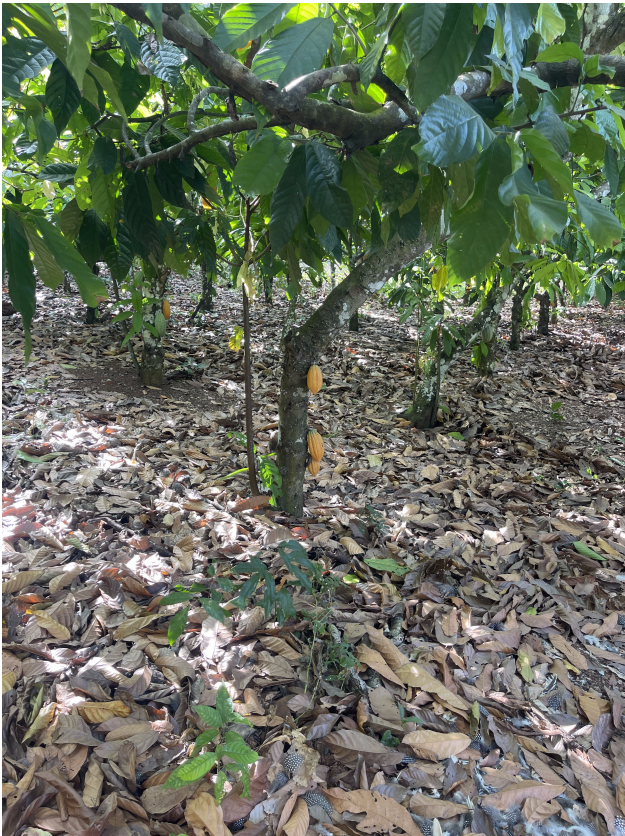
| Observation: | Mature cacao trees, pods on trunks (cauliflory); healthy canopy; no visible disease. |
| Hazards assessed: | Microbial contamination: low · Insect infestation: low · Foreign objects: low · Mold: none observed · Pesticides: none observed |

Facility A — cacao grove at Santa Anna Fazenda (IMG\_7732)

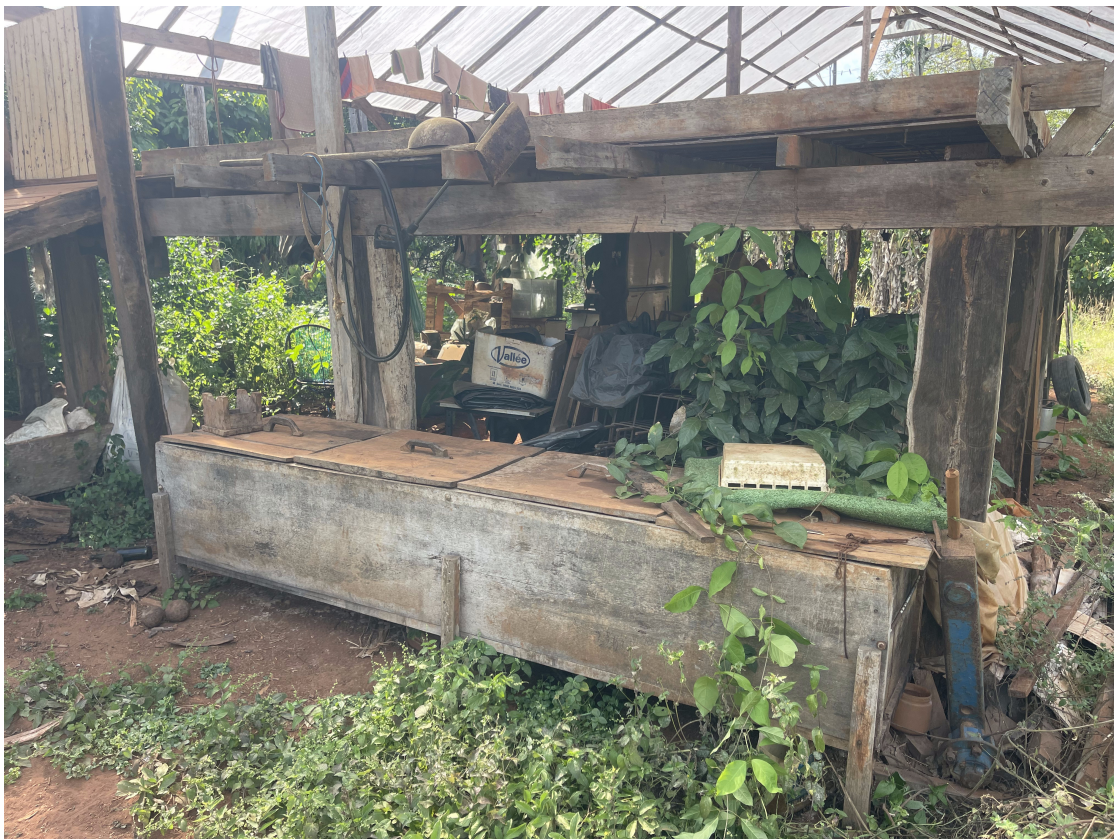
| Observation: | Wooden fermentation boxes; batch turned by hand; 5–7 day typical protocol; clean environment. |
| Hazards assessed: | Microbial contamination: low (controlled fermentation) · Insect infestation: low · Foreign objects: low · Mold: |

Facility B — wooden fermentation boxes (IMG\_7735)

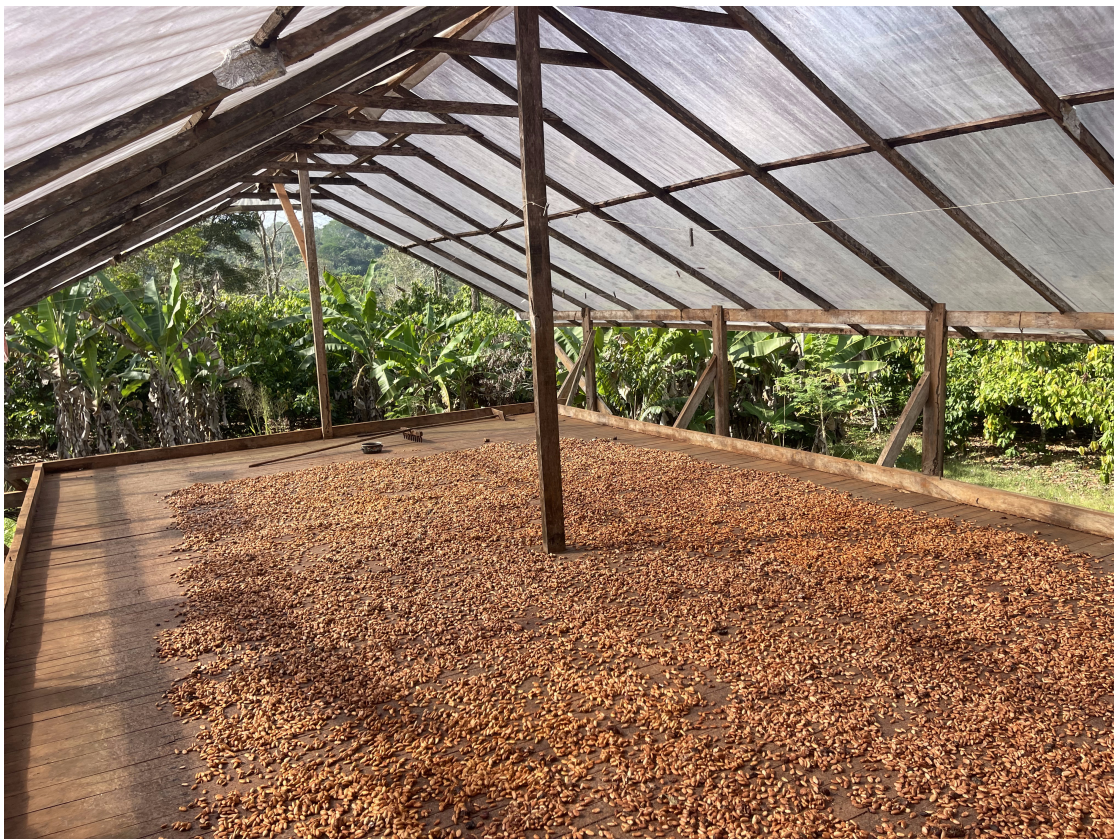
| Observation: | Open-sided drying shed, beans spread on floor in thin layer; airflow management; no contamination source |
| Hazards assessed: | Microbial contamination: low (low moisture) · Insect infestation: low · Foreign objects: none observed · Mold |

Facility C — drying shed (IMG\_7742)

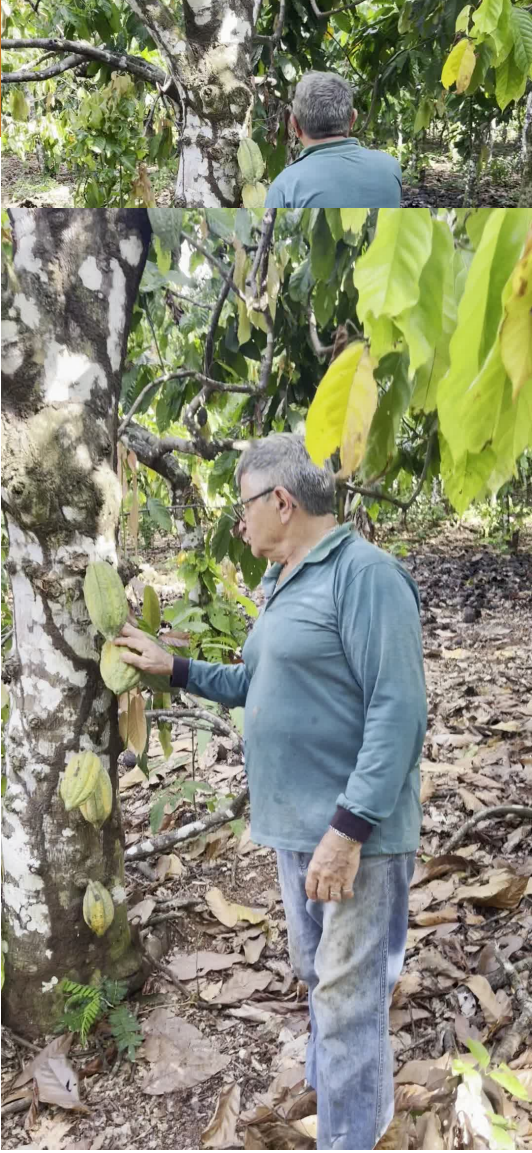
/ (7.7s) — walk through cacao grove

frame 2 — pods on trunk

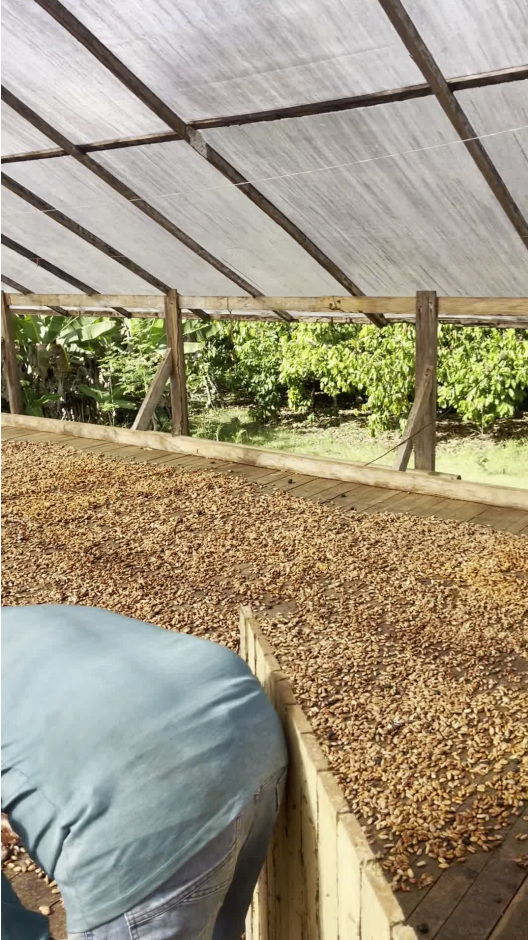
IMG\_7741 — drying shed
