## CEPOTX site visit 9th September 2026 — Sítio Torres

### Supplier and visit dates

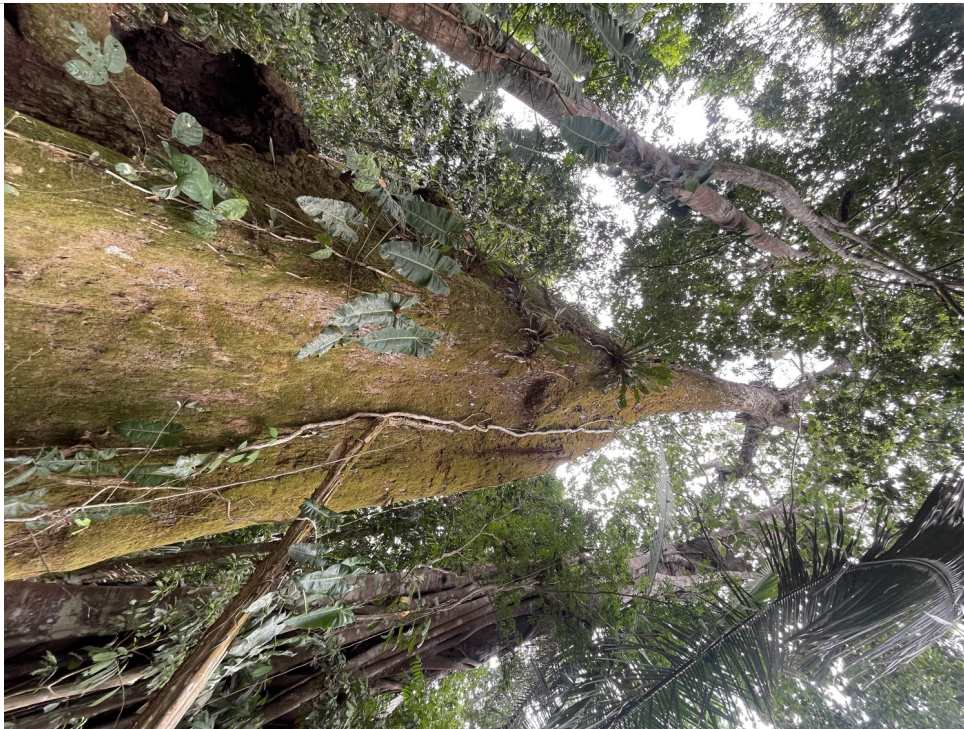
| Visual Observation | Remarks |
|---|---|
| Microbial Contamination (salmonella) | Existing cacao grove walked and inspected on 09-Sep-2026 (videos IMG_9623, IMG_9624, IMG_9630). Managed organically under the CEPOTX/CoopCao IBD NOP system. Cacao verdadeiro/híbrido across blocks aged 2/4/5 yr plus a >20 yr block (Alexandre's narration, IMG_9624). Enrichment planting (“enriquecimento”) into standing capoeira (IMG_9630). |
| Insect Infestation | Organic agroforestry under native shade — cumaru (native Amazon) planted through the grove (IMG_9623/IMG_9624). No pest outbreak observed during the walk. |
| Foreign objects like rocks, dirt, or debris from the field | Pods harvested selectively by hand; grove floor clear during the walk. No foreign-object contamination source observed at the harvest area. |

Facility A – cacao grove, Sítio Torres (photo from 09-Sep-2026 site walk; one of the 38 archived HEIC originals).

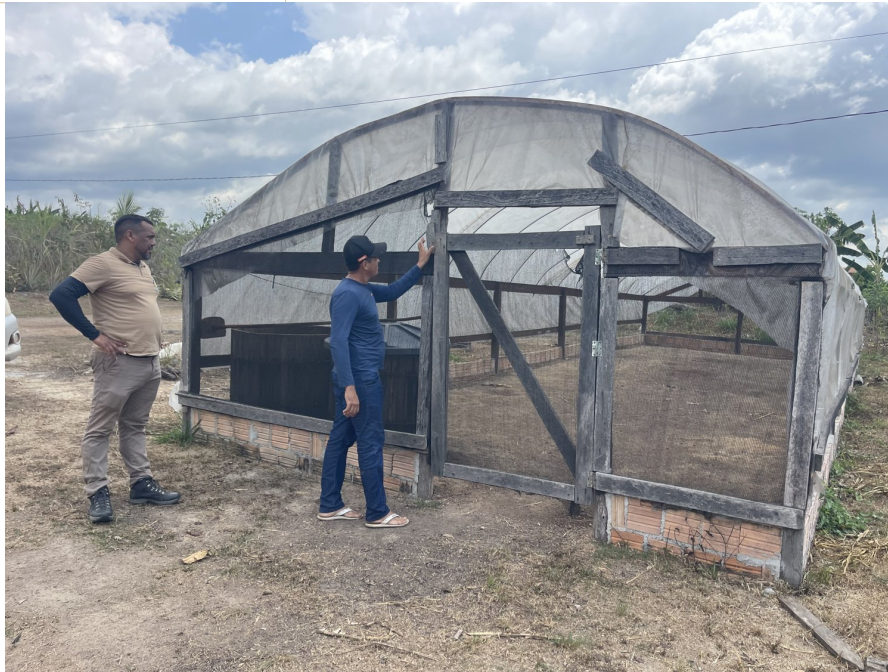
| Visual Observation | Remarks |
|---|---|
| Undesirable Fermentation | Fermentation is carried out in a wooden box / vessel on-site, documented in photo evidence IMG_9673 (screened processing structure) and IMG_9677 (wooden fermentation vessel, 13:22 local), plus walk clip IMG_9678 (“fermentação... tanque... este aberto”). Regime details (box construction, days, turning) to be confirmed — [PENDING]. |
| Inclusion of non-cacao materials in fermentation containers | Only cacao beans are placed in the fermentation vessel; the structure is dedicated to cacao (IMG_9673/IMG_9677 + IMG_9678 walk-through). No non-cacao material observed in the container during the visit. |

Facility B – screened processing structure with fermentation vessel area, Sítio Torres – IMG\_9673.HEIC, captured 09-Sep-2026 13:21:37 local, GPS -3.5298, -51.1451 (alt 83.2 m).

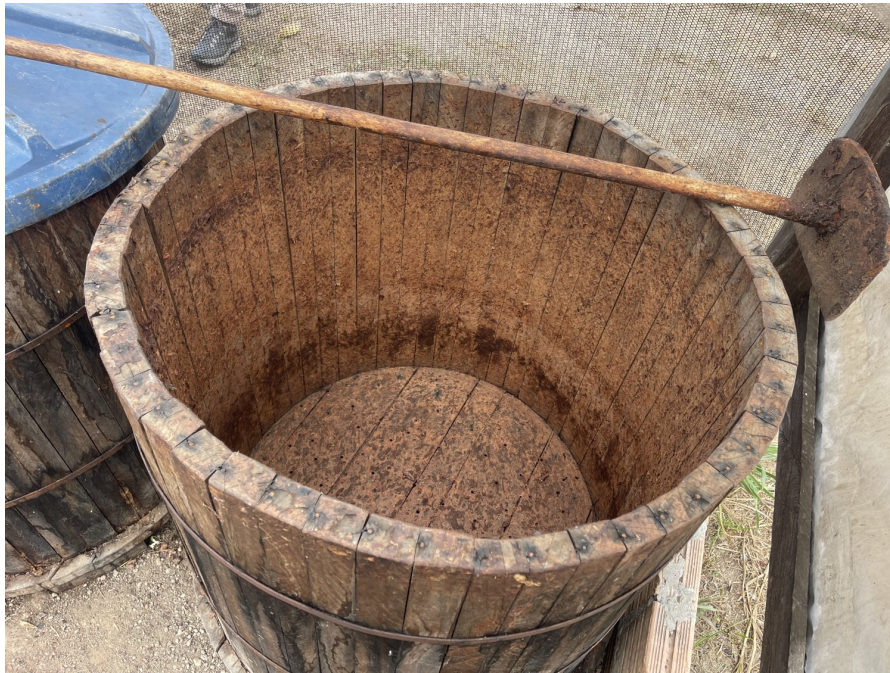
Facility B – wooden fermentation vessel (barrel/box), Sítio Torres – IMG\_9677.HEIC, captured 09-Sep-2026 13:22:07 local, GPS -3.5299, -51.1451 (alt 86.5 m).

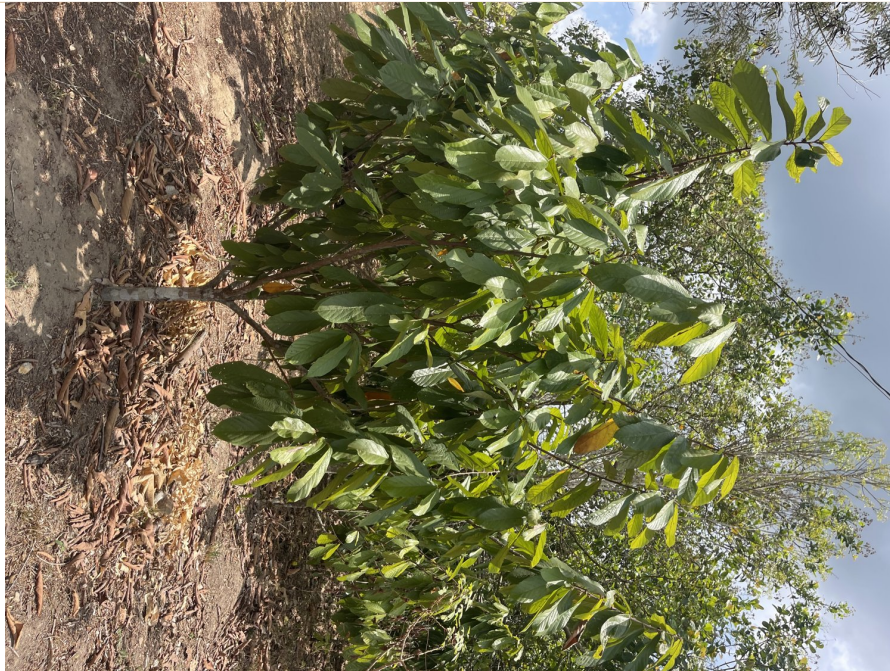
Sítio Torres – grove / processing area during the 09-Sep-2026 walk – IMG\_9682.HEIC, captured 13:27:44 local, GPS –3.5298, –51.1451.
