## CEPOTX site visit 9th September 2026 — Sítio Cacau na Veia

FSVP Site Inspection Record · TrueSight DAO / Agroverse

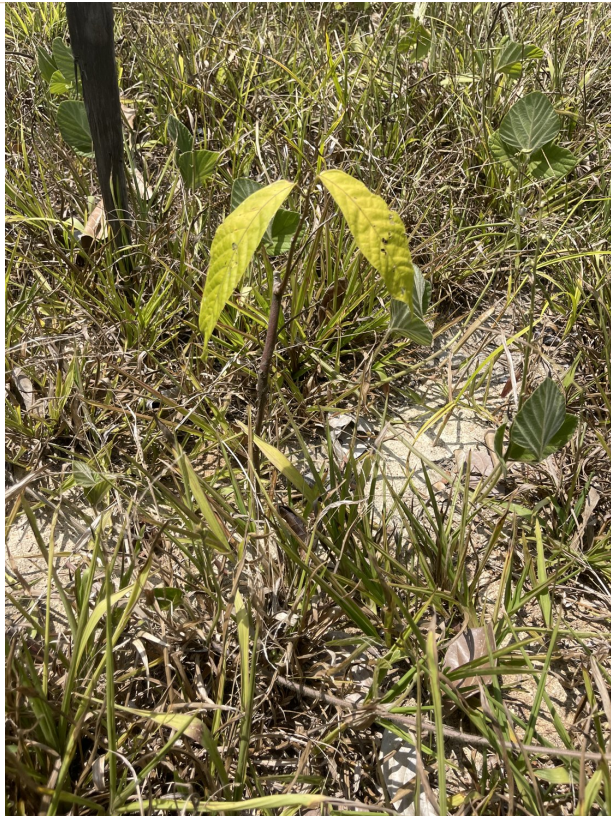
| Visual observation | Preventive control | Examined | Remarks |
|---|---|---|---|
| Microbial contamination (salmonella) | Organic agroforest, no pesticides or artificial chemicals on the certified premise. | Grove walked and inspected on 09-Sep-2026; foliage, pods and floor observed in good condition — no spoilage lesions noted. | Confirmed on visual observation. |
| Insect Infestation | Organic management under native forest shade; natural balance maintained. | No pest outbreak or pod-borer damage observed during the walk. | Confirmed on visual observation. |
| Foreign objects like rocks, dirt, or debris from the field | Selective hand-harvest of mature pods; beans extracted on the property. | Grove floor clear during the walk; no foreign-object contamination source at the harvest area. | Field debris removal is completed at the later drying / sorting stage. |

Facility A – cacao grove, Sítio Cacau na Veia — IMG\_9548, captured 09-Sep-2026 (one of the archived HEIC originals).

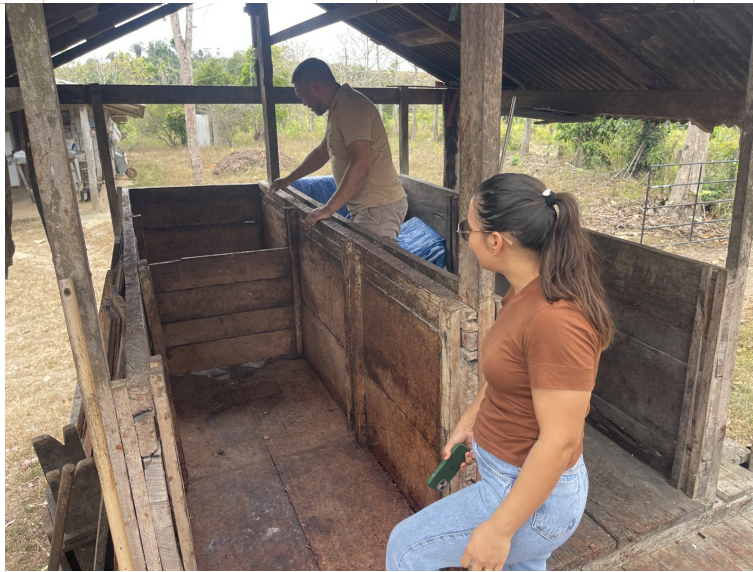
| Visual observation | Preventive control | Examined | Remarks |
|---|---|---|---|
| Undesirable fermentation / microbial contamination | Fermentation in dedicated wooden boxes; batch checked by smell / pH / professional taste (pH target 4.8–5.8). | Three fermentation boxes observed clean and dedicated to cacao; no off-odour. | Structures weathered but functional, consistent with traditional cacao fermentation. |

Facility B – wooden fermentation boxes (barcaças), Sítio Cacau na Veia — IMG\_9506, 09-Sep-2026 10:43:03 local, GPS -3.6093, -51.0337 (alt 106.1 m).

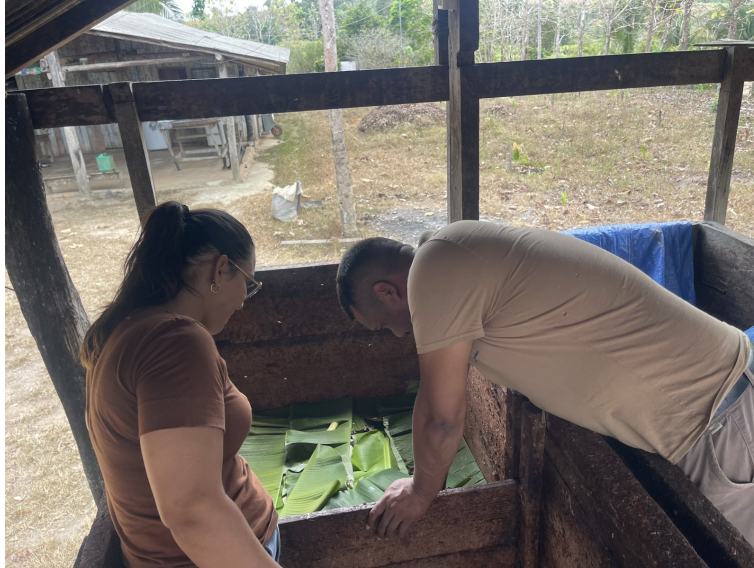
Facility B – fermentation box under inspection, Sítio Cacau na Veia — IMG\_9507, 09-Sep-2026 10:43:08 local, GPS –3.6093, –51.0337 (alt 105.6 m).

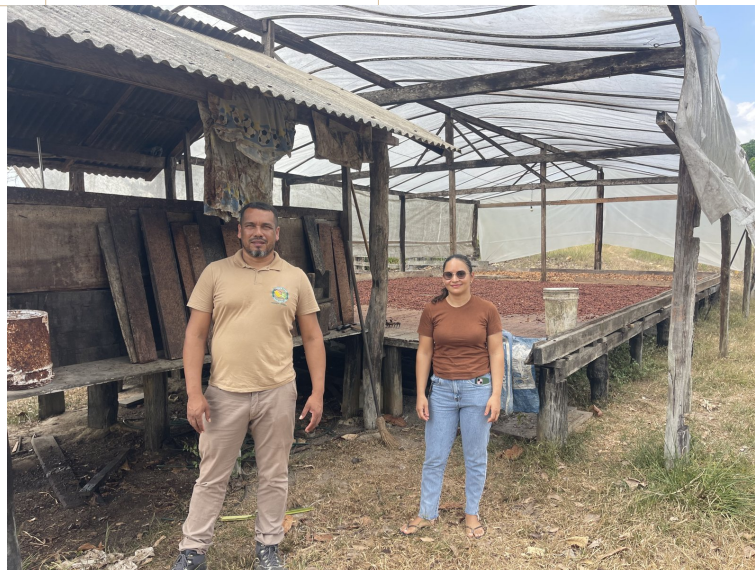
| Visual observation | Preventive control | Examined | Remarks |
|---|---|---|---|
| Mold growth due to improper drying practices | Beans turned over frequently in the sun; drying on raised slatted racks under cover. | Beans spread in thin, even layers in mid-drying stage; no mold or clumping observed. | Confirmed on visual observation. |
| Inclusion of foreign objects during drying and sorting process | Drying and sorting carried out on-site; cleaning of the drying surface between batches. | No debris or foreign objects observed on the racks or in the beans. | Confirmed on visual observation. |
| Residues from cleaning agents or pesticides | Property within the organically certified CEPOTX/COOPCAO system; no cleaning-agent or pesticide residue sources observed. | No chemical residue sources observed at the drying premises. | Confirmed on visual observation. |

Facility C – drying platform with cacao beans, Sítio Cacau na Veia — IMG\_9504, 09-Sep-2026 10:42:43 local, GPS –3.6093, –51.0337 (alt 107.1 m).
