# CEPOTX — Cleide Factory

FSVP Site Inspection Record · TrueSight DAO / Agroverse

For: FDA FSVP compliance — TrueTech Inc (Importer of Record, EIN 88-3411514)  
From: TrueSight DAO / Agroverse — verified on-site inspection record  
Date: 8 September 2026 (photos 15:56–17:00 local)  
Status: Facility completed — inspected post-construction, equipment operational  
Site: Fazenda Cleide — Cleide Maris Suk — site code B-06-108 (CEPOTX / COOPOXIN)

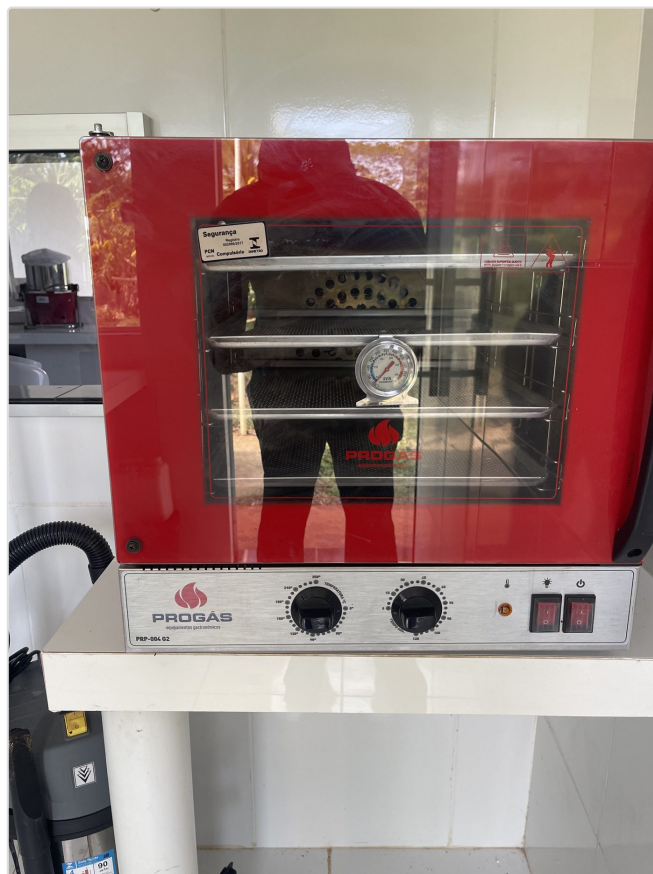
Photo evidence — Cacao roaster (8 Sept 2026)

| Visual observation | Preventive control | Examined | Remarks |
|---|---|---|---|
| <b>Microbial survival during roasting</b> | Roast nibs to 180°C internal for 30 min. | Roaster observed in working order; temperature/time verified on unit. | Roasting kills microbial growth. |
| <b>Equipment hygiene &amp; maintenance</b> | Daily cleaning; full maintenance yearly, parts quarterly; repairs before next batch. | Machine observed clean, good working order. | Confirmed. |
| <b>Sealing / foreign objects</b> | Stove sealed during roasting; regular seal maintenance. | Equipment observed sealed during operation. | Confirmed. |
