# CEPOTX — Cleide Factory

FSVP Site Inspection Record · TrueSight DAO / Agroverse

For: FDA FSVP compliance — TrueTech Inc (Importer of Record, EIN 88-3411514)  
From: TrueSight DAO / Agroverse — verified on-site inspection record  
Date: 8 September 2026 (photos 15:56–17:00 local)  
Status: Facility completed — inspected post-construction, equipment operational  
Site: Fazenda Cleide — Cleide Maris Suk — site code B-06-108 (CEPOTX / COOPOXIN)

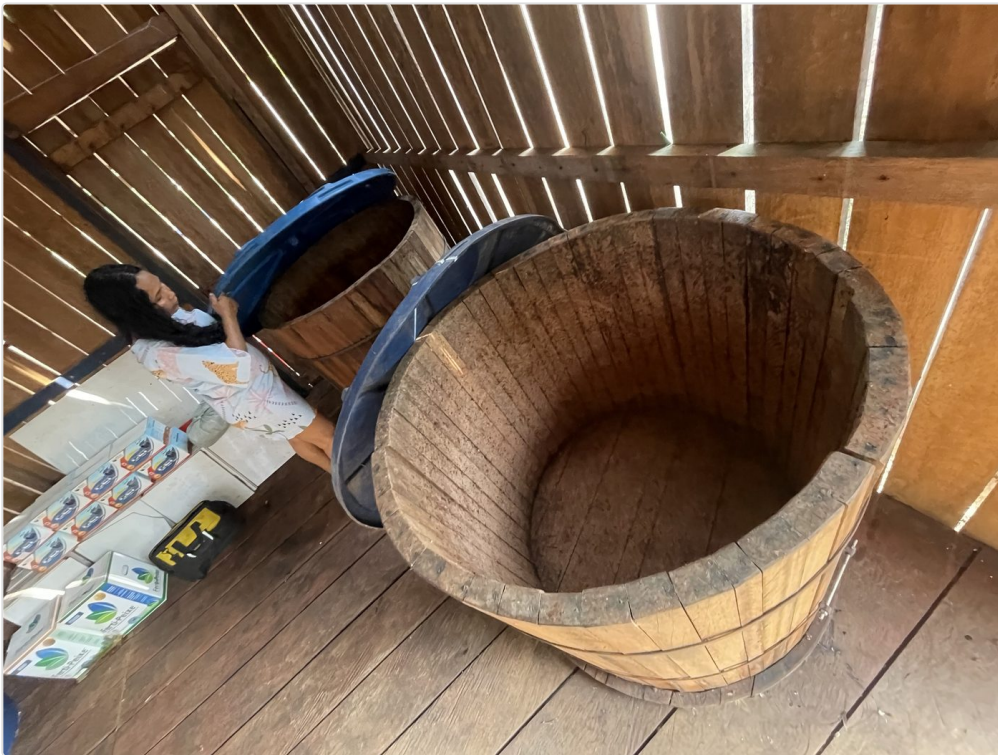
Photo evidence — Cacao fermentation facility (8 Sept 2026)

| Visual observation | Preventive control | Examined | Remarks |
|---|---|---|---|
| <b>Microbial contamination / undesirable fermentation</b> | Dedicated fermentation tank; smell / pH / professional taste batch checks (pH 4.8-5.8 target). | Tank observed clean, dedicated to cacao. | Visual observation confirmed. |
| <b>Chemical cross-contamination</b> | Organic premise; no pesticides / artificial chemicals allowed. | No chemical containers observed in fermentation area. | Visual observation confirmed. |

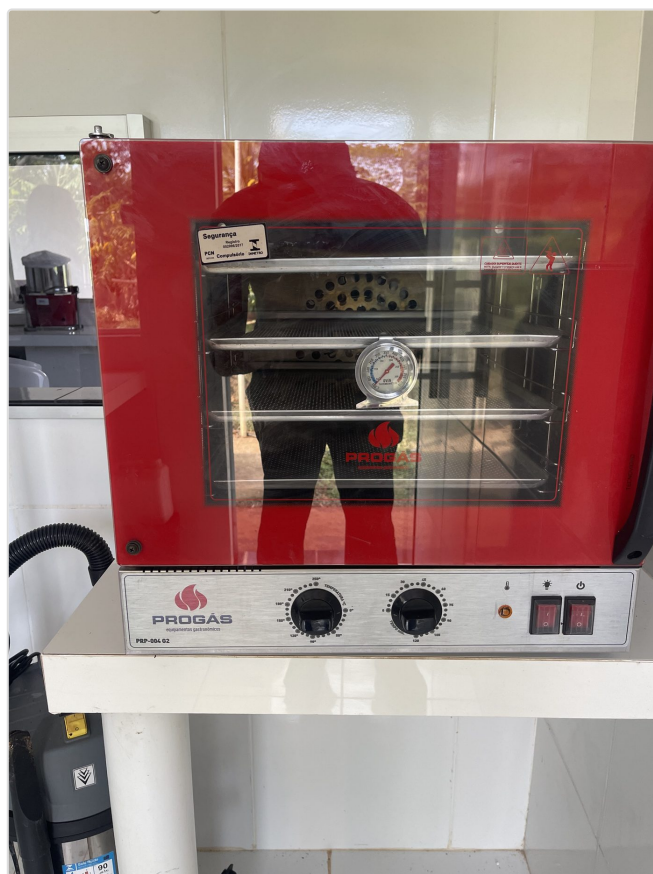
Photo evidence — Cacao roaster (8 Sept 2026)

| Visual observation | Preventive control | Examined | Remarks |
|---|---|---|---|
| <b>Microbial survival during roasting</b> | Roast nibs to 180°C internal for 30 min. | Roaster observed in working order; temperature/time verified on unit. | Roasting kills microbial growth. |
| <b>Equipment hygiene &amp; maintenance</b> | Daily cleaning; full maintenance yearly, parts quarterly; repairs before next batch. | Machine observed clean, good working order. | Confirmed. |
| <b>Sealing / foreign objects</b> | Stove sealed during roasting; regular seal maintenance. | Equipment observed sealed during operation. | Confirmed. |

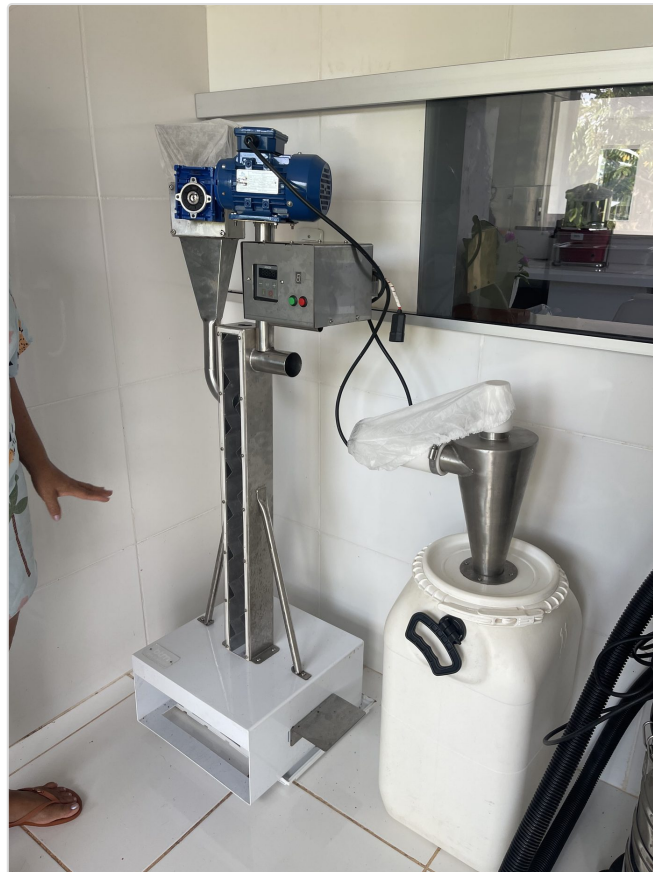
Photo evidence — Winnowing & cracking facility (8 Sept 2026)

| Visual observation | Preventive control | Examined | Remarks |
|---|---|---|---|
| <b>Shell fragments in nibs</b> | Automated cracking + winnowing; visual inspection & sieving. | Winnower/cracker observed in use; shell removal automated. | Only cacao nibs processed. |
| <b>Allergen / cross-contact</b> | Clean & sanitize between batches; cacao only. | No other materials observed processed. | Confirmed. |
| <b>Personnel hygiene</b> | Workers wear hair mesh and gloves. | Hair mesh observed worn. | Confirmed. |

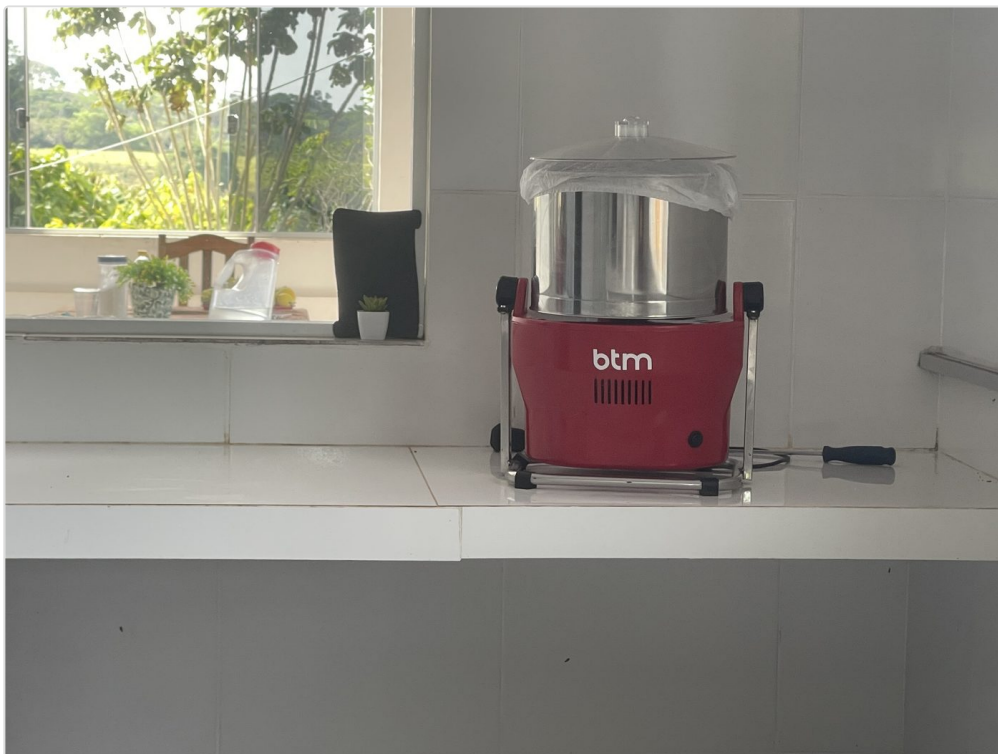
Photo evidence — Melanger (chocolate mass grinding) (8 Sept 2026)

| Visual observation | Preventive control | Examined | Remarks |
|---|---|---|---|
| <b>Metal contamination</b> | Proper maintenance, metal detection; sealed during operation. | Machine good working condition; no metal fragments in cacao mass. | Confirmed. |
| <b>Hygiene between batches</b> | Daily cleaning; openings sealed between uses. | Machine observed clean and sealed when idle. | Confirmed. |

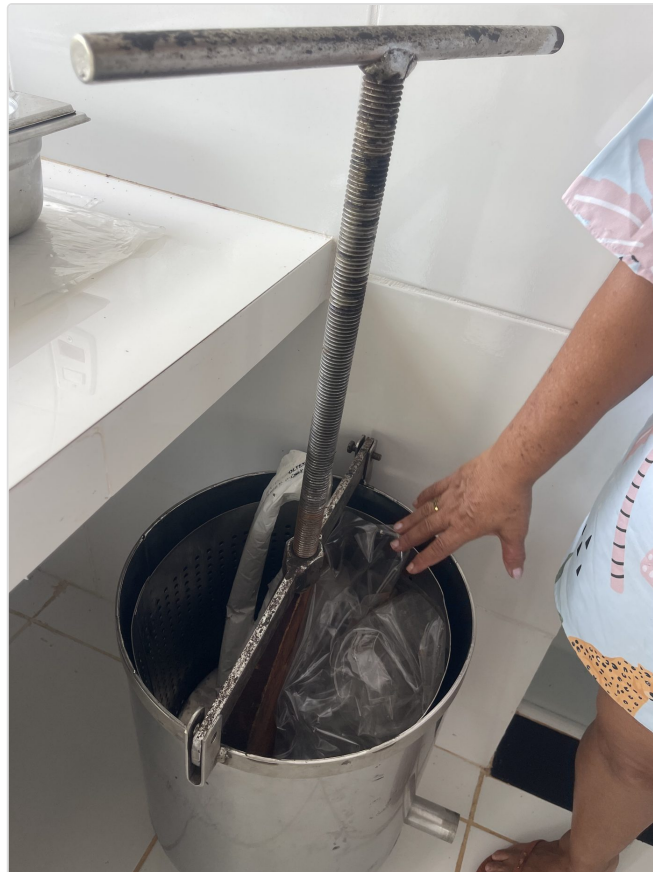
Photo evidence — Cacao juice (honey) press (8 Sept 2026)

| Visual observation | Preventive control | Examined | Remarks |
|---|---|---|---|
| <b>Microbial contamination</b> | Regular cleaning & sanitizing of press; approved rinse agents. | Press observed clean; no visual contamination. | Confirmed. |
| <b>Chemical cross-contamination</b> | Juice extraction isolated from chemical processes. | No evidence of cross-contamination. | Confirmed. |
| <b>Foreign objects</b> | Screens / filters; regular equipment inspection. | No foreign objects observed in juice. | Confirmed. |

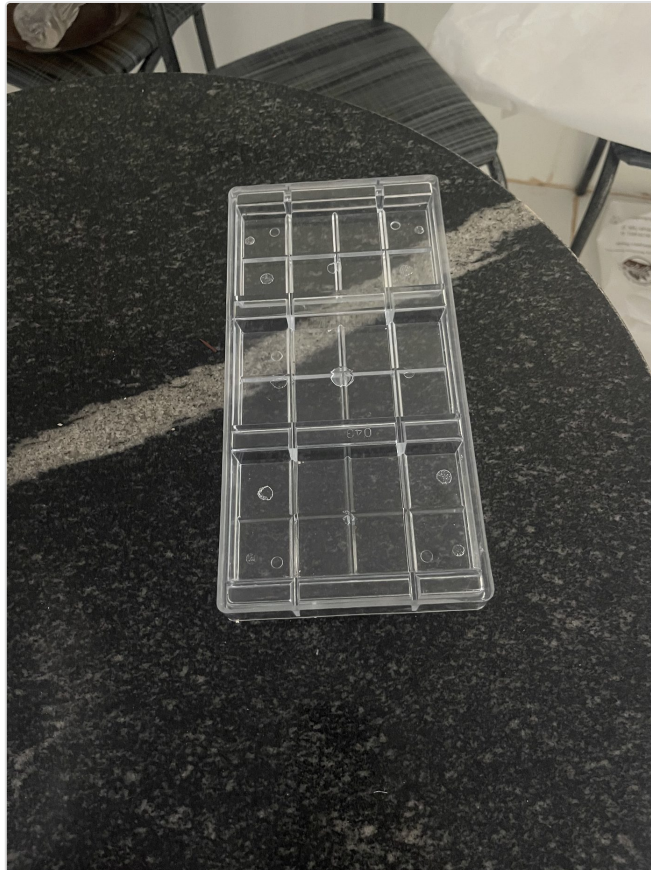
Photo evidence — Chocolate moulding (bars) (8 Sept 2026)

| Visual observation | Preventive control | Examined | Remarks |
|---|---|---|---|
| Hygiene practices | Gloves / masks; regular cleaning & sanitizing of moulds and area. | Moulding area clean; no visual contamination. | Confirmed. |
| Allergen / cross-contact | Facility processes cacao/ chocolate only. | No non-cacao materials observed. | Confirmed. |
| Foreign objects | Inspect moulds; food-grade moulds. | No foreign objects observed in finished bars. | Confirmed. |

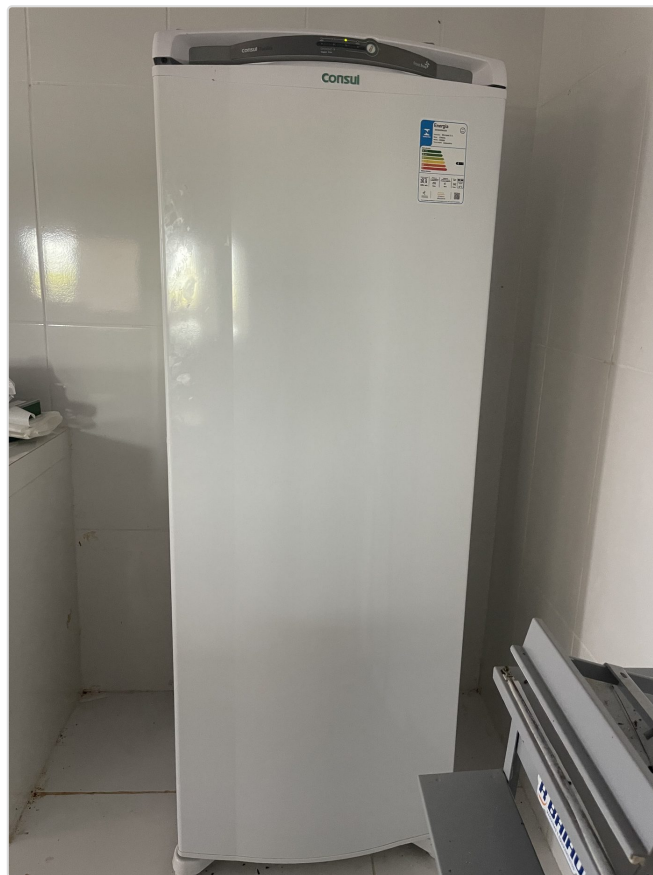
Photo evidence — Fridge / cold-hold (finished chocolate) (8 Sept 2026)

| Visual observation | Preventive control | Examined | Remarks |
|---|---|---|---|
| <b>Temperature control</b> | Monitor & maintain storage temperature within specified range. | Fridge operating; temperature within required range. | Confirmed. |
| <b>Contamination / odours</b> | Separate from strong-smelling products; sealed packaging. | Finished product stored sealed; no off-odours. | Confirmed. |
| <b>Hygiene</b> | Regular cleaning; inspect containers. | Storage clean; containers undamaged. | Confirmed. |

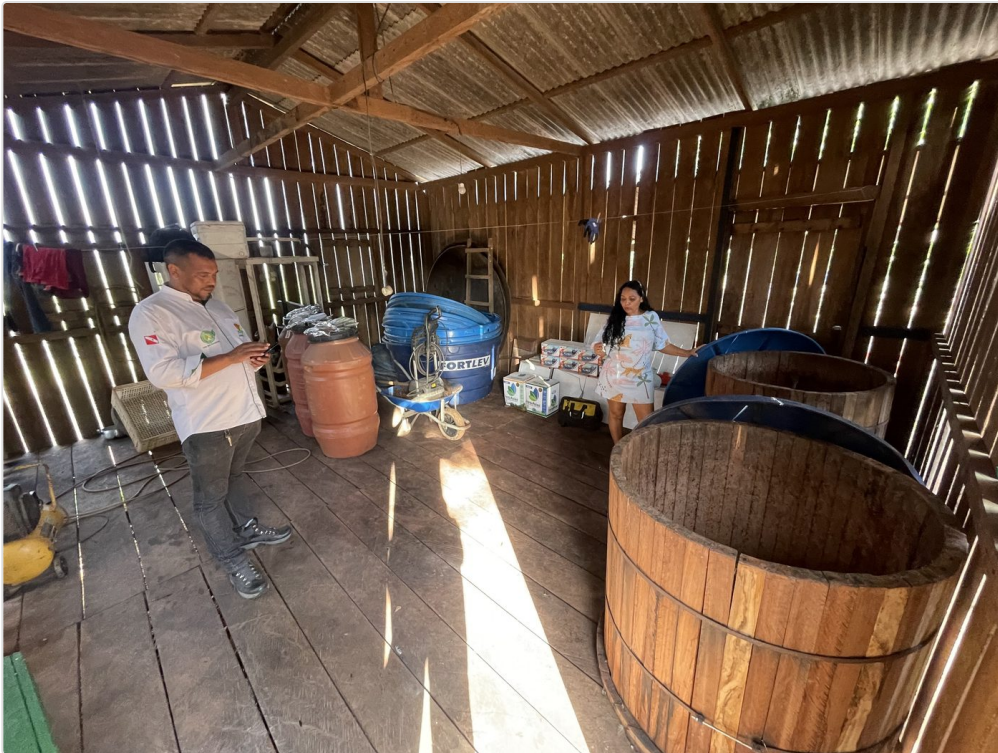
Photo evidence — Storage facility (8 Sept 2026)

| Visual observation | Preventive control | Examined | Remarks |
|---|---|---|---|
| <b>Pest / foreign objects</b> | Store off floor, sealed packaging; regular inspection. | Storage tidy; packaging sealed; no pests observed. | Confirmed. |
| <b>Chemical cross-contamination</b> | Food storage isolated from chemicals. | No chemicals in food storage area. | Confirmed. |
| <b>Hygiene &amp; housekeeping</b> | Regular cleaning & sanitizing of storage area. | Area clean and organised. | Confirmed. |
