## CEPOTX site visit 9th September 2026 — Sítio Cacau na Veia

FSVP Site Inspection Record · TrueSight DAO / Agroverse

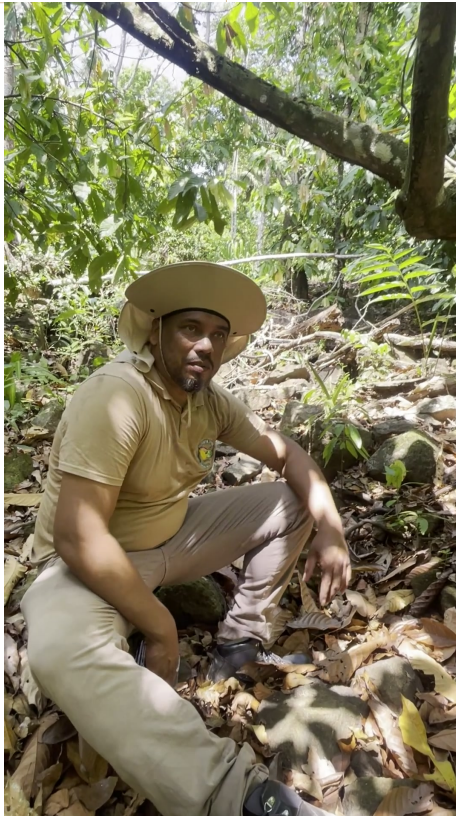
| Visual observation | Preventive control | Examined | Remarks |
|---|---|---|---|
| Microbial contamination (salmonella) | Organic agroforest, no pesticides or artificial chemicals on the certified premise. | Grove walked and inspected on 09-Sep-2026; foliage, pods and floor observed in good condition — no spoilage lesions noted. | Confirmed on visual observation. |
| Insect Infestation | Organic management under native forest shade; natural balance maintained. | No pest outbreak or pod-borer damage observed during the walk. | Confirmed on visual observation. |
| Foreign objects like rocks, dirt, or debris from the field | Selective hand-harvest of mature pods; beans extracted on the property. | Grove floor clear during the walk; no foreign-object contamination source at the harvest area. | Field debris removal is completed at the later drying / sorting stage. |

Facility A – mature cacao agroforest (SAF), Sítio Cacao na Veia — frame from walk video IMG\_9545 (mature hybrid cacao, 35+ yr; ~22,000 plants over 22 ha), captured 09-Sep-2026.
