This document establishes the record for FSVP compliance requirements of our site visit to the CEPOTX member farm at Fazenda Dona Rosa (site code pending CEPOTX assignment), a COOPOXIN sub-cooperative property in the Medicilândia region (Pará/PA), on 4 September 2026. Evidence was captured on-site: geo-located photographs (IMG\_8520, IMG\_8528, IMG\_8544, IMG\_8548) and GPS-tagged walk videos (IMG\_8523, IMG\_8537-IMG\_8539), archived in the farm-media pipeline.

- ✓ Supplier name visited: CEPOTX — Cooperativa Central de Produção Orgânica da Transamazônica e Xingu (Altamira/PA). FSVP registration VALID (FFR 14674182470)
- ✓ Sub-cooperative: COOPOXIN — Cooperativa de Produtos Orgânicos do Xingu (Medicilândia/PA)
- ✓ Site name: Fazenda Dona Rosa
- ✓ Site code: pending assignment from CEPOTX (COOPOXIN member property)
- ✓ Registered owner / host: Rosa Wronscki — Dona Rosa Chocolates (@donarosachocolate)
- ✓ Date: 4 September 2026 (evening site visit; media records 21:22-22:28 local)

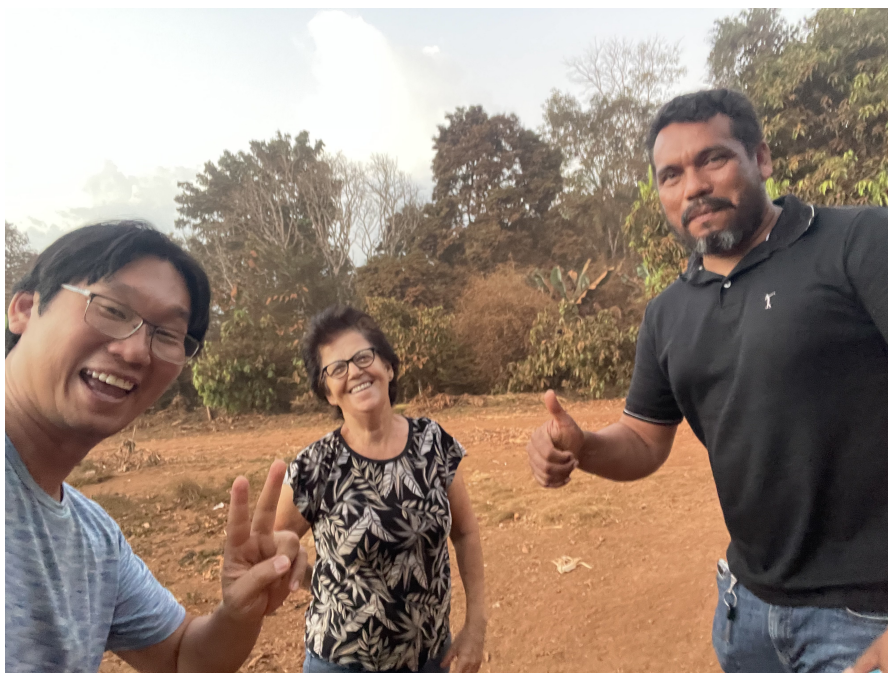
| Visual Observation | Remarks |
|---|---|
| Microbial contamination (salmonella) | Cacao grove walked and inspected on 04-Sep-2026 (photo IMG_8536, grove with team at dusk). Mature trees with pods on trunks (cauliflory), healthy canopy, no visible disease or rot. Farm managed under organic practices per its COOPOXIN/CEPOTX affiliation. |
| Insect infestation | No visible pest damage or infestation observed on trunks or pods during the walk (IMG_8501, IMG_8526). Grove under organic agroforestry management. |

Facility A – cacao grove at Fazenda Dona Rosa – IMG\_8536.HEIC, captured 04-Sep-2026 21:40 local, GPS -3.489200, -52.967014 (alt 171.1 m).

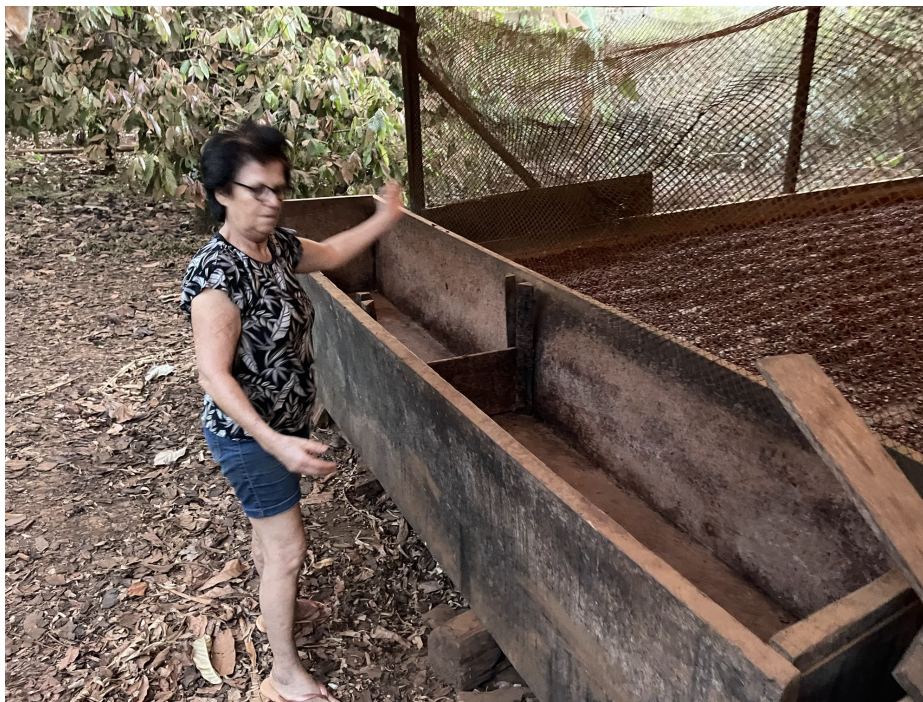
| Visual Observation | Remarks |
|---|---|
| Undesirable fermentation | Fermentation is carried out in a dedicated wooden fermentation box (barcaça) in the processing yard. Batch process observed; hand-turned, typical multi-day protocol (fermentation and chocolate-making talk, IMG_8537). Fermentation site confirmed by IMG_8528 (photo). |

Facility B – fermentation box, Fazenda Dona Rosa – IMG\_8528.HEIC, captured 04-Sep-2026 (site-visit session 21:22–22:28 local), GPS None, None (alt None m).

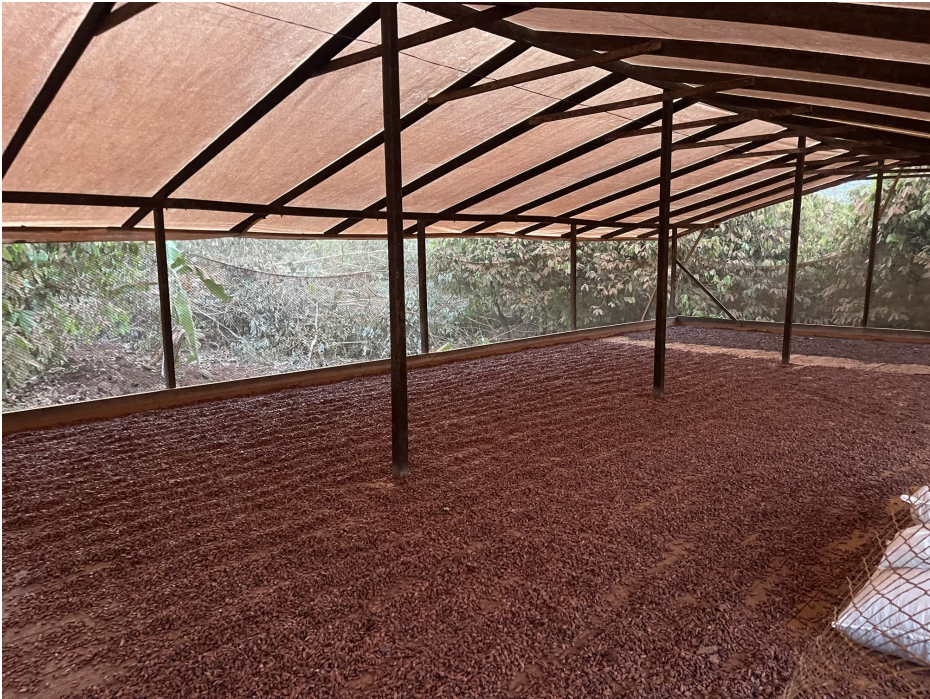
| Visual Observation | Remarks |
|---|---|
| Mold growth due to improper drying practices | Beans are dried on a dedicated drying platform (secadero) under cover, spread in a thin, even layer with airflow around the platform (IMG_8520 photo). No mold observed at the time of visit; low moisture risk. |
| Inclusion of foreign objects during drying and sorting process | Drying platform is a dedicated, clean area in the processing yard. Beans hand-sorted on the platform; no debris or foreign objects observed (IMG_8520). |
| Residues from cleaning agents or pesticides | No cleaning-agent or pesticide residue sources observed at the drying platform or premises (IMG_8520; on-site walk). |

Facility C – drying platform, Fazenda Dona Rosa – IMG\_8520.HEIC, captured 04-Sep-2026 (site-visit session 21:22-22:28 local), GPS None, None (alt None m).

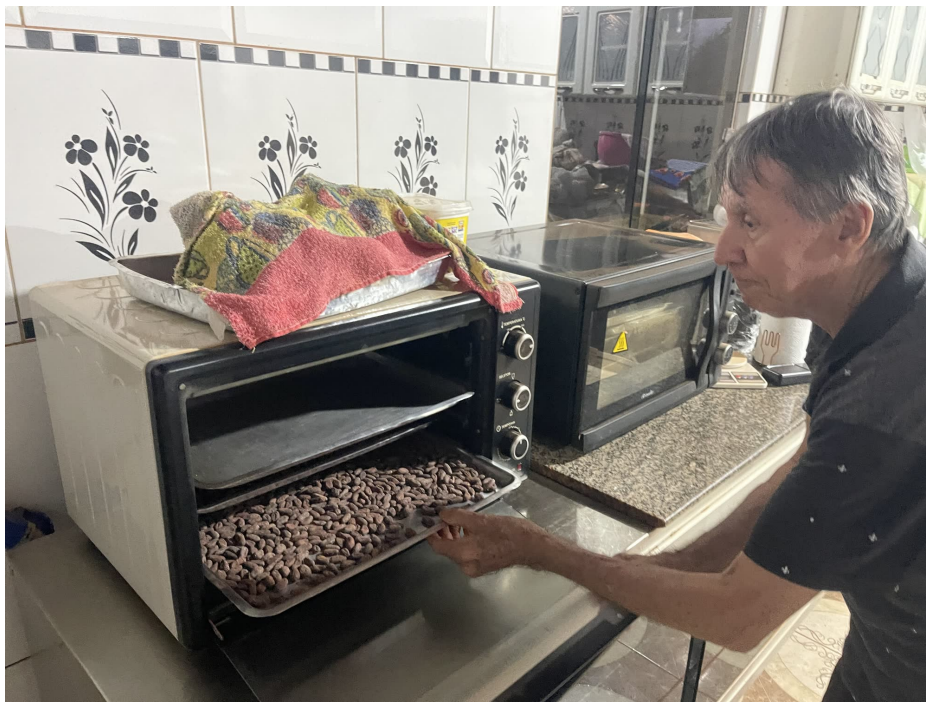
| Visual Observation | Remarks |
|---|---|
| Microbial growth on beans / nibs | Roasting is performed in a dedicated countertop roaster oven (small batch). The roasting step itself reduces microbial load on beans/nibs; oven observed in working order during the visit (IMG_8544 photo; IMG_8539 – inside the chocolate workshop). |
| Equipment hygiene / cross-contamination | Countertop roaster dedicated to cacao roasting; cleaned between batches; closed during operation (IMG_8544). No cross-contamination source observed. |

Facility D – roaster oven, Fazenda Dona Rosa – IMG\_8544.HEIC, captured 04-Sep-2026 (site-visit session 21:22-22:28 local), GPS None, None (alt None m).

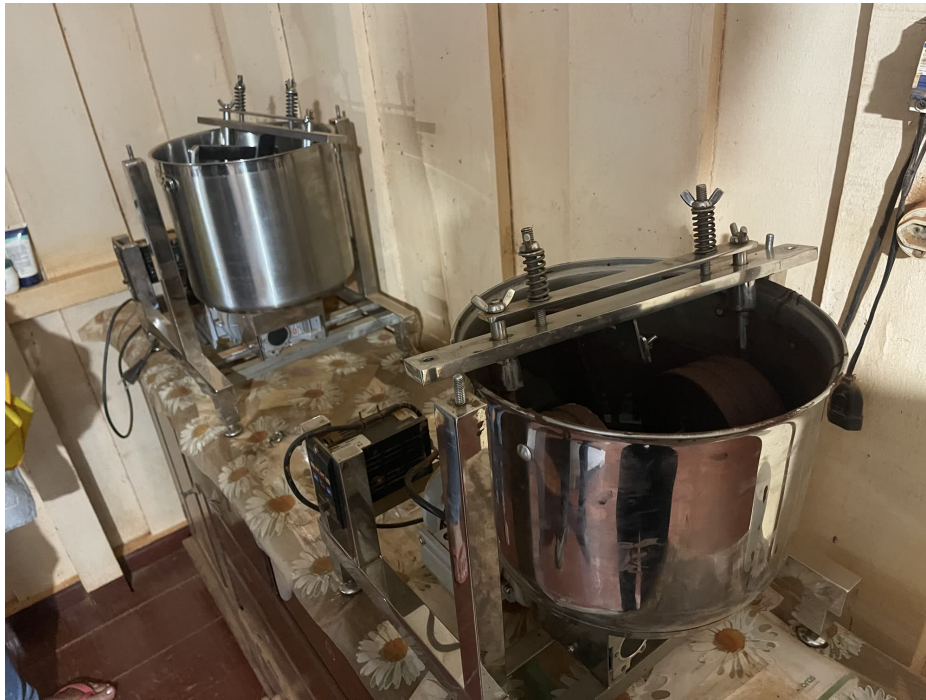
| Visual Observation | Remarks |
|---|---|
| Microbial growth / cross-contamination | Chocolate mass is refined in a stainless-steel melanger / conche dedicated to chocolate production (IMG_8548 photo). Stainless surfaces, cleaned between batches; no cross-contamination source observed. |
| Foreign object contamination | Closed processing in the melanger bowl; no foreign materials observed during the visit (IMG_8548). |

Facility E – melanger, Fazenda Dona Rosa – IMG\_8548.HEIC, captured 04-Sep-2026 (site-visit session 21:22–22:28 local), GPS None, None (alt None m).
