## CEPOTX site visit 9th September 2026 — Sítio Torres

### Supplier and visit dates

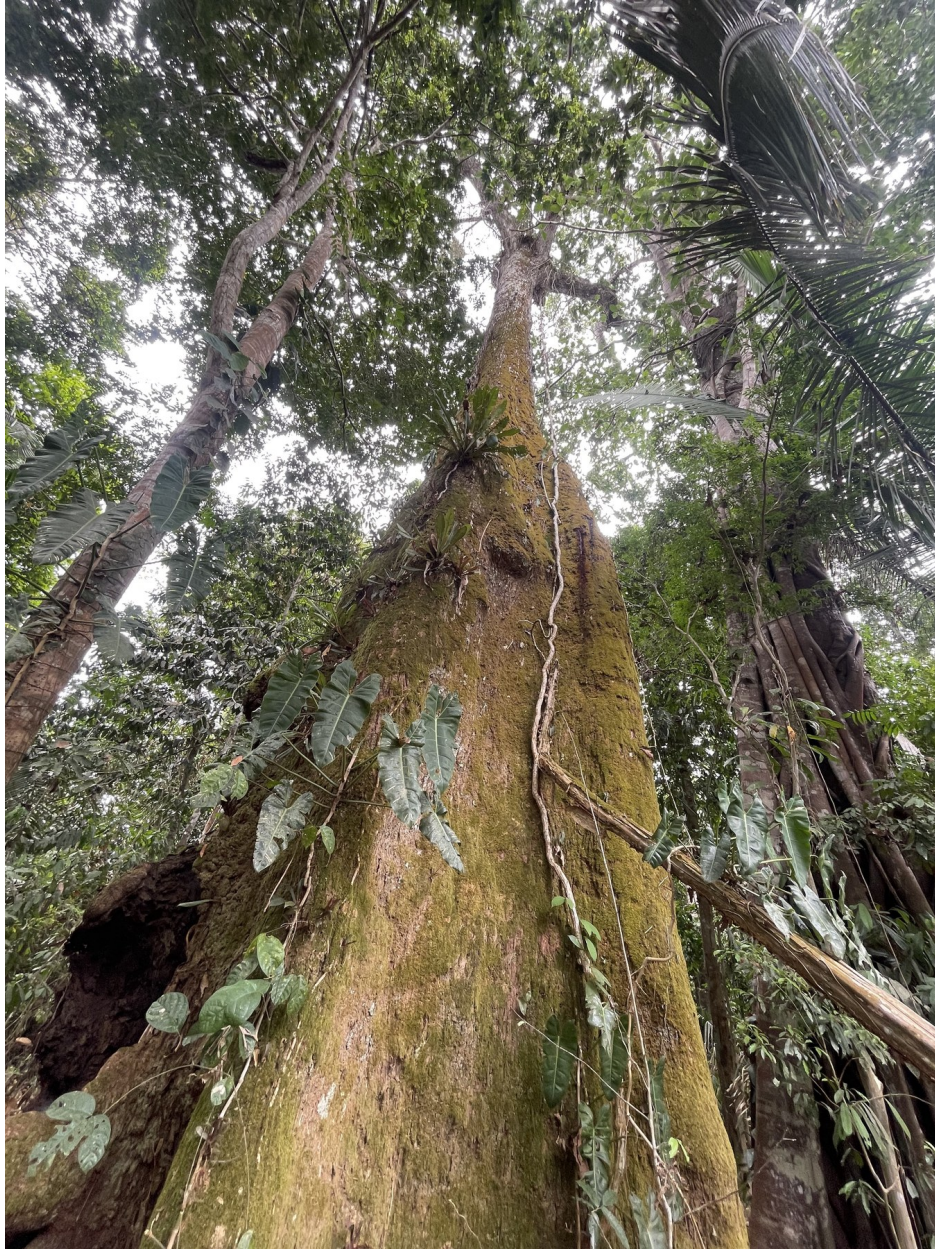
| Visual Observation | Remarks |
|---|---|
| Microbial Contamination (salmonella) | Existing cacao grove walked and inspected on 09-Sep-2026 (videos IMG_9623, IMG_9624, IMG_9630). Managed organically under the CEPOTX/CoopCao IBD NOP system. Cacao verdadeiro/híbrido across blocks aged 2/4/5 yr plus a >20 yr block (Alexandre's narration, IMG_9624). Enrichment planting ("enriquecimento") into standing capoeira (IMG_9630). |
| Insect Infestation | Organic agroforestry under native shade — cumaru (native Amazon) planted through the grove (IMG_9623/IMG_9624). No pest outbreak observed during the walk. |
| Foreign objects like rocks, dirt, or debris from the field | Pods harvested selectively by hand; grove floor clear during the walk. No foreign-object contamination source observed at the harvest area. |

Facility A – cacao grove, Sítio Torres (photo from 09-Sep-2026 site walk; one of the 38 archived HEIC originals).

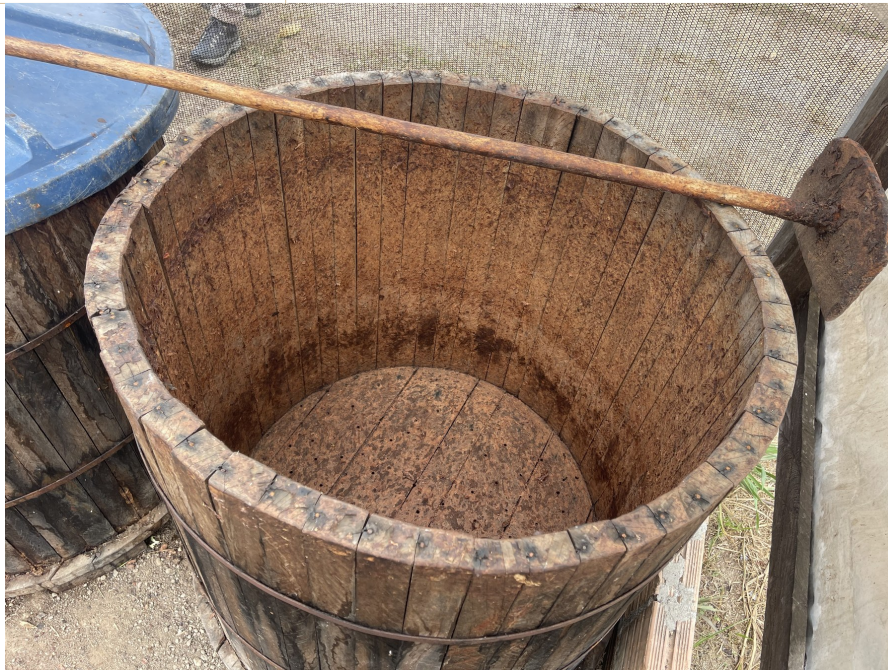
| Visual Observation | Remarks |
|---|---|
| Undesirable Fermentation | Fermentation is carried out in wooden vessels/tanks housed inside the on-site covered processing structure (screened walls, translucent roof over a brick footing) — the SAME physical structure used for sun-drying (see Facility C). Documented in photo evidence IMG_9677 (wooden fermentation vessel inside the structure) and IMG_9673 (the covered structure itself), plus walk clip IMG_9678 (“fermentação... tanque... este aberto”). Regime details (box construction, days, turning) to be confirmed — <i>[PENDING]</i> . |
| Inclusion of non-cacao materials in fermentation containers | Only cacao beans are placed in the fermentation vessels; the structure is dedicated to cacao processing (IMG_9677 vessel + IMG_9673 structure + IMG_9678 walk-through). No non-cacao material observed in the container during the visit. |

Facility B – wooden fermentation vessel (barrel/box) inside the covered processing structure, Sítio Torres – IMG\_9677.HEIC, captured 09-Sep-2026 13:22:07 local, GPS –3.5299, –51.1451 (alt 86.5 m).

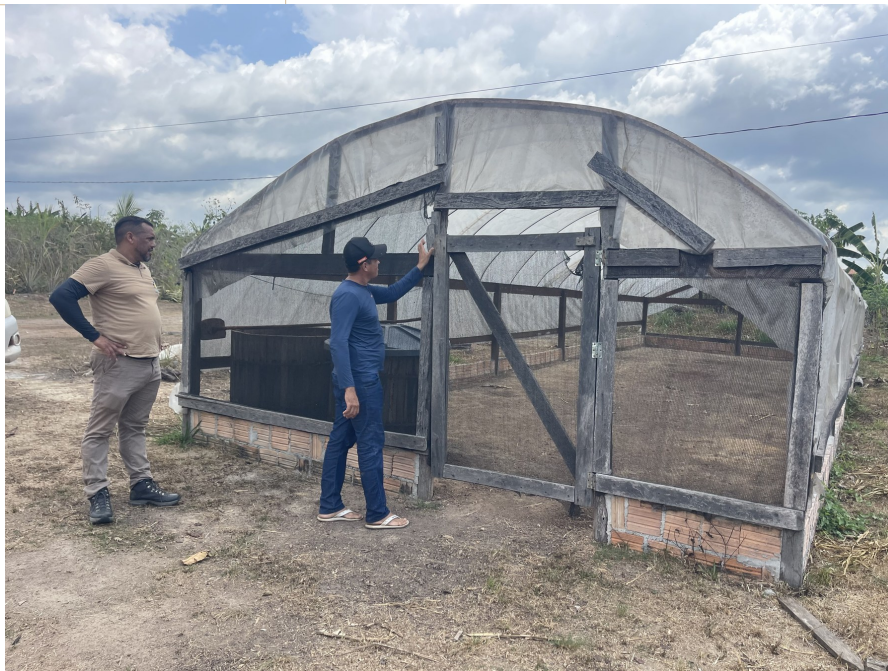
| Visual Observation | Remarks |
|---|---|
| Mold growth due to improper drying practices | Sun-drying (“secagem”, IMG_9703) is carried out on-site under the covered processing structure (screened walls, translucent roof, brick footing — IMG_9673), the SAME physical structure in which the fermentation vessels are housed (Facility B). No mold observed at the time of visit. Drying-regime details (bed surface, batch depth, turning) to be confirmed — <i>[PENDING]</i> . |
| Inclusion of foreign objects during drying and sorting process | Beans dried and sorted on-site under the covered structure; no debris or foreign objects observed. Dedicated clean drying-surface details to be confirmed — <i>[PENDING]</i> . |

Facility C – the covered processing structure (screened walls, translucent roof on a brick footing) under which sun-drying is carried out and in which the fermentation vessels are housed — the same structure shown under Facility B. Sítio Torres – IMG\_9673.HEIC, captured 09-Sep-2026 13:21:37 local, GPS –3.5298, –51.1451 (alt 83.2 m).

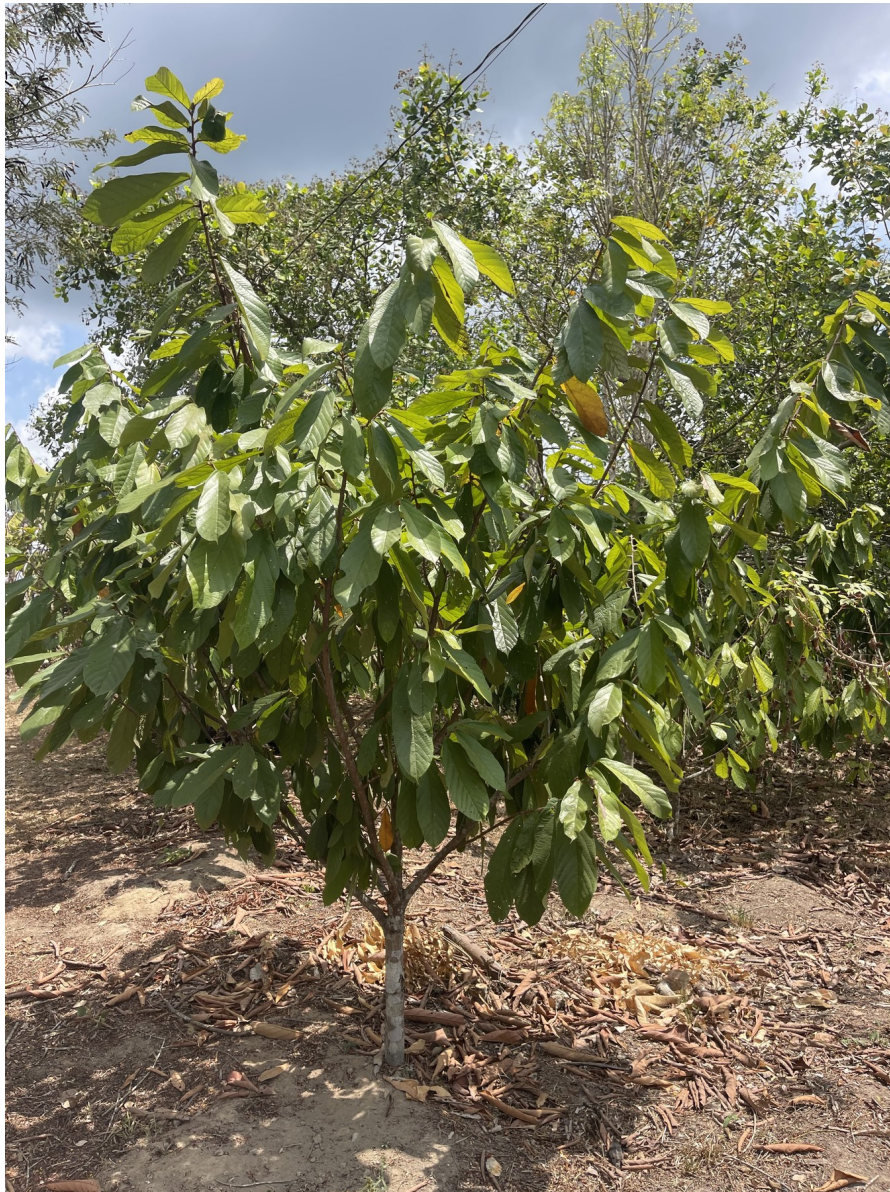
Sítio Torres – cacao plant growth: young cacao tree in vegetative stage (dense oblong-leaf canopy, slender trunk) within the grove – IMG\_9682.HEIC, captured 09-Sep-2026 13:27:44 local, GPS –3.5298, –51.1451.
