# TrueSight DAO · FSVP Site Inspection

CEPOTX — Cleide factory (bean-to-bar facilities)

For: FDA FSVP compliance — TrueTech Inc (Importer of Record, EIN 88-3411514)  
From: TrueSight DAO / Agroverse — verified on-site inspection record  
Date: 8 September 2026 (photos 15:56–17:00 local)  
Status: Facility completed — inspected post-construction, equipment operational  
Site: Fazenda Cleide — Cleide Maris Suk — site code B-06-108 (CEPOTX / COOPOXIN)

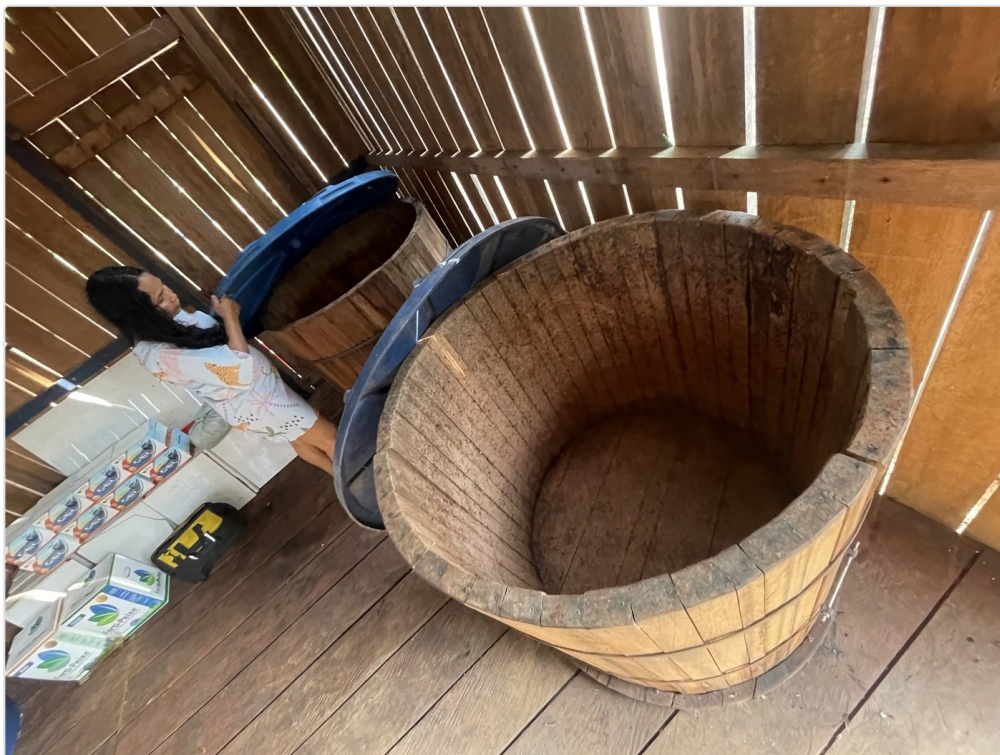
Photo evidence — Cacao fermentation facility (8 Sept 2026)

Fermentation in dedicated tank on premise; nothing else processed in the fermentation house. Premise is organically certified - no pesticides or artificial chemicals on site.

| Visual observation | Preventive control | Examined | Remarks |
|---|---|---|---|
| <b>Microbial contamination / undesirable fermentation</b> | Dedicated fermentation tank; smell / pH / professional taste batch checks (pH 4.8-5.8 target). | Tank observed clean, dedicated to cacao. | Visual observation confirmed. |
| <b>Chemical cross-contamination</b> | Organic premise; no pesticides / artificial chemicals allowed. | No chemical containers observed in fermentation area. | Visual observation confirmed. |

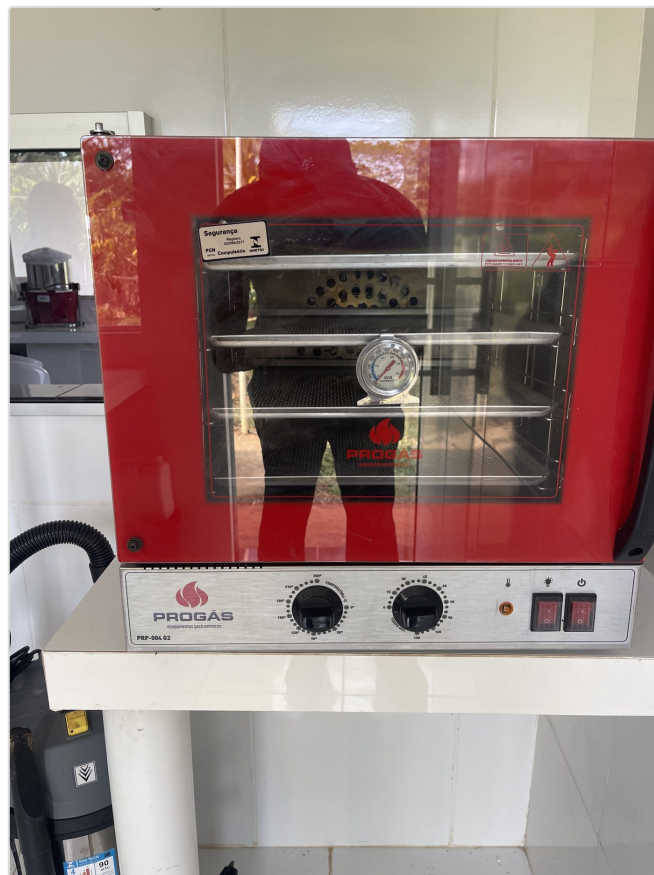
Photo evidence — Cacao roaster (8 Sept 2026)

Batch roaster. Roasting process kills off microbial growth - internal cacao nib temperature reaches 180°C for 30 minutes.

| Visual observation | Preventive control | Examined | Remarks |
|---|---|---|---|
| <b>Microbial survival during roasting</b> | Roast nibs to 180°C internal for 30 min. | Roaster observed in working order; temperature/time verified on unit. | Roasting kills microbial growth. |
| <b>Equipment hygiene &amp; maintenance</b> | Daily cleaning; full maintenance yearly, parts quarterly; repairs before next batch. | Machine observed clean, good working order. | Confirmed. |
| <b>Sealing / foreign objects</b> | Stove sealed during roasting; regular seal maintenance. | Equipment observed sealed during operation. | Confirmed. |

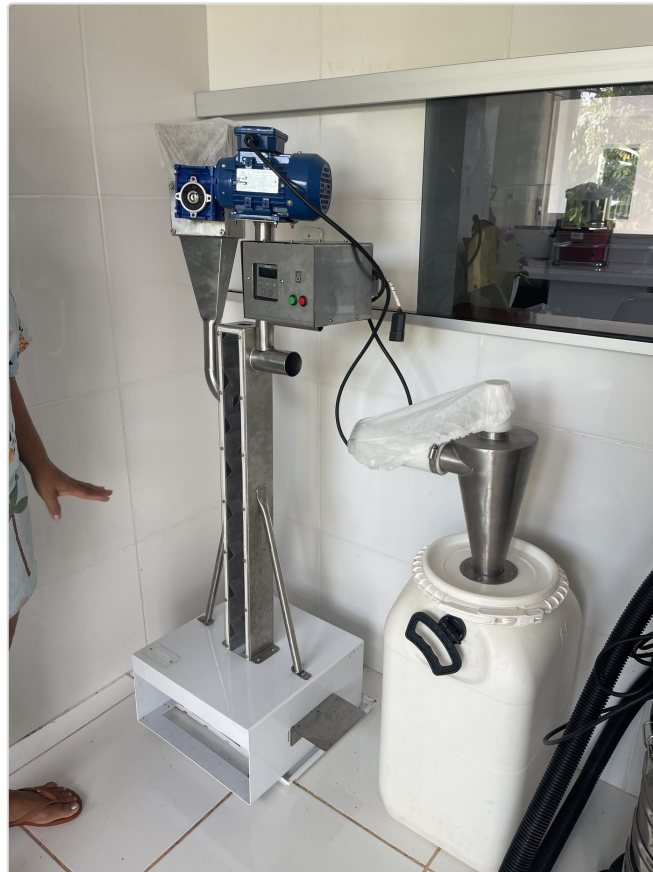
Photo evidence — Winnowing & cracking facility (8 Sept 2026)

Cracker + winnower remove shell fragments after roasting; only cacao nibs processed here.

| Visual observation | Preventive control | Examined | Remarks |
|---|---|---|---|
| <b>Shell fragments in nibs</b> | Automated cracking + winnowing; visual inspection & sieving. | Winnower/cracker observed in use; shell removal automated. | Only cacao nibs processed. |
| <b>Allergen / cross-contact</b> | Clean & sanitize between batches; cacao only. | No other materials observed processed. | Confirmed. |
| <b>Personnel hygiene</b> | Workers wear hair mesh and gloves. | Hair mesh observed worn. | Confirmed. |

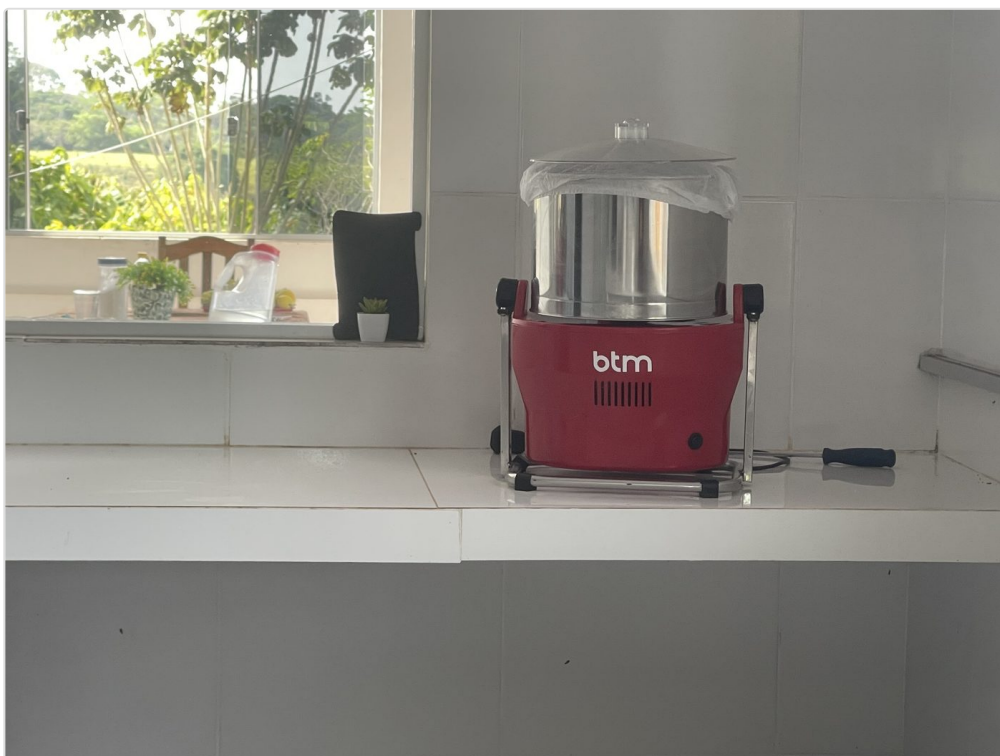
Photo evidence — Melanger (chocolate mass grinding) (8 Sept 2026)

| Visual observation | Preventive control | Examined | Remarks |
|---|---|---|---|
| <b>Metal contamination</b> | Proper maintenance, metal detection; sealed during operation. | Machine good working condition; no metal fragments in cacao mass. | Confirmed. |
| <b>Hygiene between batches</b> | Daily cleaning; openings sealed between uses. | Machine observed clean and sealed when idle. | Confirmed. |

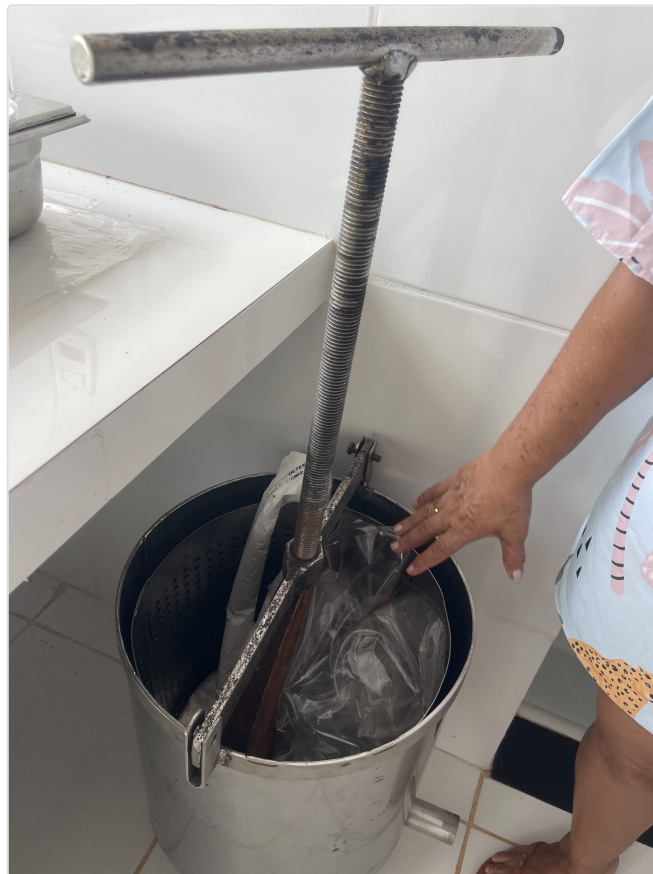
Photo evidence — Cacao juice (honey) press (8 Sept 2026)

| Visual observation | Preventive control | Examined | Remarks |
|---|---|---|---|
| <b>Microbial contamination</b> | Regular cleaning & sanitizing of press; approved rinse agents. | Press observed clean; no visual contamination. | Confirmed. |
| <b>Chemical cross-contamination</b> | Juice extraction isolated from chemical processes. | No evidence of cross-contamination. | Confirmed. |
| <b>Foreign objects</b> | Screens / filters; regular equipment inspection. | No foreign objects observed in juice. | Confirmed. |

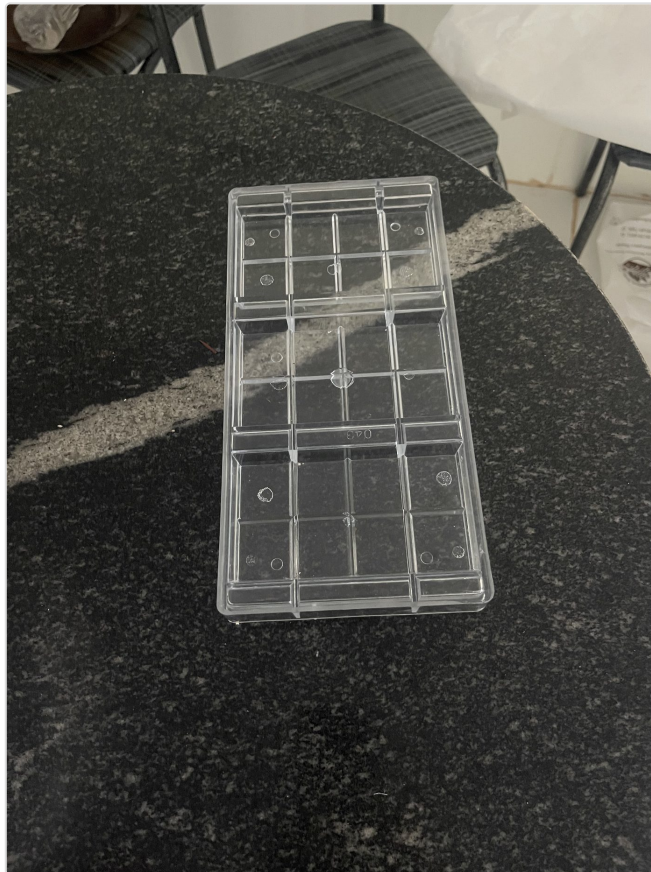
Photo evidence — Chocolate moulding (bars) (8 Sept 2026)

| Visual observation | Preventive control | Examined | Remarks |
|---|---|---|---|
| <b>Hygiene practices</b> | Gloves / masks; regular cleaning & sanitizing of moulds and area. | Moulding area clean; no visual contamination. | Confirmed. |
| <b>Allergen / cross-contact</b> | Facility processes cacao/ chocolate only. | No non-cacao materials observed. | Confirmed. |
| <b>Foreign objects</b> | Inspect moulds; food-grade moulds. | No foreign objects observed in finished bars. | Confirmed. |

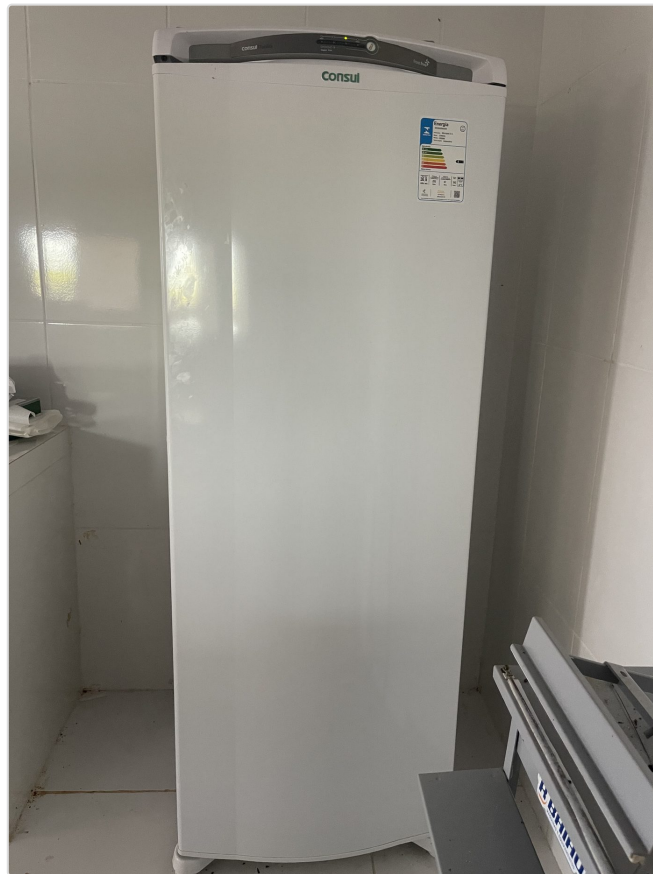
Photo evidence — Fridge / cold-hold (finished chocolate) (8 Sept 2026)

| Visual observation | Preventive control | Examined | Remarks |
|---|---|---|---|
| <b>Temperature control</b> | Monitor & maintain storage temperature within specified range. | Fridge operating; temperature within required range. | Confirmed. |
| <b>Contamination / odours</b> | Separate from strong-smelling products; sealed packaging. | Finished product stored sealed; no off-odours. | Confirmed. |
| <b>Hygiene</b> | Regular cleaning; inspect containers. | Storage clean; containers undamaged. | Confirmed. |

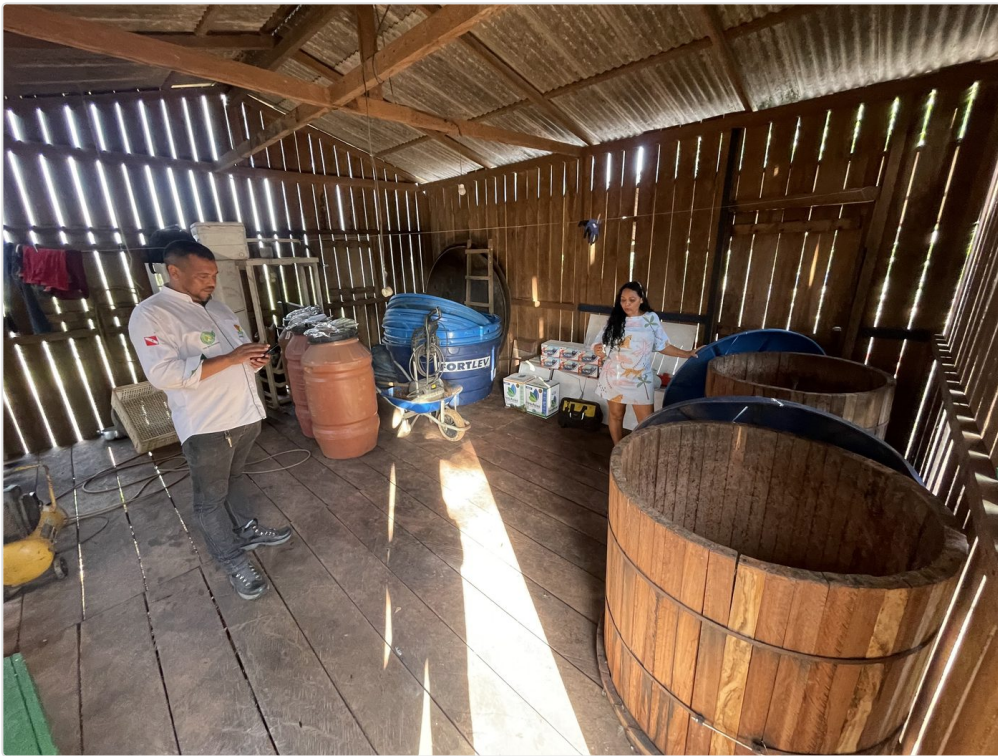
Photo evidence — Storage facility (8 Sept 2026)

| Visual observation | Preventive control | Examined | Remarks |
|---|---|---|---|
| <b>Pest / foreign objects</b> | Store off floor, sealed packaging; regular inspection. | Storage tidy; packaging sealed; no pests observed. | Confirmed. |
| <b>Chemical cross-contamination</b> | Food storage isolated from chemicals. | No chemicals in food storage area. | Confirmed. |
| <b>Hygiene &amp; housekeeping</b> | Regular cleaning & sanitizing of storage area. | Area clean and organised. | Confirmed. |
