## CEPOTX site visit 3rd September 2026

This document establishes record for FSVP compliance requirements of our site visit to the CEPOTX facility at Fazenda Santa Rosa (site code U-06-06), a member farm of the COPOPS sub-cooperative (Uruará/PA), on 3rd September 2026. Evidence was captured as GPS-tagged walk videos and photos, archived in the media archive and published on the Fazenda Santa Rosa farm page.

| <b>Site name:</b> | Fazenda Santa Rosa |

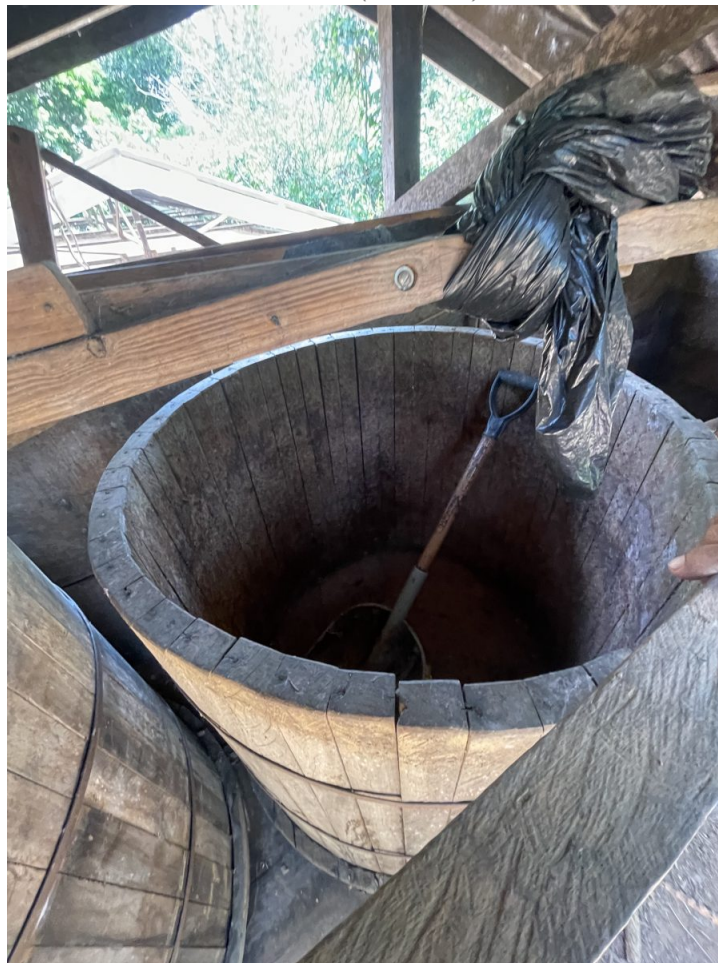
| <b>Undesirable Fermentation</b> | Fermentation is carried out at a dedicated fermentation station on the farm (IMG_8328 — fermentation station photo, 03-Sep-2026). Fermentation practice is managed to avoid putrefaction and maintain controlled, quality-oriented fermentation. |
| <b>Inclusion of non-cacao materials in fermentation containers</b> | Only cacao beans are handled in the fermentation area; the station is dedicated to fermentation. No non-cacao material observed in the containers during the visit. |

Facility B — fermentation station at Fazenda Santa Rosa — IMG\_8328.HEIC, captured 03-Sep-2026 14:15:27 local, GPS -3.634142, -53.670319 (alt 161.4 m).

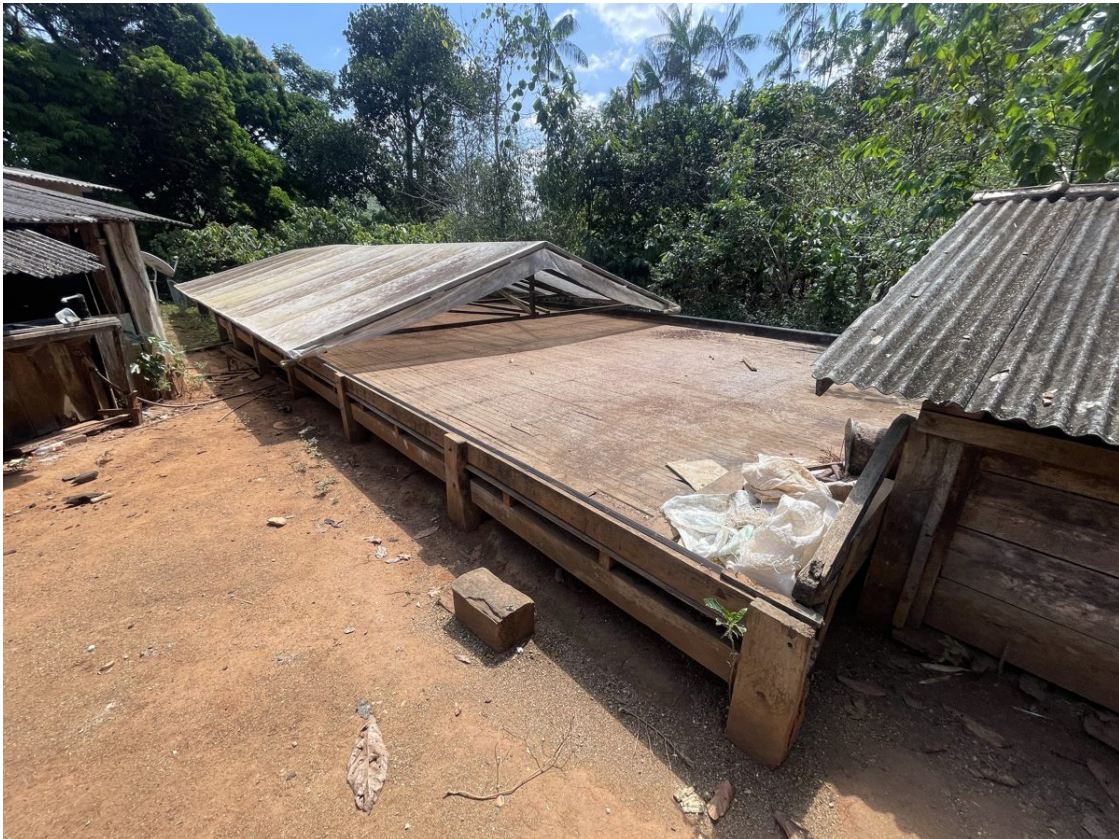
| <b>Mold growth due to improper drying practices</b> | Beans are dried at the dedicated drying station (IMG_8327 — drying station photo, 03-Sep-2026). Sun-exposed, thin-layer drying observed at the station. No mold observed at the time of visit. |
| <b>Inclusion of foreign objects during drying and sorting process</b> | The drying station is a dedicated area adjacent to the fermentation station (IMG_8327/IMG_8328). Beans handled on the drying surface only; no debris or foreign objects observed. |

*Facility C — drying station at Fazenda Santa Rosa — IMG\_8327.HEIC, captured 03-Sep-2026 14:15:16 local, GPS -3.634142, -53.670254 (alt 159.0 m).*
