## CEPOTX site visit 9th September 2026 — Sítio Torres

### Supplier and visit dates

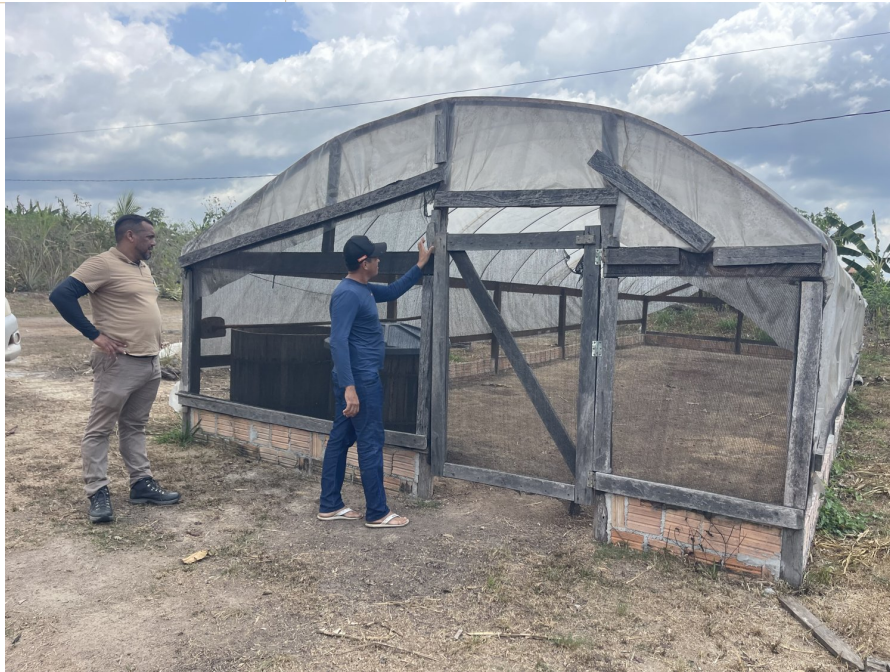
| Visual Observation | Remarks |
|---|---|
| Undesirable Fermentation | Fermentation is carried out in a wooden box / vessel on-site, documented in photo evidence IMG_9673 (screened processing structure) and IMG_9677 (wooden fermentation vessel, 13:22 local), plus walk clip IMG_9678 (“fermentação... tanque... este aberto”). Regime details (box construction, days, turning) to be confirmed — [PENDING]. |
| Inclusion of non-cacao materials in fermentation containers | Only cacao beans are placed in the fermentation vessel; the structure is dedicated to cacao (IMG_9673/IMG_9677 + IMG_9678 walk-through). No non-cacao material observed in the container during the visit. |

Facility B – screened processing structure with fermentation vessel area, Sítio Torres – IMG\_9673.HEIC, captured 09-Sep-2026 13:21:37 local, GPS -3.5298, -51.1451 (alt 83.2 m).
