## CEPOTX site visit 9th September 2026 — Sítio Torres

### Supplier and visit dates

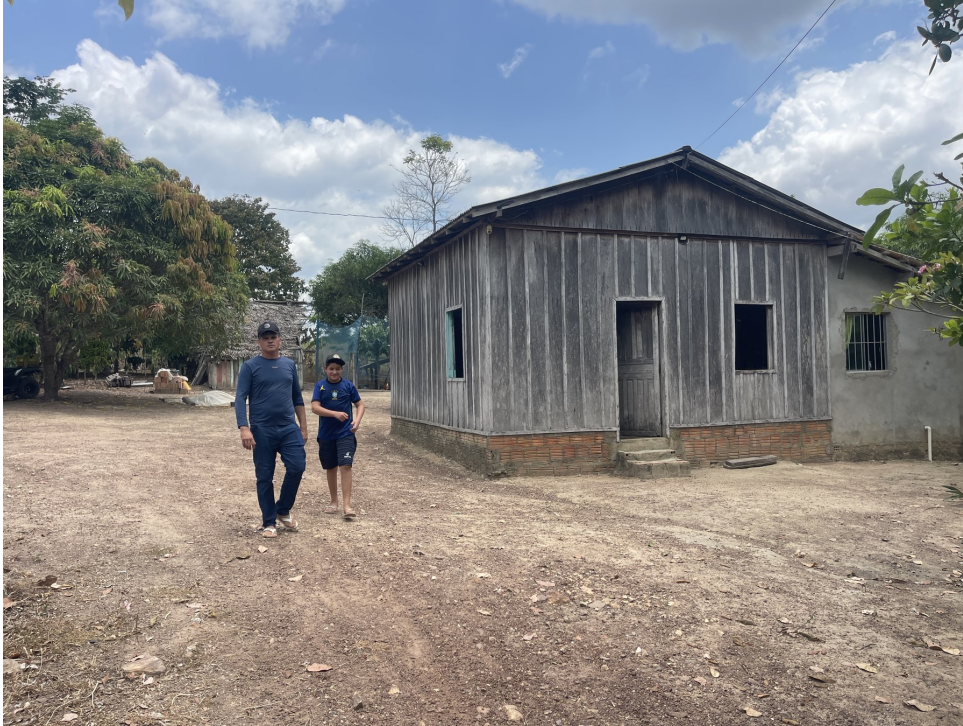
Reference image – Facility A cacao farm (existing grove), Sítio Torres; representative farm view from the 09-Sep-2026 site walk (IMG\_9622).

| Visual Observation | Remarks |
|---|---|
| Microbial Contamination (salmonella) | Existing cacao grove walked and inspected on 09-Sep-2026 (videos IMG_9623, IMG_9624, IMG_9630). Managed organically under the CEPOTX/CoopCao IBD NOP system. Cacao verdadeiro/híbrido across blocks aged 2/4/5 yr plus a >20 yr block (Alexandre's narration, IMG_9624). Enrichment planting ("enriquecimento") into standing capoeira (IMG_9630). |
| Insect Infestation | Organic agroforestry under native shade — cumaru (native Amazon) planted through the grove (IMG_9623/IMG_9624). No pest outbreak observed during the walk. |
| Foreign objects like rocks, dirt, or debris from the field | Pods harvested selectively by hand; grove floor clear during the walk. No foreign-object contamination source observed at the harvest area. |

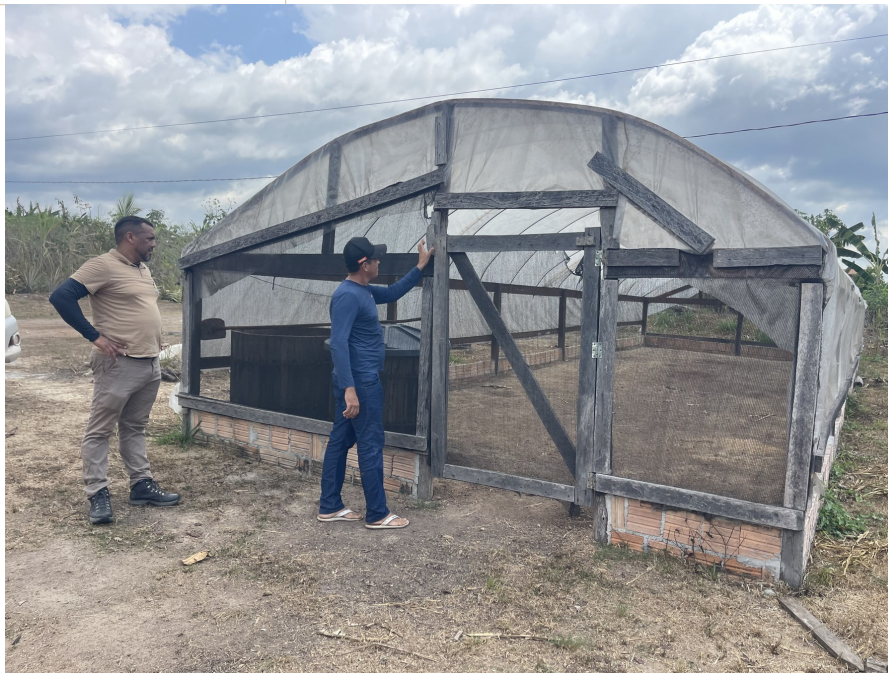
| Visual Observation | Remarks |
|---|---|
| Mold growth due to improper drying practices | Sun-drying (“secagem”, IMG_9703) is carried out on-site under the covered processing structure (screened walls, translucent roof, brick footing — IMG_9673), the SAME physical structure in which the fermentation vessels are housed (Facility B). No mold observed at the time of visit. Drying-regime details (bed surface, batch depth, turning) to be confirmed — <i>[PENDING]</i> . |
| Inclusion of foreign objects during drying and sorting process | Beans dried and sorted on-site under the covered structure; no debris or foreign objects observed. Dedicated clean drying-surface details to be confirmed — <i>[PENDING]</i> . |
| Residues from cleaning agents or pesticides | Property within the organically certified (IBD NOP) CEPOTX/CoopCao system; no cleaning-agent or pesticide residue sources observed at the site premises. |

Facility C – the covered processing structure (screened walls, translucent roof on a brick footing) under which sun-drying is carried out and in which the fermentation vessels are housed — the same structure shown under Facility B. Sítio Torres – IMG\_9673.HEIC, captured 09-Sep-2026 13:21:37 local, GPS –3.5298, –51.1451 (alt 83.2 m).
