## CEPOTX site visit 9th September 2026 — Sítio Torres

This document establishes the record for FSVP compliance requirements (21 CFR 1.470–1.514) of our site visit to the CEPOTX facility at Sítio Torres — recorded on the farm as “Sítio 2” (plot code N-06-66), a member property of the COOPCAO cooperative (CEPOTX family), Pacajá/PA, on 9th September 2026. Evidence was captured on-site: 38 geotagged photographs, 35 locus-tagged walk videos and 8 artefacts, archived in the media-archive pipeline (farm\_media\_manifests/sitio-torres-pacaja-para.json + 20260909\_pacaje\_location\_2\_nursery.zip.archive.json).

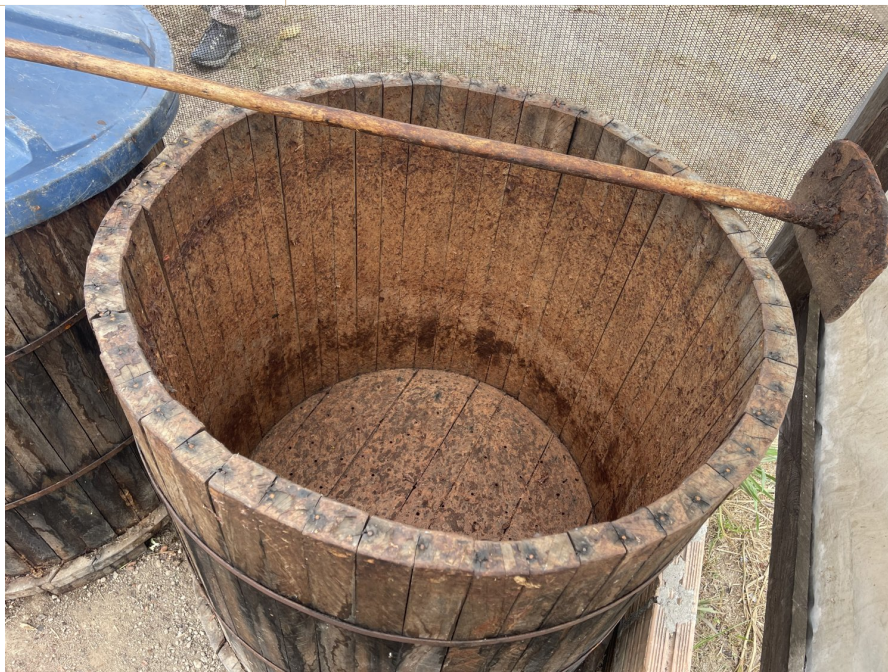
| Visual Observation | Remarks |
|---|---|
| Undesirable Fermentation | Fermentation is carried out in wooden vessels/tanks housed inside the on-site covered processing structure (screened walls, translucent roof over a brick footing) — the SAME physical structure used for sun-drying (see Facility C). Documented in photo evidence IMG_9677 (wooden fermentation vessel inside the structure) and IMG_9673 (the covered structure itself), plus walk clip IMG_9678 (“fermentação... tanque... este aberto”). Regime details (box construction, days, turning) to be confirmed — <i>[PENDING]</i> . |
| Inclusion of non-cacao materials in fermentation containers | Only cacao beans are placed in the fermentation vessels; the structure is dedicated to cacao processing (IMG_9677 vessel + IMG_9673 structure + IMG_9678 walk-through). No non-cacao material observed in the container during the visit. |
| Contamination from pesticides or chemicals used in cacao plantations | The property sits within the organically certified (IBD NOP) CEPOTX/CoopCao system; no pesticide or artificial chemical use, and no chemical containers, observed on the premises during the walk. |

Facility B – wooden fermentation vessel (barrel/box) inside the covered processing structure, Sítio Torres – IMG\_9677.HEIC, captured 09-Sep-2026 13:22:07 local, GPS –3.5299, –51.1451 (alt 86.5 m).

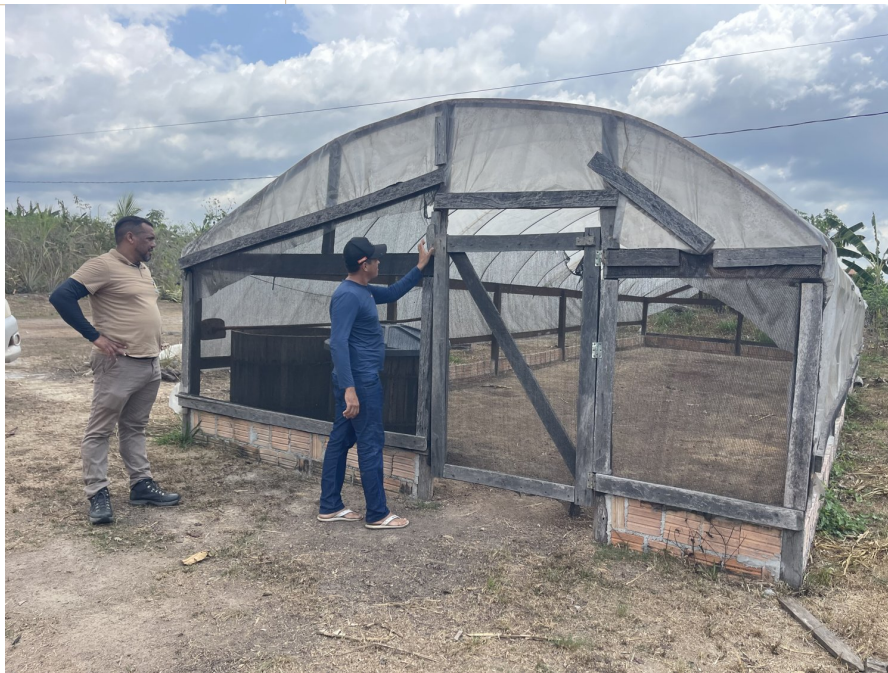
| Visual Observation | Remarks |
|---|---|
| Mold growth due to improper drying practices | Sun-drying (“secagem”, IMG_9703) is carried out on-site under the covered processing structure (screened walls, translucent roof, brick footing — IMG_9673), the SAME physical structure in which the fermentation vessels are housed (Facility B). No mold observed at the time of visit. Drying-regime details (bed surface, batch depth, turning) to be confirmed — <i>[PENDING]</i> . |
| Inclusion of foreign objects during drying and sorting process | Beans dried and sorted on-site under the covered structure; no debris or foreign objects observed. Dedicated clean drying-surface details to be confirmed — <i>[PENDING]</i> . |
| Residues from cleaning agents or pesticides | Property within the organically certified (IBD NOP) CEPOTX/CoopCao system; no cleaning-agent or pesticide residue sources observed at the site premises. |

Facility C – the covered processing structure (screened walls, translucent roof on a brick footing) under which sun-drying is carried out and in which the fermentation vessels are housed — the same structure shown under Facility B. Sítio Torres – IMG\_9673.HEIC, captured 09-Sep-2026 13:21:37 local, GPS –3.5298, –51.1451 (alt 83.2 m).

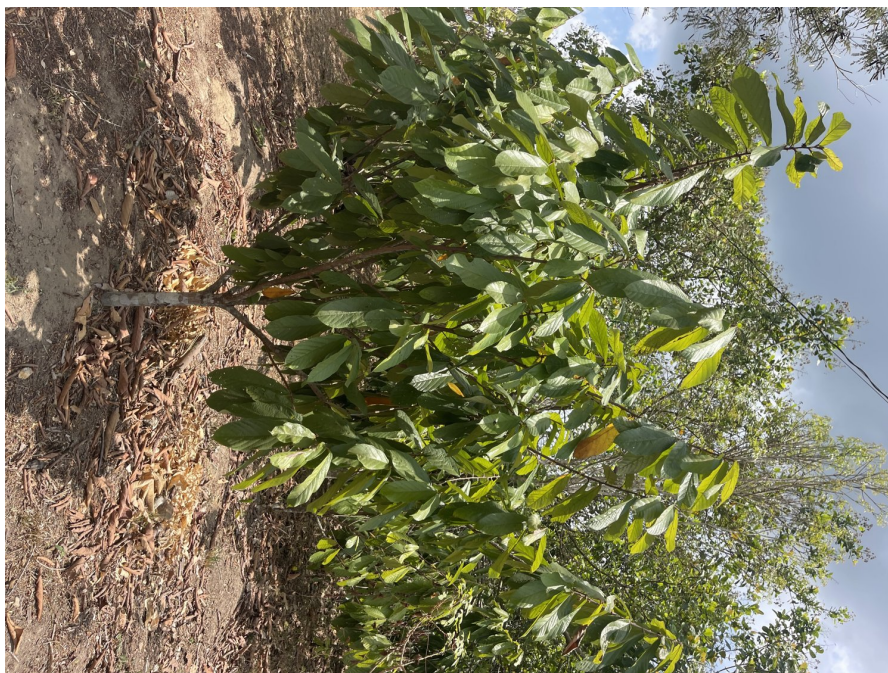
Sítio Torres – cacao plant growth: young cacao tree in vegetative stage (dense oblong-leaf canopy, slender trunk) within the grove – IMG\_9682.HEIC, captured 09-Sep-2026 13:27:44 local, GPS -3.5298, -51.1451.
