# CEPOTX site visit 8th Sept 2026

This document established record for FSVP compliance requirements of our site visit to CEPOTX facility

- Supplier name visited: CEPOTX
- Site name: Cleide Maris Suk
- Site code: B-06-108
- Date: 8th Sept 2026

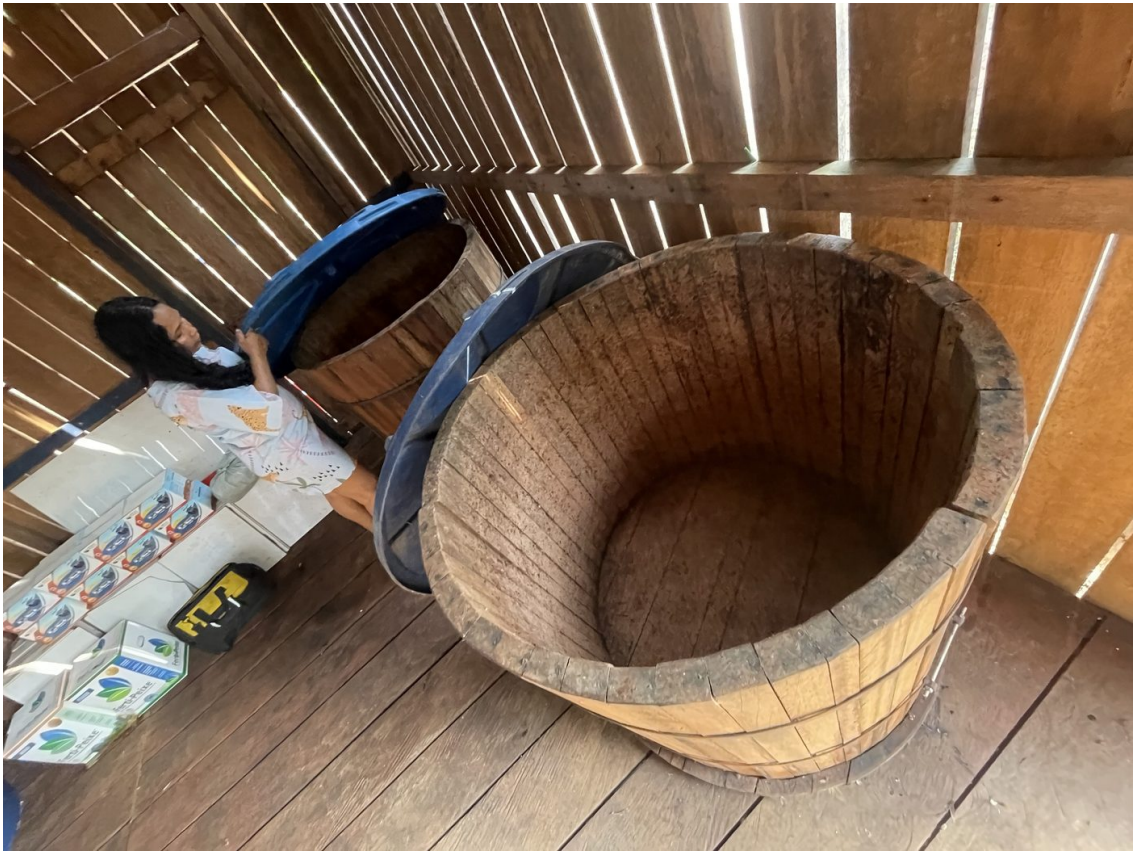
Photo evidence - Cacao fermentation facility (8 Sept 2026)

| Visual Observation | Preventive Control | Examined | Remarks |
|---|---|---|---|
| Microbial contamination / undesirable fermentation | Fermentation in dedicated fermentation tank/box on premise; nothing else processed in the fermentation house. | Fermentation tank observed clean and dedicated to cacao; standard smell/PH/taste batch checks per farm practice. | Visual observation confirmed. |
| Cross-contamination with chemicals | Premise is organically certified; no pesticides or artificial chemicals on site. | No chemical containers observed in fermentation area. | Visual observation confirmed. |

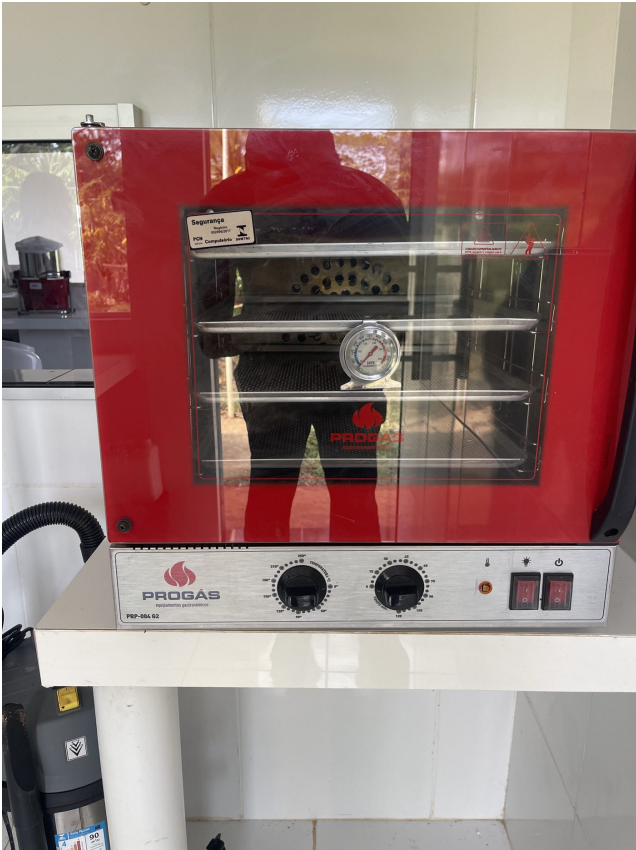
Photo evidence - Cacao roaster (8 Sept 2026)

| Visual Observation | Preventive Control | Examined | Remarks |
|---|---|---|---|
| Microbial survival during roasting | Roast until internal nib temperature reaches 180°C for 30 minutes. | Roaster observed in working order; temperature/time verified on unit. | Roasting process itself kills off microbial growth. |
| Equipment hygiene & maintenance | Daily cleaning; full maintenance yearly, part maintenance quarterly; repairs before next batch. | Machine observed clean and in good working order. | Confirmed. |
| Sealing / foreign objects | Stove sealed during roasting; regular maintenance of seals. | Equipment observed sealed during operation. | Confirmed. |

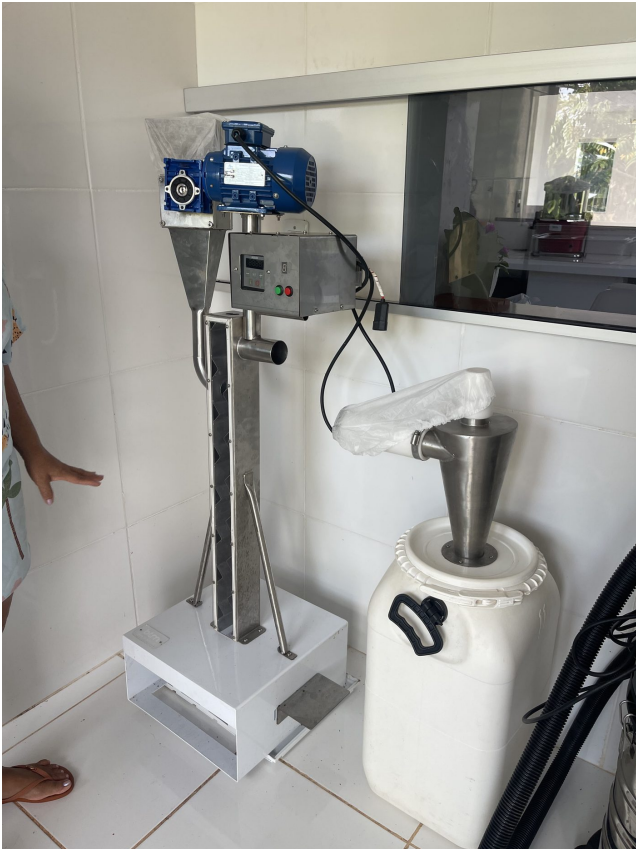
Photo evidence - Winnowing and cracking facility (8 Sept 2026)

| Visual Observation | Preventive Control | Examined | Remarks |
|---|---|---|---|
| Shell fragments in nibs | Proper cracking + winnowing equipment automates shell-fragment removal; visual inspection and sieving. | Winnower/cracker observed in use; shell removal automated. | Only cacao nibs processed at this facility. |
| Contamination / allergens | Clean and sanitize winnowing equipment between batches; only cacao processed (no cross-contact). | No other materials observed being processed. | Confirmed. |
| Personnel hygiene | Workers to wear hair mesh and gloves. | Hair mesh observed worn. | Confirmed. |

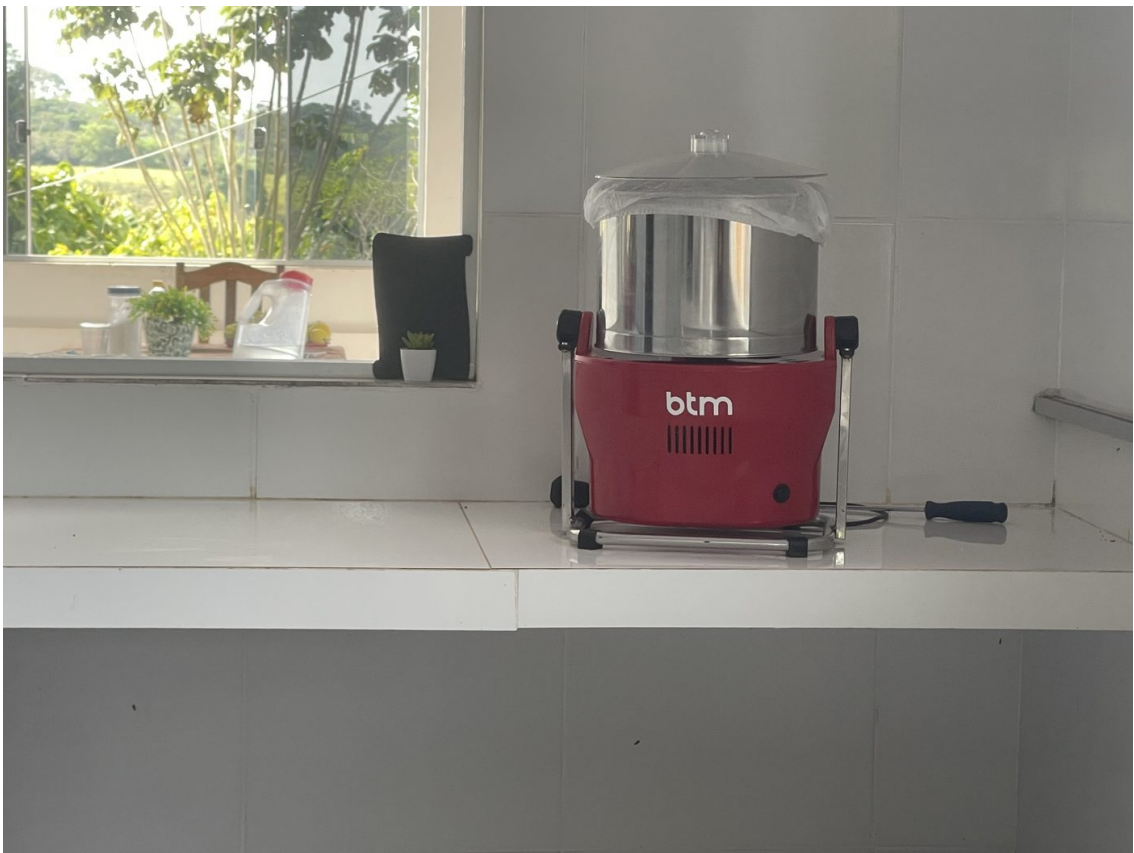
Photo evidence - Melanger (chocolate mass grinding) (8 Sept 2026)

| Visual Observation | Preventive Control | Examined | Remarks |
|---|---|---|---|
| Metal contamination | Proper maintenance, metal detection; machine is sealed during operation. | Machine observed in good working condition; no metal fragments observed in cacao mass. | Confirmed. |
| Hygiene between batches | Daily cleaning; in-between uses openings sealed with covers to prevent contaminant entry. | Machine observed clean and sealed when idle. | Confirmed. |

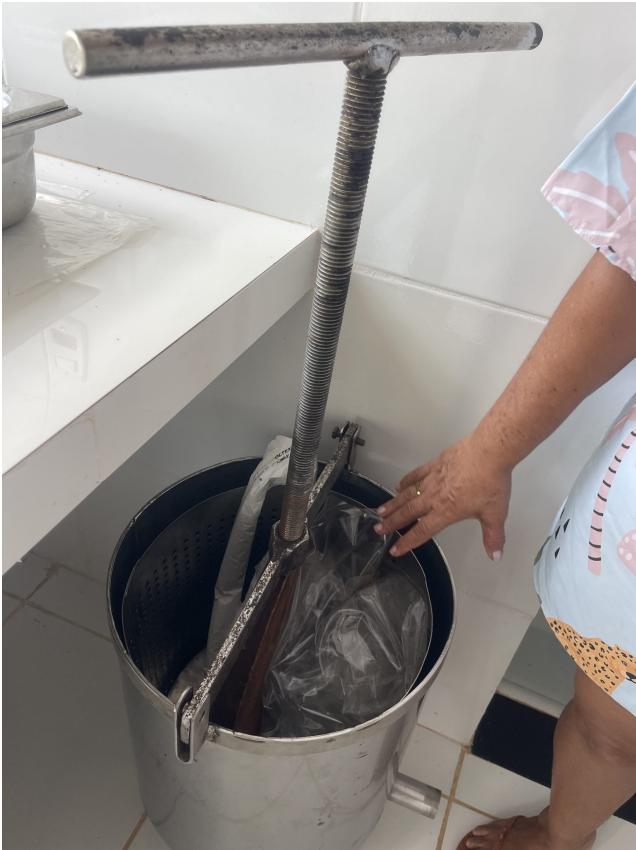
Photo evidence - Cacao juice (honey) press (8 Sept 2026)

| Visual Observation | Preventive Control | Examined | Remarks |
|---|---|---|---|
| Microbial contamination | Regular cleaning and sanitizing of press equipment; rinse after cleaning with approved agents. | Press equipment observed clean; no visual signs of contamination. | Confirmed. |
| Cross-contamination with chemicals | Isolate cacao juice extraction from chemical-related processes; proper chemical storage/handling. | No evidence of cross-contamination with chemicals. | Confirmed. |
| Foreign objects | Use screens or filters; regular inspection of equipment. | No foreign objects observed in juice. | Confirmed. |

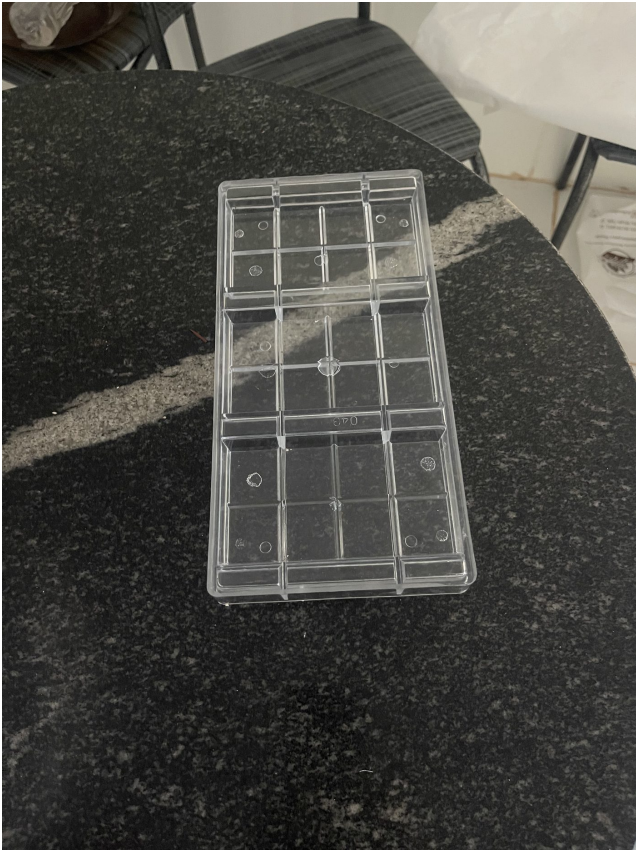
Photo evidence - Chocolate moulding (molds / bars) (8 Sept 2026)

| Visual Observation | Preventive Control | Examined | Remarks |
|---|---|---|---|
| Hygiene practices | Proper hygiene; gloves/masks; regular cleaning and sanitizing of moulding area and moulds. | Moulding area observed clean; no visual signs of contamination. | Confirmed. |
| Allergen / cross-contact | Facility only processes cacao/chocolate; allergen controls in place. | No non-cacao materials observed being processed. | Confirmed. |
| Foreign objects | Regular inspection of moulds and equipment; approved food-grade moulds. | No foreign objects observed in finished bars. | Confirmed. |

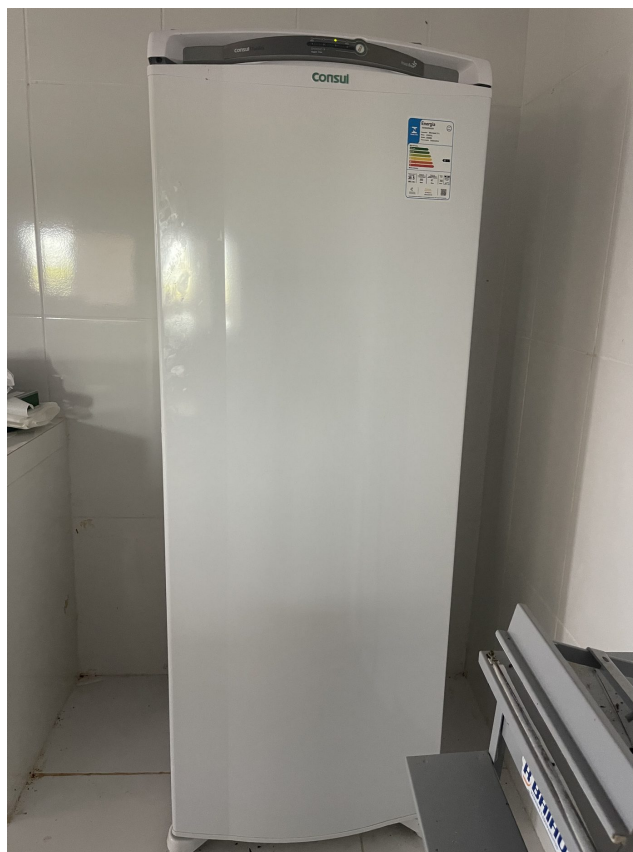
Photo evidence - Fridge / cold-hold (tempering & storage of finished chocolate) (8 Sept 2026)

| Visual Observation | Preventive Control | Examined | Remarks |
|---|---|---|---|
| Temperature control | Monitor storage temperature; maintain refrigeration equipment; temperature kept in specified range. | Fridge observed operating; temperature maintained below/within required range for finished chocolate. | Confirmed. |
| Contamination / odours | Separate chocolate from strong-smelling products; proper packaging and sealing. | Finished product stored sealed; no off-flavours or odours observed. | Confirmed. |
| Hygiene | Regular cleaning and sanitizing of storage area; inspect containers. | Storage clean; no visible damage to containers. | Confirmed. |

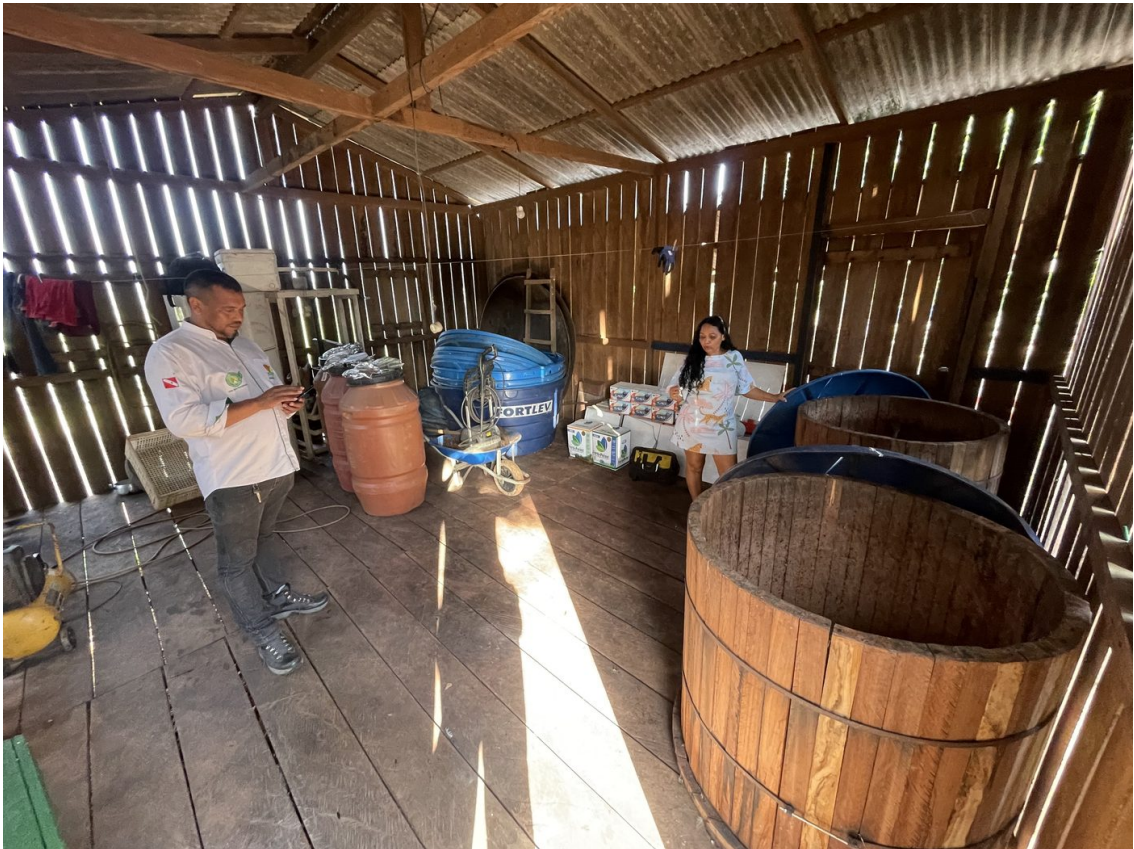
Photo evidence - Storage facility (8 Sept 2026)

| Visual Observation | Preventive Control | Examined | Remarks |
|---|---|---|---|
| Pest / foreign objects | Store materials off floor, sealed packaging; regular inspection of storage area. | Storage observed tidy; bags/packageging sealed; no evidence of pests. | Confirmed. |
| Cross-contamination with chemicals | Isolate food storage from chemical-related processes; proper chemical storage. | No chemicals observed in food storage area. | Confirmed. |
| Hygiene & housekeeping | Regular cleaning and sanitizing of storage area. | Area observed clean and organised. | Confirmed. |
