## CEPOTX site visit 3rd September 2026

### Supplier and visit dates

- **Supplier name visited:** CEPOTX — Cooperativa Central de Produção Orgânica da Transamazônica e Xingu (Altamira/PA). FSVP registration VALID (FFR 14674182470)
- **Sub-cooperative:** COPOPS — Cooperativa de Produtos Orgânicos de Perpétuo Socorro (Uruará/PA)
- **Site name:** Sítio Raimundo & Geniza
- **Site code:** U-06-07
- **Registered owner / host:** Raimundo Silva (Presidente, COPOPS) & Geniza
- **Date:** 3rd September 2026 (media records: 22 photos 10:44–13:29 local; 14 videos)

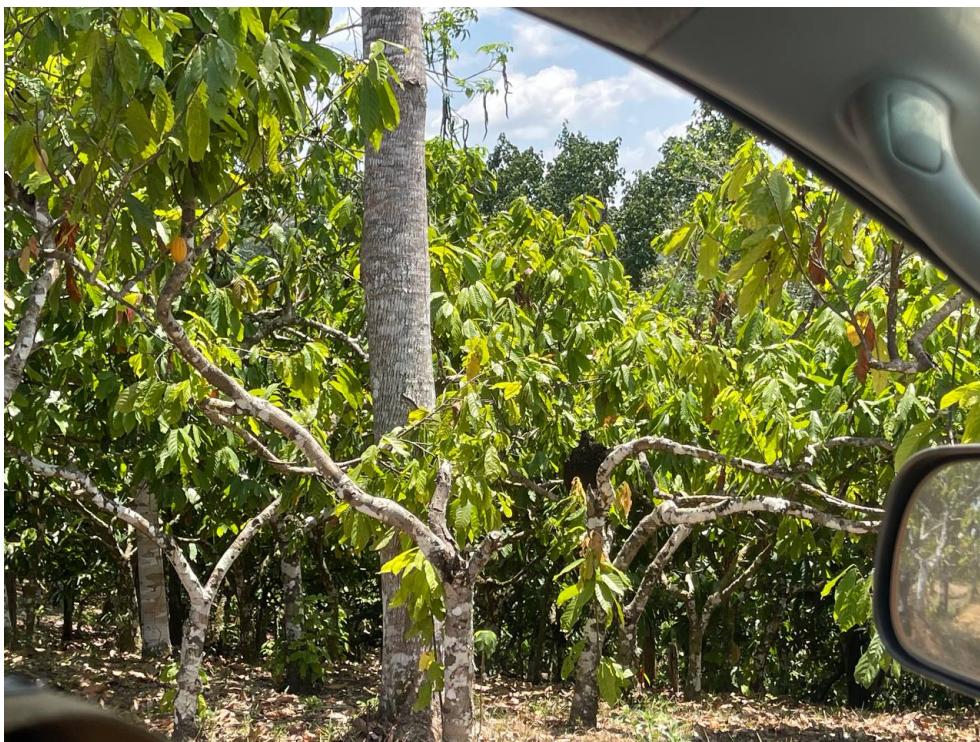
| Visual Observation | Remarks |
|---|---|
| Microbial Contamination (salmonella) | Existing cacao grove walked and inspected on 03-Sep-2026 (videos IMG_8206, IMG_8210, IMG_8215, IMG_8259). Farm managed organically and certified IBD NOP since 2006 (Raimundo's narration, IMG_8210). Family has farmed cacao since 1980 (IMG_8210). Grove includes trinitário-forasteiro hybrid managed organically (IMG_8215). |
| Insect Infestation | Organic agroforestry management; native shade species (comaru, andiroba, copaíba) planted between rows for shade and ecological balance (IMG_8206). No pest outbreak observed during the walk. |
| Foreign objects like rocks, dirt, or debris from the field | Pods harvested selectively by hand; beans extracted on-site; the sítio runs a renovation planting (younger grove, 4 m mechanisation rows / 3 m irrigation rows – IMG_8244, IMG_8259). No foreign-object contamination source observed at harvest/extraction area. |

Facility A – existing cacao tree inspection, Sítio Raimundo & Geniza (photo from 03-Sep-2026 site walk; one of the 22 archived HEIC originals).

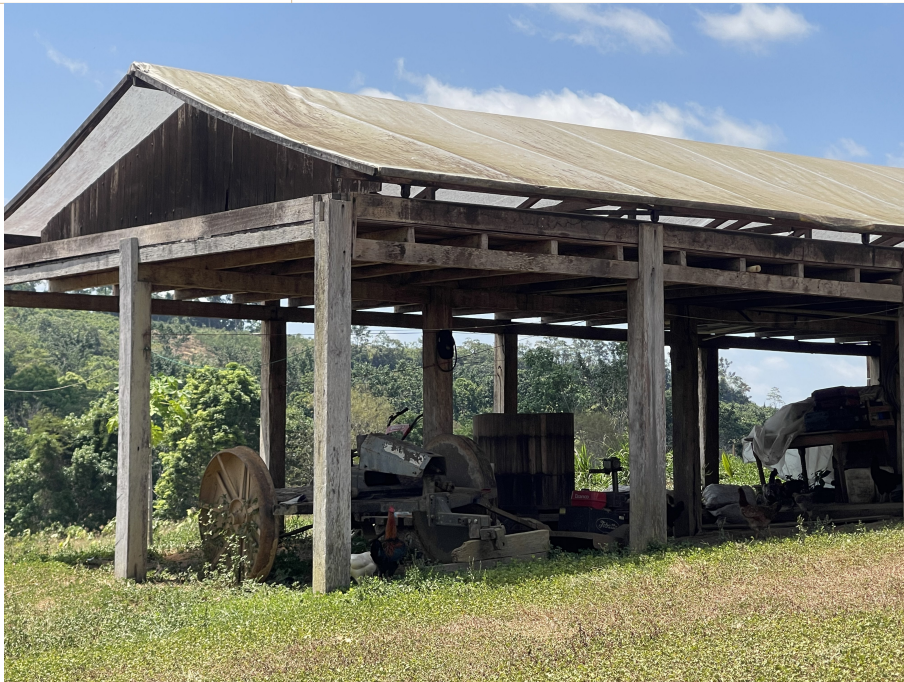
| Visual Observation | Remarks |
|---|---|
| Undesirable Fermentation | Fermentation is carried out in a dedicated wooden barçaça (fermentation box). Raimundo improved the fermentation structure specifically “to focus on quality cacao” – a definitive barçaça construction that does not need rebuilding every three years (IMG_8237 narration). Fermentation site confirmed by IMG_8277 (photo) and IMG_8235 (walk clip: “fermentação”). |
| Inclusion of non-cacao materials in fermentation containers | Only cacao beans are placed in the fermentation barçaça; the structure is dedicated to fermentation (IMG_8237 walk-through). No non-cacao material observed in the container during the visit. |
| Contamination from pesticides or chemicals used in cacao plantations | The sítio is organically certified (IBD NOP) since 2006; no pesticide or artificial chemical use observed on the premises (IMG_8210 narration, on-site walk). |

Facility B – fermentation barçaça area, Sítio Raimundo & Geniza – IMG\_8277.HEIC, captured 03-Sep-2026 13:29:07 local, GPS -3.630242, -53.652017 (alt 180.7 m).

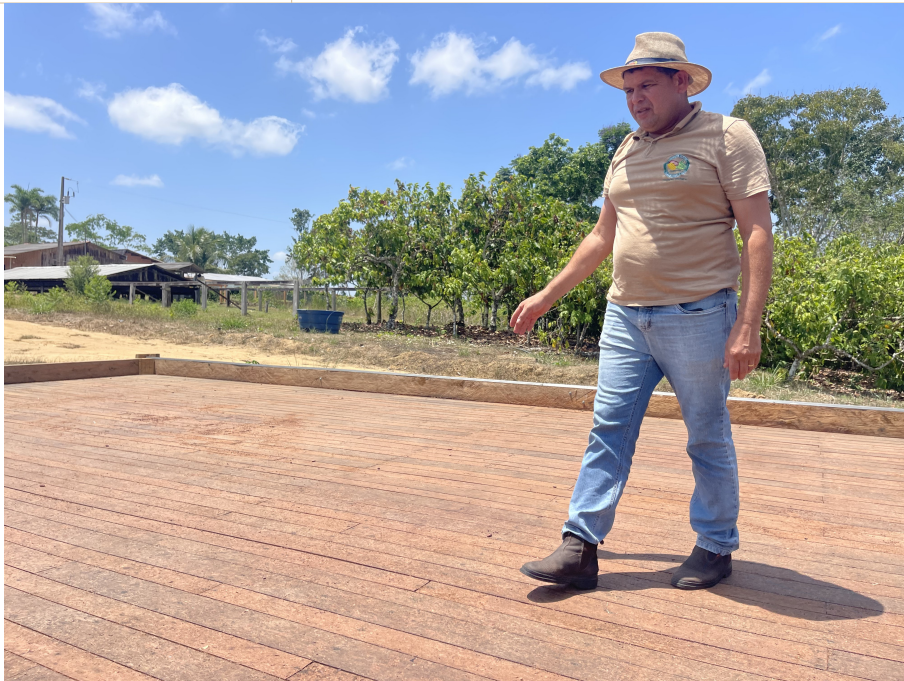
| Visual Observation | Remarks |
|---|---|
| Mold growth due to improper drying practices | Beans are dried at the dedicated sun drying station (“estação de sol” – IMG_8235 narration), in the open air on drying platforms. Sun-exposed, thin-layer drying observed at the station (IMG_8236 photo). No mold observed at the time of visit. |
| Inclusion of foreign objects during drying and sorting process | Drying station is a dedicated, clean area adjacent to the fermentation barçaça (IMG_8235/IMG_8236). Beans handled on the drying surface only; no debris or foreign objects observed. |
| Residues from cleaning agents or pesticides | Sítio organically certified (IBD NOP) since 2006; no cleaning-agent or pesticide residue sources observed at the drying station or premises (IMG_8210 narration, on-site walk). |

Facility C – sun drying station, Sítio Raimundo & Geniza – IMG\_8236.HEIC, captured 03-Sep-2026 11:41:58 local, GPS -3.630328, -53.652011 (alt 181.1 m).
