**KATHMANDU UNIVERSITY**  
**SCHOOL OF ENGINEERING**  
**DEPARTMENT OF MECHANICAL ENGINEERING**

**PROJECT REPORT ON**  
**Inspection and Preliminary Maintenance of CNC VESTA 660 at KU**

2025-11-09

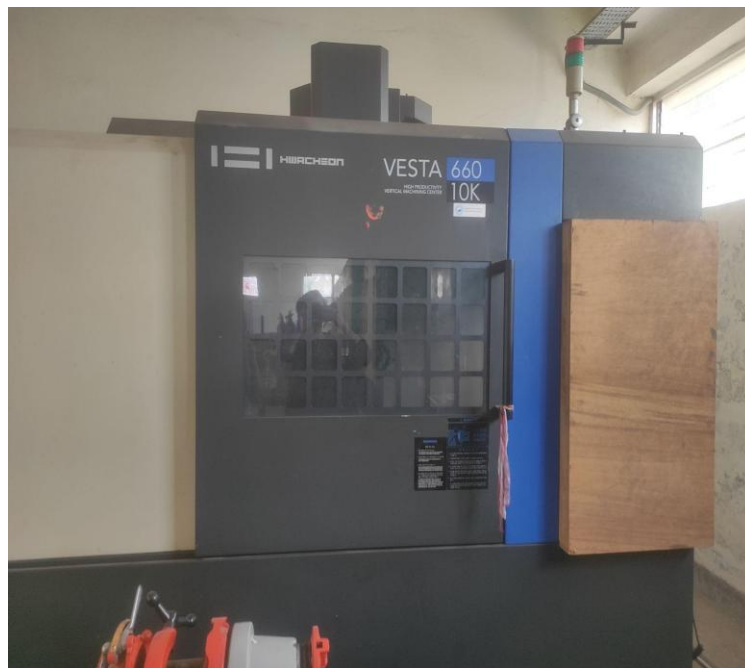
Figure 1: CNC at KU

As a result, the machine remained inactive for a prolonged period, creating an environment that allowed rodent intrusion. Over time, mice severely damaged internal wiring, especially within the operating panel and control circuits, leading to the complete breakdown of the system.

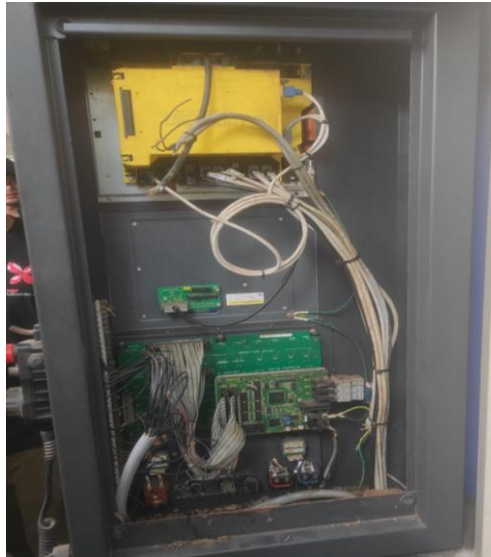
Figure 3: Operating Panel

Among all external compartments, the operating panel of the CNC VESTA 660 was selected for detailed examination. This decision was based on the observation that the majority of damaged wires were concentrated in this section. The operating panel serves as the central

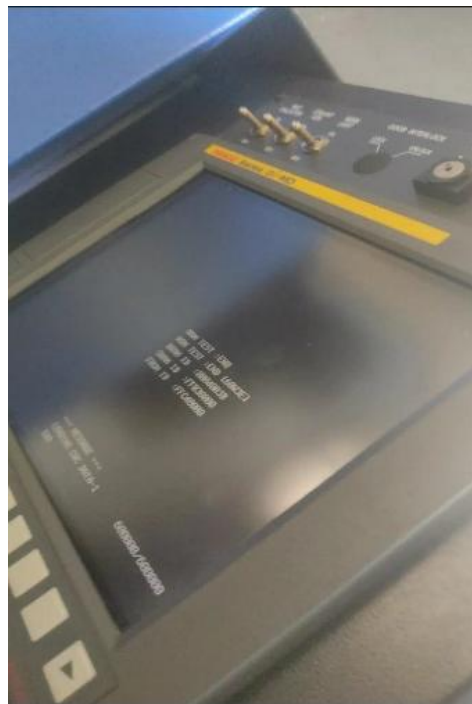
Figure 5: Display

An external regulated 24V DC power supply was applied directly to the control unit's power input. The system successfully initiated the **Fanuc Boot System**, completing both **RAM and ROM integrity tests** with an "END" status. This result confirms that:

- **Hardware Viability:** The main CPU board, DRAM, and SRAM modules are electronically functional and do not require replacement.
- **Display Integrity:** The LCD backlight and screen module are operational, indicating that the failure to boot previously was a result of external wiring damage rather than hardware failure.
- **Isolation of Faults:** The diagnostic confirms that the current system "hang" at the boot loader is a logical issue (loss of SRAM data or missing I/O link signals) rather than a physical hardware defect in the display unit.

- CNC Control & Display Viability:** The Fanuc 0i-MD Control Unit and LCD monitor are electronically functional. Isolated testing via a 24VDC external supply confirmed that the main CPU board successfully passes internal **RAM and ROM integrity tests**. This suggests that the core "intelligence" of the machine is intact and the primary issues are restricted to external communication and power delivery.

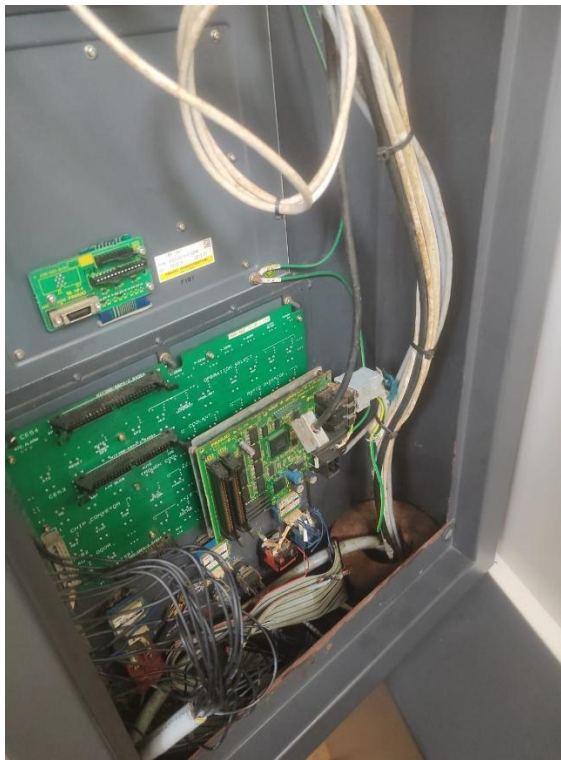
Figure 6: Damaged parts

- **MDI Logic Interface:** The MDI Interface Board (A20B-2004-0430/01A) showed visible damage to the connector headers. Due to the proprietary nature of Fanuc's serial communication protocols, this unit must be restored to its original specification to ensure the CNC receives accurate input signals.
- **Internal Interconnect Failure:** The 40-pin MDI-to-CPU ribbon cable has suffered total failure due to severed conductors. Since this specific Fanuc model does not support standard USB keyboard inputs for system-level diagnostics, the restoration of this proprietary link is a critical path for machine recovery.
- **Signal Routing (JA3/CP1):** Severe degradation was found in the external wiring routed to the JA3 (Signal) and CPD1 (Power) ports. These links are essential for the MDI unit to communicate with the main CNC rack in the electrical cabinet.

- HMI and MDI System Integrity:** The Human-Machine Interface (HMI), specifically the MDI (Manual Data Input) unit, was identified as a critical failure point. Physical inspection revealed severed proprietary ribbon cables and terminal damage to the A20B-2004-0430/01A Interface Board.

- Cabling and Communication Faults:** Extensive rodent damage was documented on the JD1A/JD1B (I/O Link) and JA3 (Signal) cables. These faults currently prevent the CNC from communicating with its "limbs" (I/O modules and motors). Replacement is required to meet Fanuc's electromagnetic compatibility (EMC) standards.

The following components and cable assemblies have been identified as non-functional based solely on the current **diagnostic inspection and physical results**. Because these units handle proprietary Fanuc Serial Bus (FSSB) and I/O Link protocols, they must be replaced with specified industrial parts to ensure system integrity and allow the restoration process to move beyond the "Boot System" stage.
